# Technical Service Bulletin

## 00 Q4 - Workaround for residual DTCs at PDI (B184C00, B18B0F2, C110B54)

00 22 60 2067878/1 August 30, 2022.

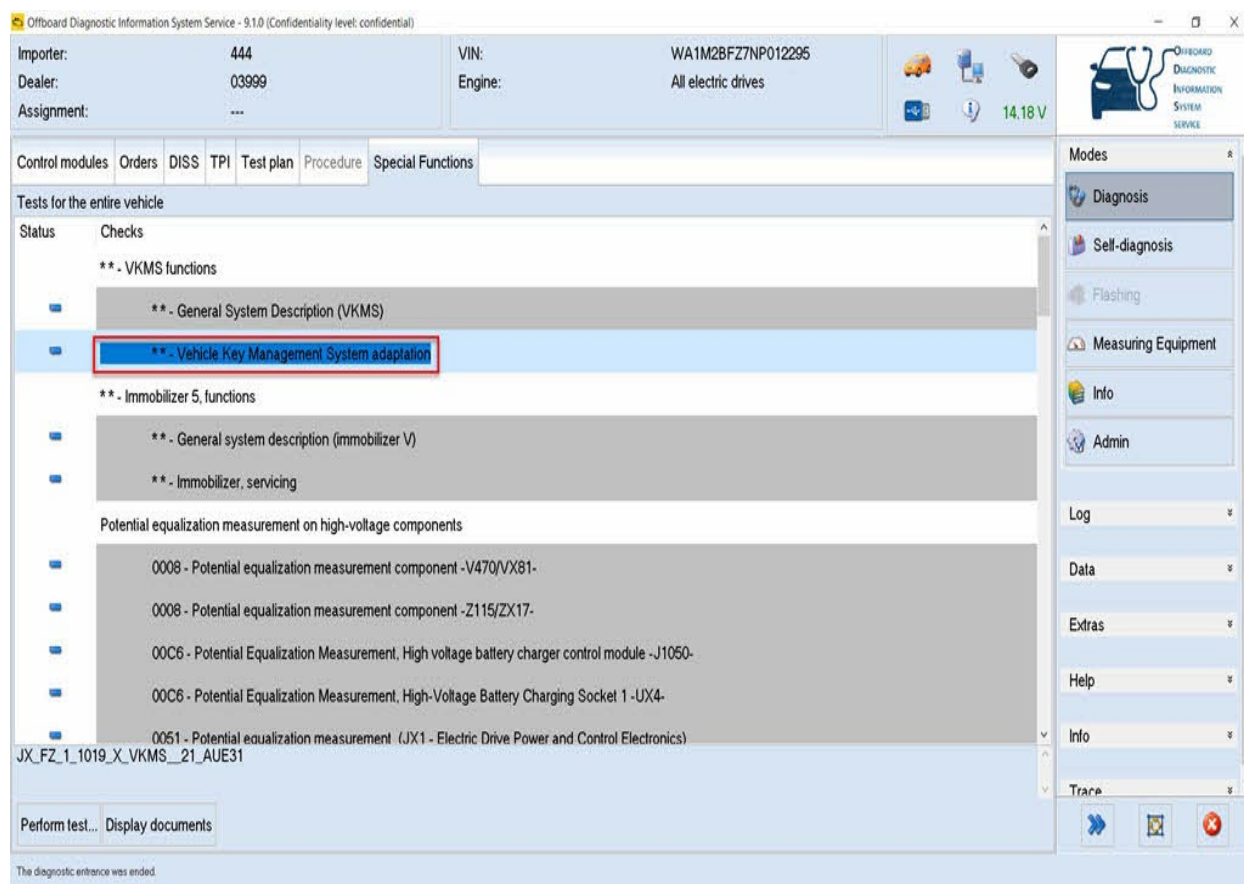
*VKMS adaption*

1. In ODIS GFF, go to the tab “*Special Functions*” (Figure 1).
2. Run the test plan “\*\* - *Vehicle Key Management System adaption*” (Figure 1).
