Technical product information

Topic	Oil leak from the oil separator/breather connection - Intake manifold whistle - Emission control warning within the DIP
Market area	Russische Föderation (5RU),Australia E04 Bentley rest Asia and Australia (6E04),China 796 VW Import Comp. Ltd (Vico), Beijing (6796),Germany E02 Bentley rest Europe (6E02),Japan E03 Bentley Japan (6E03),Korea, (South) E08 Bentley South Korea (6E08),United Arab Emirates E06 Bentley Middle East and Africa (6E06),United Kingdom E01 Bentley UK (6E01),United States E05 Bentley USA and rest America (6E05)
Brand	Bentley
Transaction No.	2066040/2
Level	EH
Status	Approval
Release date

Bentayga-New GT/GTC-New Flying Spur-W12 TSI & Speed models

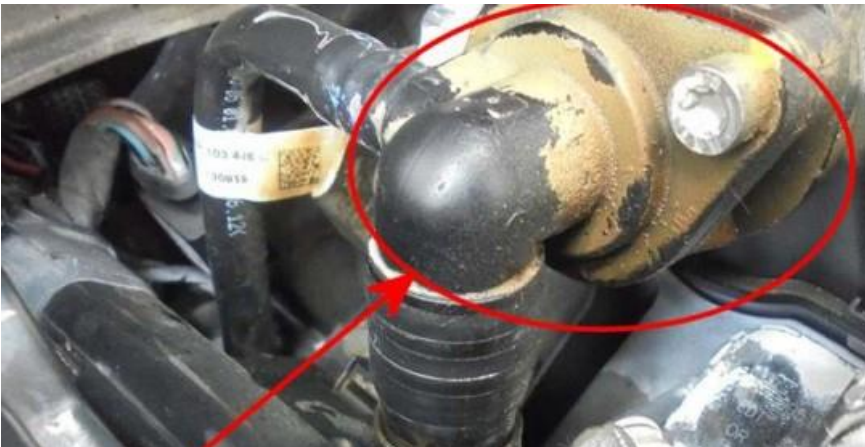
Figure 1

Oil leak between the oil separator tank and the Bank 1 breather line connection (Figure 1)

NOTE: Oil leak detection spray is evident within Figure1, the use of detection spray in the example shown highlights the location of the leak

- 1) Referring to Rep.Gr 17 - Gain access to the oil separator tank
- 2) Referring to Figure 2 - Replace the following parts and all associated parts as detailed within the applicable Rep.Gr and the ETKA parts catalogue
