Technical Service Bulletin

68 Noises from the MMI screen

68 22 38 2061722/4 August 30, 2022. Supersedes Technical Service Bulletin Group 68 number 22-37 dated June 6, 2022, for reasons listed below.

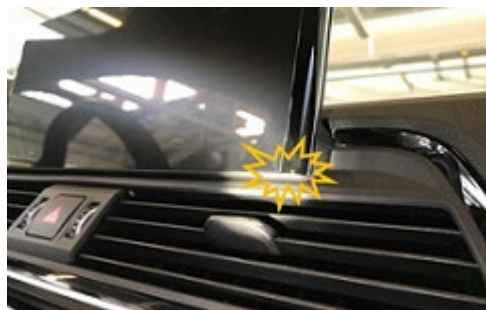
Relative movement between the MMI screen and its mounting surfaces in the dash panel.

1. Check the gap between the MMI screen and the center vent with a feeler gauge (Figure 1). A gap of 1.0 mm is ideal to avoid any noise-related concerns. If the gap

is less than 0.5 mm, perform the following repair.

Figure 1. *The gap between the MMI screen and the center vent should be 0.5 mm or greater.*

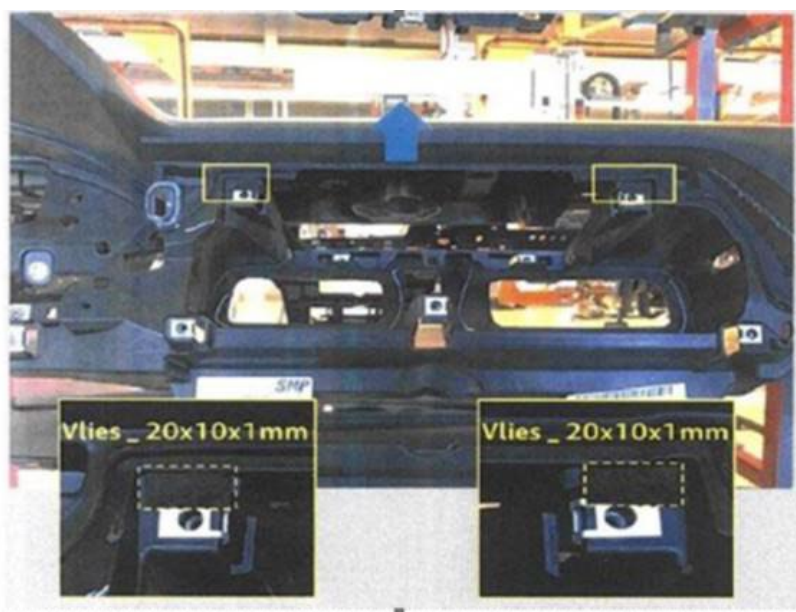
Figure 2. *Apply two pieces of felt tape to the dash panel in the area shown.*

- Felt strips with part number 533867910A (dimensions: 20x10x1 mm).

2. Remove the MMI screen according to the Elsa repair manual.
3. Attach two pieces of felt tape to the MMI screen mounting surfaces in the dash panel (Figure 2).
