Technical product information

Topic	W12 Engine management light on - Turbocharger speed sensor DTC's stored
Market area	Bentley: worldwide (2WBE)
Brand	Bentley
Transaction No.	2053348/7
Level	EH
Status	Approval
Release date

W12 - New GT/C - New Flying Spur & Bentayga

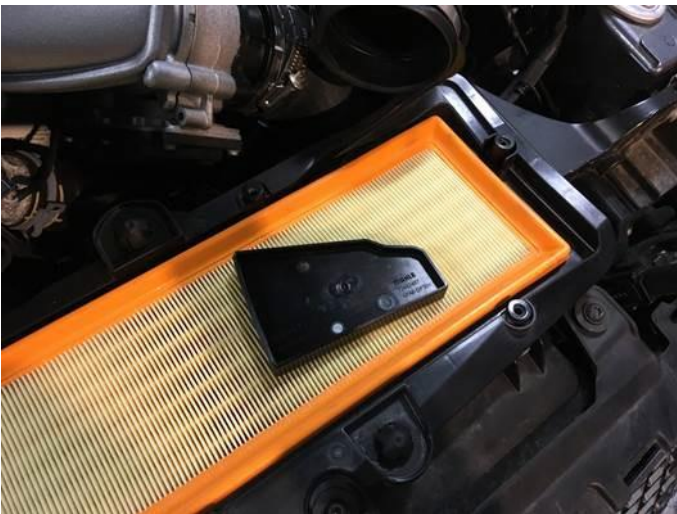
- Inspect for damage or missing components NOTE: The example in Figure 1 shows an air filter box divider that has become detached, causing DTC-P259400: Turbocharger Speed Sensor "B" - Circuit Range/Performance
- Reattach the divider and retest the vehicle if this particular fault is found
