Technical product information

Topic	Bentayga Hybrid - Unable to charge the high voltage battery or charging starts and then stops
Market area	Russische Föderation (5RU),Australia E04 Bentley rest Asia and Australia (6E04),China 796 VW Import Comp. Ltd (Vico), Beijing (6796),Germany E02 Bentley rest Europe (6E02),Japan E03 Bentley Japan (6E03),Korea, (South) E08 Bentley South Korea (6E08),United Arab Emirates E06 Bentley Middle East and Africa (6E06),United Kingdom E01 Bentley UK (6E01),United States E05 Bentley USA and rest America (6E05)
Brand	Bentley
Transaction No.	2066497/2
Level	EH
Status	Approval
Release date

Bentayga Hybrid

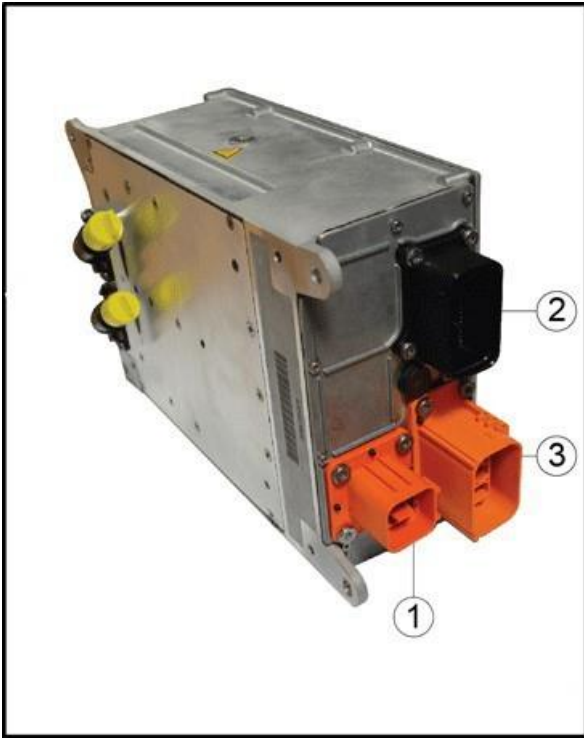
5) Referring to Figure 1 - Disconnect the 12V and the high voltage connections from the On Board Charger (AX4)

- 12V (Number 2)
- High voltage connections (Numbers 1 and 3)

- 6) Conduct a visual check of the On Board Charger (AX4) plugs/terminals
- 7) Conduct a visual check of the On Board Charger (AX4) connections and pins
- 8) Connect the 12V and high voltage connections back to the On Board Charger (AX4)
 - Conduct a pull test to confirm the plugs are connected to specification
- 9) Re-energise the high voltage system - RepGr 93 - Electric Drive - Re-energising high - voltage system
- 10) Check to confirm if the DTC's within the Technical background section are still evident

Yes - The DTC's within the Technical background section are still evident - Replace the On Board Charger (AX4) Refer to Rep. Gr 93 - Charging unit 1 for high voltage battery AX4 - To remove and refit
