Location: Powertrain

Topic: Procedure for recovering McLaren Artura engine coolant pump seal

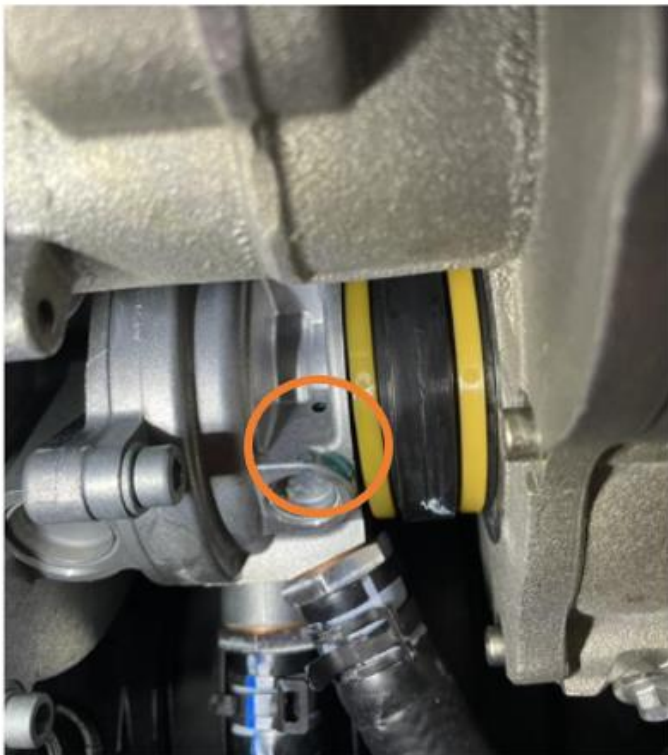
A leak can be caused at the engine coolant pump after the engine coolant has been refilled incorrectly.

If the coolant system has been vacuumed for longer or vacuumed at a higher value than stated in SIS, the coolant pump internal seal can be dislodged, causing a small coolant leak from the expansion chamber of the coolant pump. See **figure 1.1**.

Figure 1.1 – Leak From Coolant Pump Expansion Chamber

To attempt recovery of the internal seal of the coolant pump, pressurise the cooling system with a coolant pressure tester to a **maximum of 1.1 bar** and leave the system pressurised for **4 hours**.

After 4 hours, release the pressure from the system and re-inspect the coolant pump for leaks.

Leave the car idling for 20 minutes to confirm the leak has been rectified.

By following these steps the internal seal within the coolant pump reforms to its original shape, therefore rectifying the leak.
