6900
> 47X
> 49X

**Western Star
Service Bulletin**

General Information

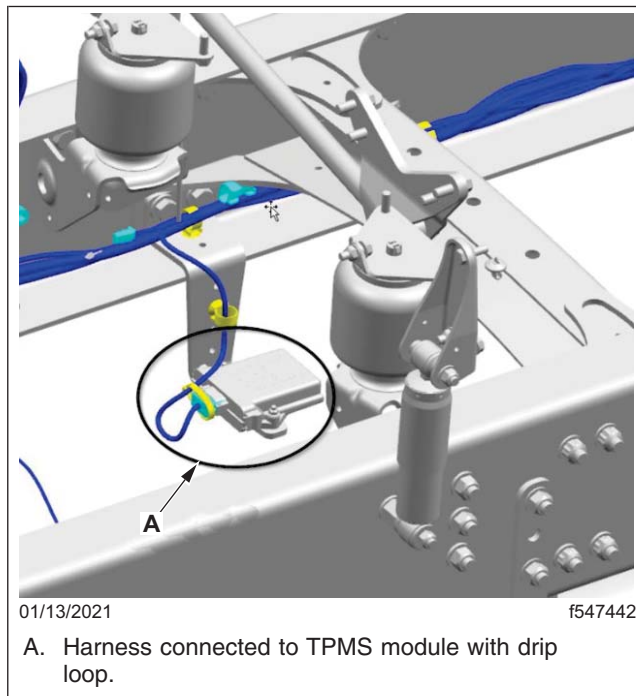
Fig. 6, Securing the Harness

A. Harness connected to TPMS module with drip loop.

8. Ensure that the harness (wire) connected to the TPMS has a drip loop and is securely fastened to the connector with the tie strap as shown in [Fig. 6](#).
