# Technical Service Bulletin

## 66 Wheel arch trim on front fender loose

66 22 91 2067881/1 August 30, 2022.

Model(s)	Year	VIN Range	Vehicle-Specific Equipment
Q3	2019 - 2023	All	Not Applicable

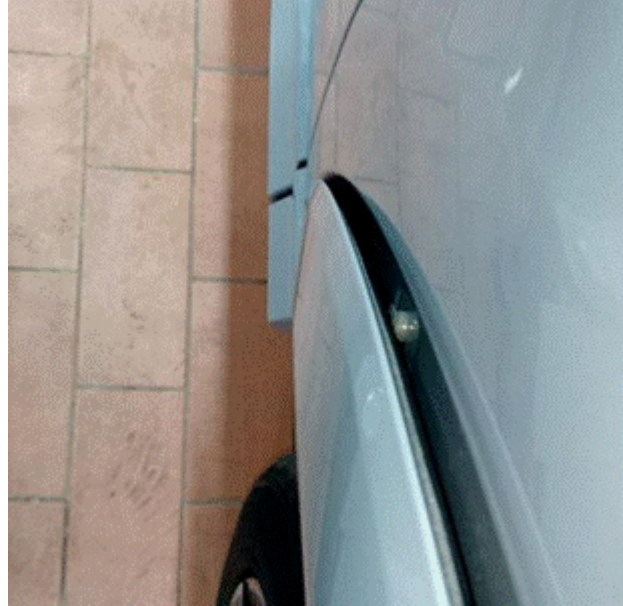
A visible gap between the front wheel arch trim and the front fender is visible.

During the trim installation process in production the female grommet that retains the male clip on the trim engages the male clip before it is fully seated to the fender surface creating a visible gap between the front wheel arch molding and the fender surface (Figures 1 & 2).

*Figure 1. The front wheel arch trim is not flush to the fender surface.*

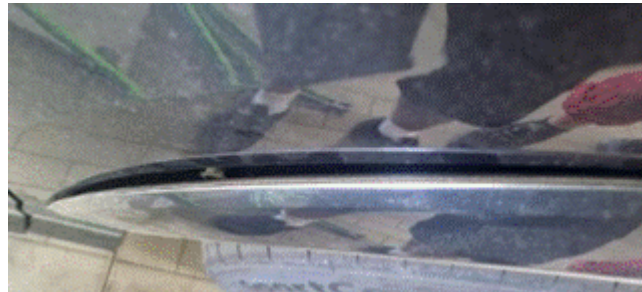
The front wheel arch molding clips are not fully seated to the fender surface.

*Figure 2. The front wheel arch trim with the retaining clips only partially engaged.*

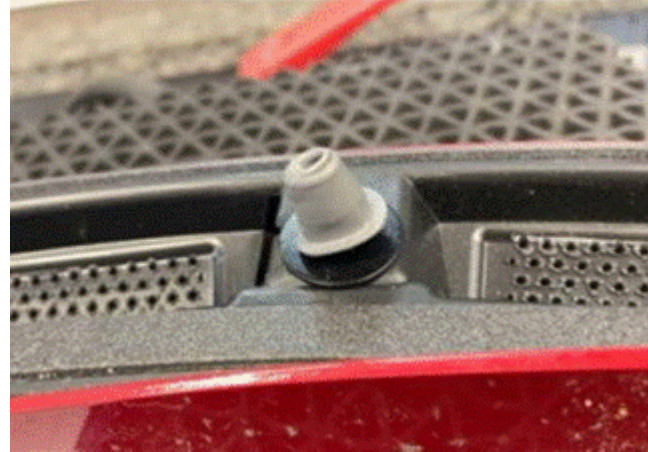
When the front wheel arch trim is removed damage to the female clip grommet is apparent (Figure 3).

*Figure 3. Front wheel arch trim with retaining clip grommet damaged.*
