GROUP	MODEL
ELE	2022MY EV6 (CV)
NUMBER	DATE
257 (Rev 1, 08/18/2022)	June 2022

TECHNICAL SERVICE BULLETIN

SUBJECT: **SERVICE ACTION: AMP LOGIC UPDATE/REPLACEMENT
FOR NOISE/NO SOUND ISSUES (SA494A)**

This issue number is SA494A.

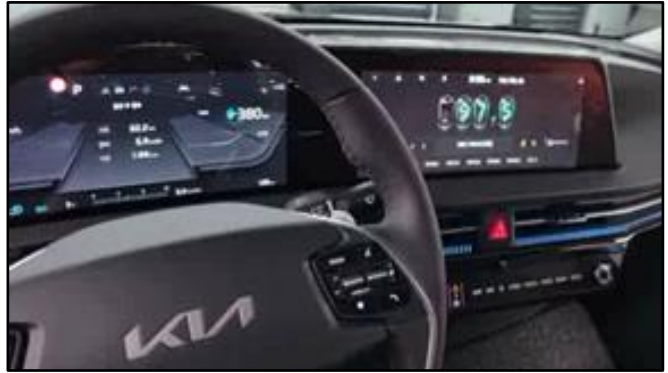
- 1a. Check for sound issues by listening for **at least one minute** in each of the following modes:
 - Radio (AM & FM)
 - Bluetooth music
 - Voice recognition
 - Phone call
 - Nature Sound
 - USB device

- 1b. Listen to identify if any of the following conditions are present:
 - Noise (clicking/popping/static)
 - No sound (brief, or for 30 seconds after switching to a Radio station)
 - Intermittent noise
 - Intermittent no sound

2. Were any of the sound conditions described above present in any mode?

YES: One or more of the above conditions are present.

- **NG: Proceed to the 'Replacement Procedure' to replace the External AMP.**

NO: Sound is normal in all modes.

- **OK: Proceed to the 'Software Update Procedure' to update the External AMP software.**
