**2022-08-29**

## Hand Control Module (HCM) Reflash Sequence

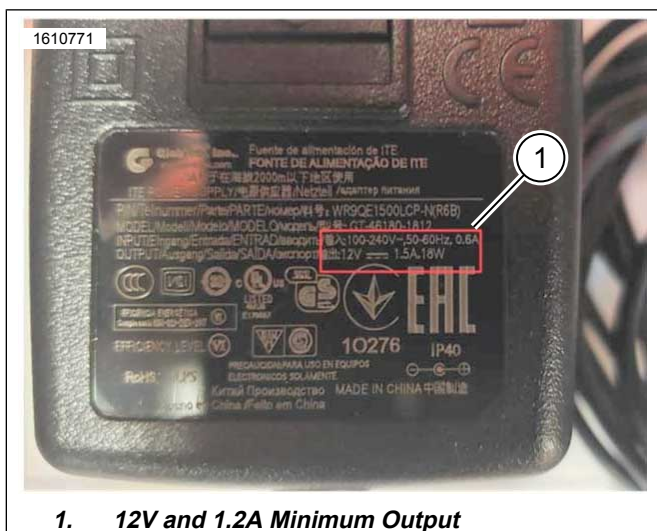
Figure 2. 12V and 1.2A Output

1. 12V and 1.2A Minimum Output
