# Frame Rail Cracks

M-711-002

(October 2008)

All CXU,CXP,CXN,CHU,and CHN built with Mack double reduction rear axle.

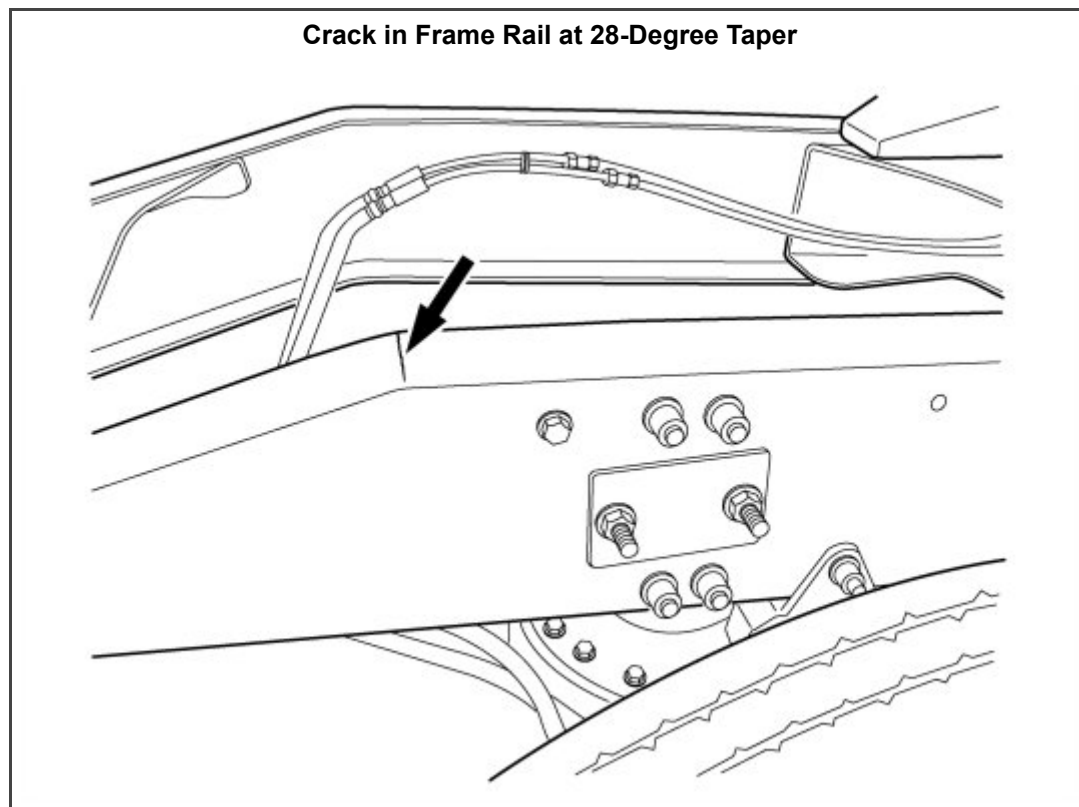
On certain CXU, CXP, CXN, CHU and CHN model chassis equipped with MACK rear axles, cracks may develop in the upper frame flange at the rear of the chassis where the upper flange is formed into the 28-degree tapered section of the frame rail. Should a crack in this area of the frame rail be encountered, reinforcement plates are available through the MACK Parts System. These plates should be installed to prevent cracks from recurring after the frame has been repaired.

*Note: Reinforcement plates must be installed on both the left- and right-hand sides of the vehicle, even if only one frame rail is cracked.*
