David J. Johnson
 Director
 Service Engineering Operations
 Ford Customer Service Division

August 31, 2022

SUBJECT: **Customer Satisfaction Program 21N01 - Supplement #2**
 Certain 2016-2018 Model Year Explorer Vehicles
 High-Speed Cooling Fan Motor Relay

CERTAIN 2016-2018 MODEL YEAR EXPLORER BJV VEHICLES — HIGH SPEED COOLING FAN MOTOR RELAY

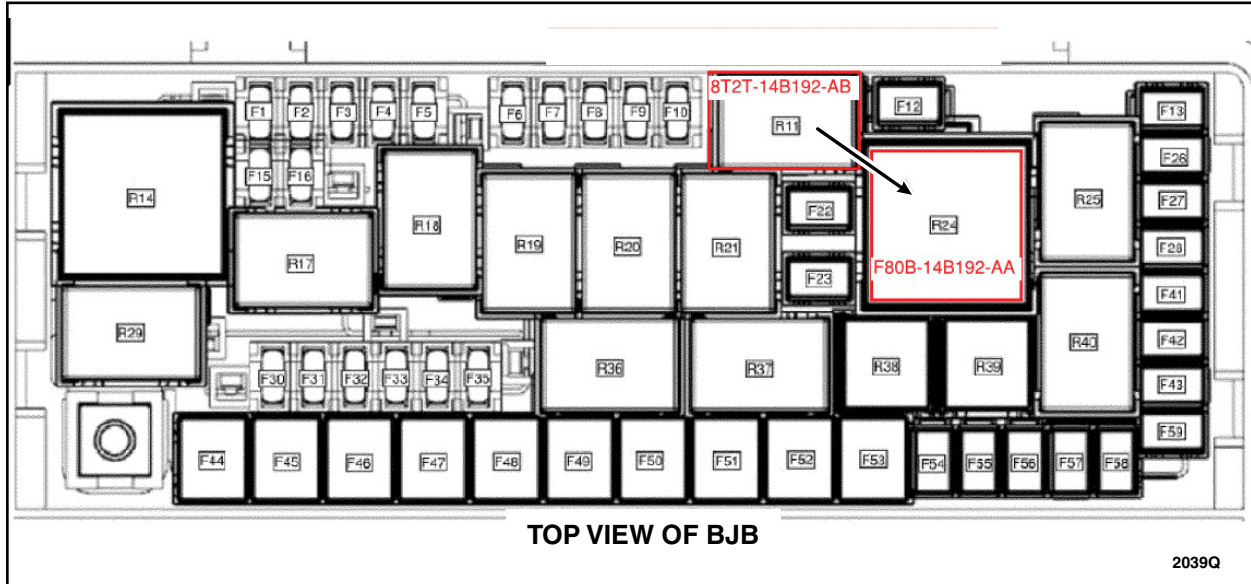
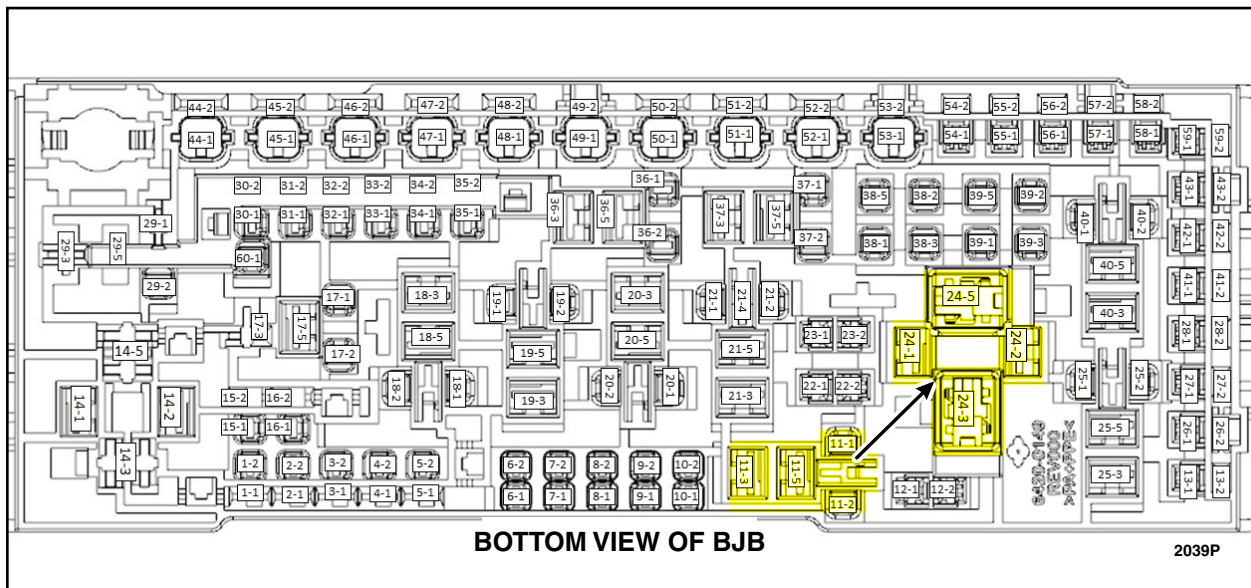
NOTE: The high speed cooling fan relay (R11) will be relocated to the (R24) position in the Battery Junction Box (BJB) as shown in Figures 1 and 2.
