TECHNICAL SERVICE BULLETIN

AN21-002A

NTB21-008A

SOFTWARE UPDATE FOR INFOTAINMENT ISSUES

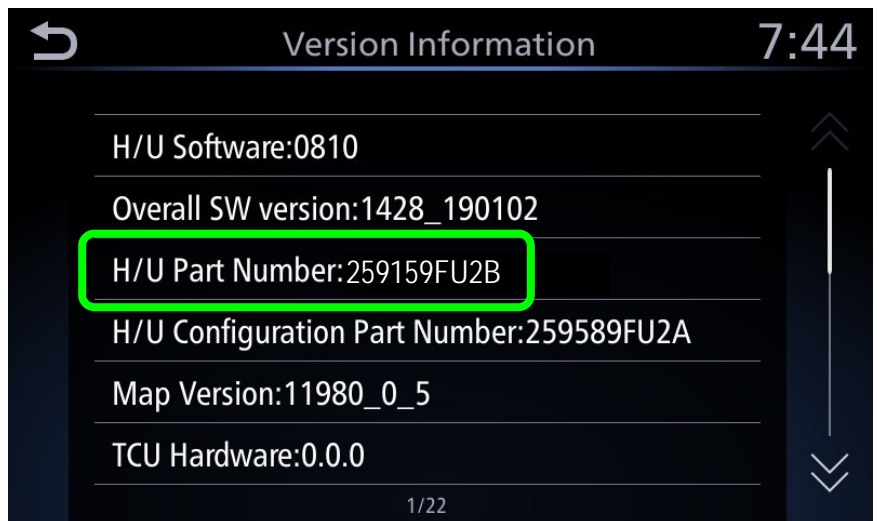
Figure 5

4. Scroll to, and then confirm the **H/U Part Number** (Figure 5).

5. Is the **H/U Part Number** listed below?

- 259159FU0A
- 259159FU0B
- 259159FU2A
- 259159FU2B
- 2591A9FU0A
- 2591A9FU0B

YES: Install the **IVI001** infotainment update-software. Proceed to step 6 on page 5 to update the AV control unit.

NO: Install the **IVI002** infotainment update-software. Proceed to step 6 on page 5 to update the AV control unit.

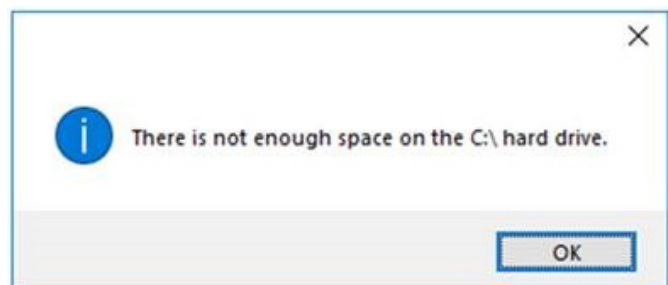
Figure 8

- The update-software is estimated to take 4 hours to download to the USB drive.
- If, while attempting to download the software to the CONSULT PC, you receive the message shown in Figure 8:
 - Attempt to clear space on the CONSULT PC hard drive.

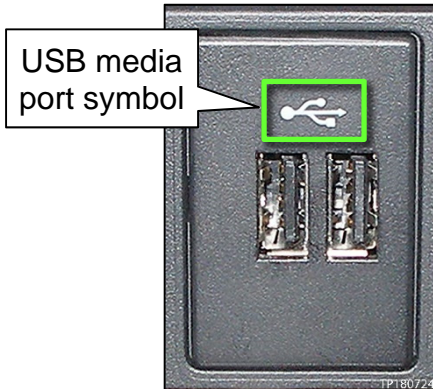
Figure 11

17. Insert the USB drive with infotainment update-software into the vehicle's USB media port (see Figure 11).
- Do not remove the USB drive during the update to the vehicle until instructed to.

Do not insert the USB drive into a charging port. If used, the update-software and/or USB drive may become damaged. Only insert the USB drive in a USB media port.

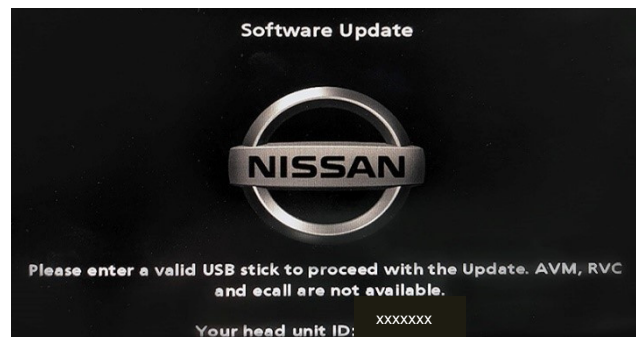
- The screen in Figure 14 may briefly appear. **Do not remove the USB drive.** The audio system will detect the USB drive and continue the update.
