TECHNICAL SERVICE BULLETIN

Classification: AT21-003B	Reference: NTB21-023B	Date: August 30, 2022
------------------------------	--------------------------	--------------------------

DTC P0780 STORED IN THE TCM

APPLIED VEHICLES: 2021 Rogue (T33)

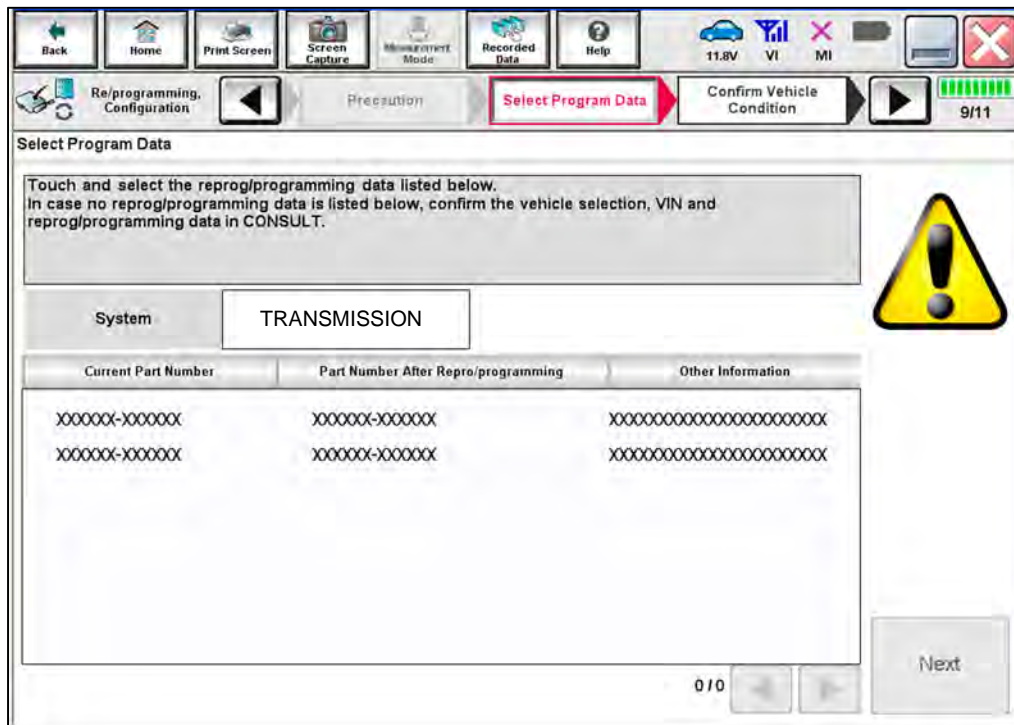
NOTE: In some cases, more than one new P/N for reprogramming is available.

- If more than one new P/N is available, the screen in Figure 11 displays.
- Select and use the reprogramming option that does **not** have the message “Caution! Use ONLY with NTBXX-XXX”.
- If you get this screen and it is blank (no reprogramming listed), it means there is no reprogramming available for this vehicle. Skip to step 25 on page 13.

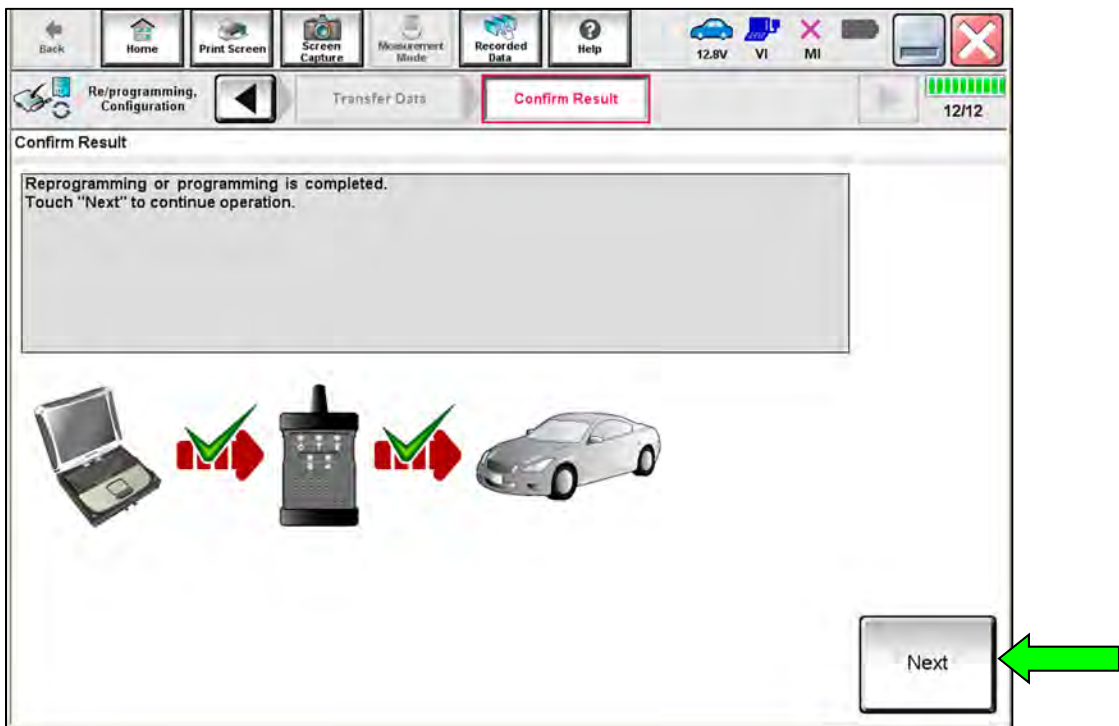
NOTE: When the screen in Figure 14 displays, reprogramming is complete. If the screen in Figure 14 does not display (indicating that reprogramming did not complete), refer to the information on the next page.

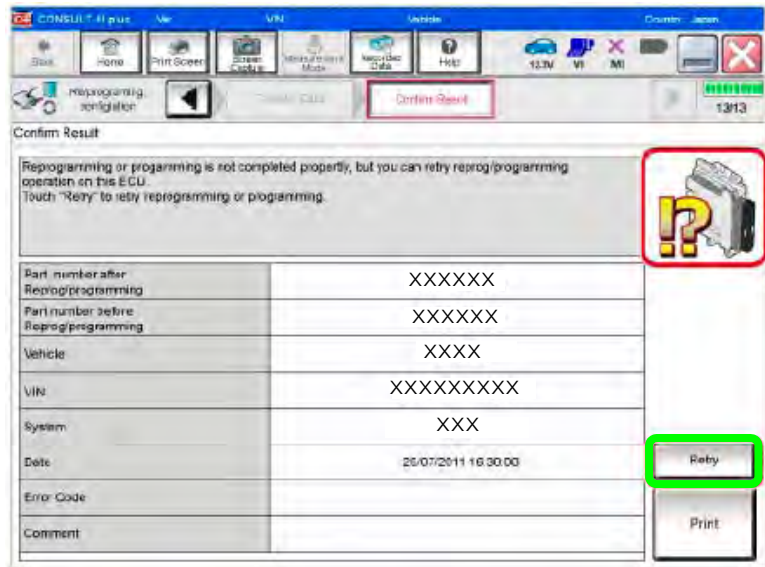
Figure 15

If reprogramming does not complete, and the “!?” icon displays as shown in Figure 15:

- Check battery voltage (12.0 V – 15.5 V).
- Ignition is ON, engine is OFF.
- External Bluetooth® devices are OFF.
- All electrical loads are OFF.
- Select retry and follow the on screen instructions.
- “Retry” may not go through on first attempt and can be selected more than once.

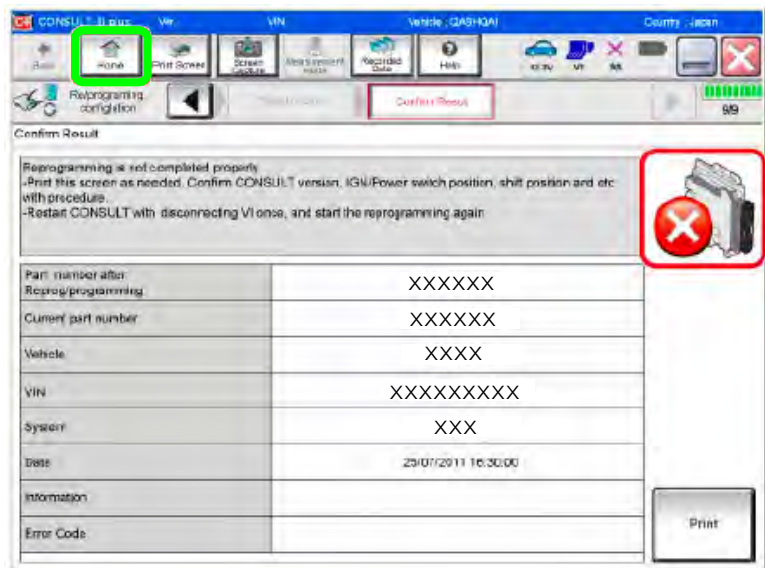
Figure 16

If reprogramming does not complete, and the “X” icon displays as shown in Figure 16:

- Check battery voltage (12.0 V – 15.5 V).
- CONSULT A/C adapter is plugged in.
- Ignition is ON, engine is OFF.
- Transmission is in Park.
- All C-III plus / VI cables are securely connected.
- All C-III plus updates are installed.
- Select Home, and restart the reprogram procedure from the beginning.
