# Cab Roof Harness Repair and Pass-Through Hole Modification

M-375-001

(March 2009)

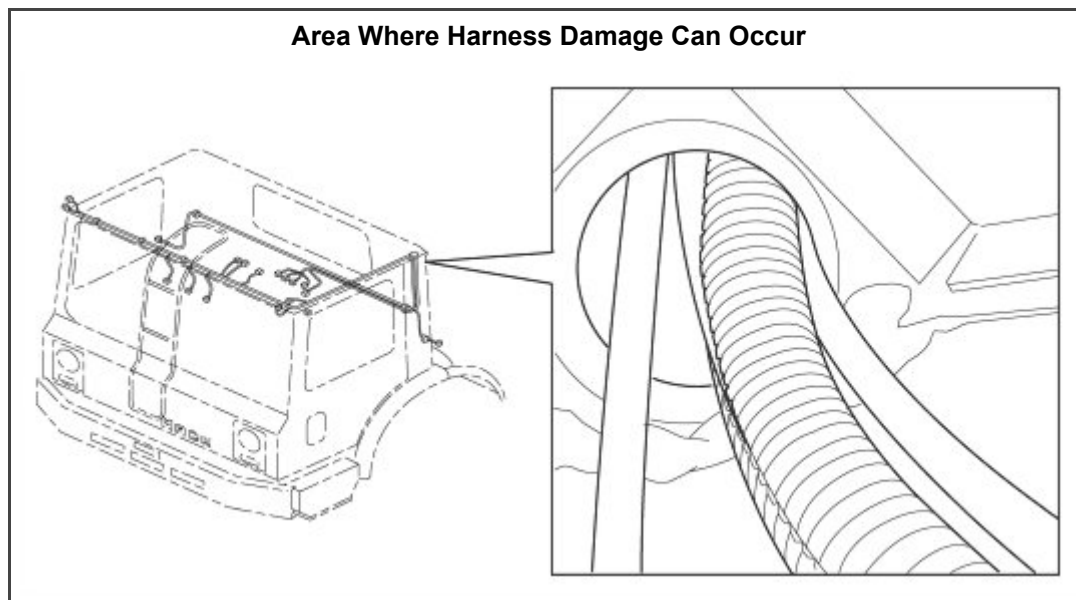
On certain MRU model chassis, the possibility exists for the cab roof harness to rub against the edge of the pass-through hole where the harness transitions down the B-post on the left-hand side of the cab. This will result in an eventual short to ground due to harness wire insulation rub-through, and become evident as various problems with the gauge illumination lamps, clearance lamps, marker lamps, headlamps and/or the headlamp switch.

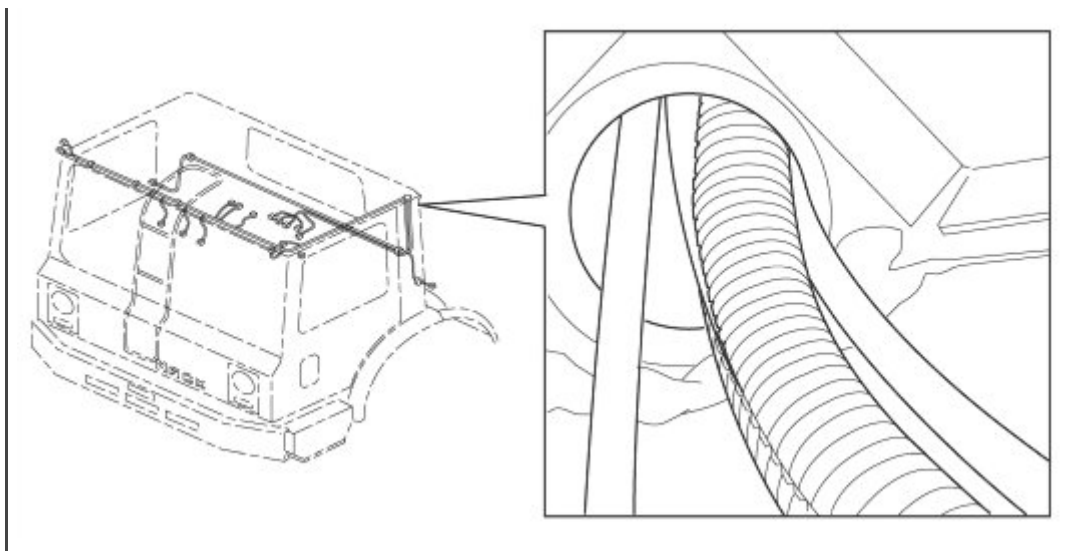
**Inspect Pass-Through Hole at Top of B-Post**

The hole should be completely open and round. If not, follow steps “a” through “o:”

- c. Feed the roof harness down through the B-post pass-through hole until completely through the hole.
- d. Using a die-grinder, completely open the pass-through hole, and then grind the edge of the hole until it is round.
- e. To prevent rust, use a vacuum cleaner to clean the metal particles created during the grinding operation from the B-post.
- f. Reinstall the cab roof harness by feeding it up through the pass-through hole, and then reconnect the connectors across the front of the cab roof.
- g. Pull the air horn line and rear view camera harness (if so equipped) back into place.
