DRV Air Line Service Kit

M-258-006

(July 2009)

Mack trucks with US07 emissions and an MP7 Mack engine.

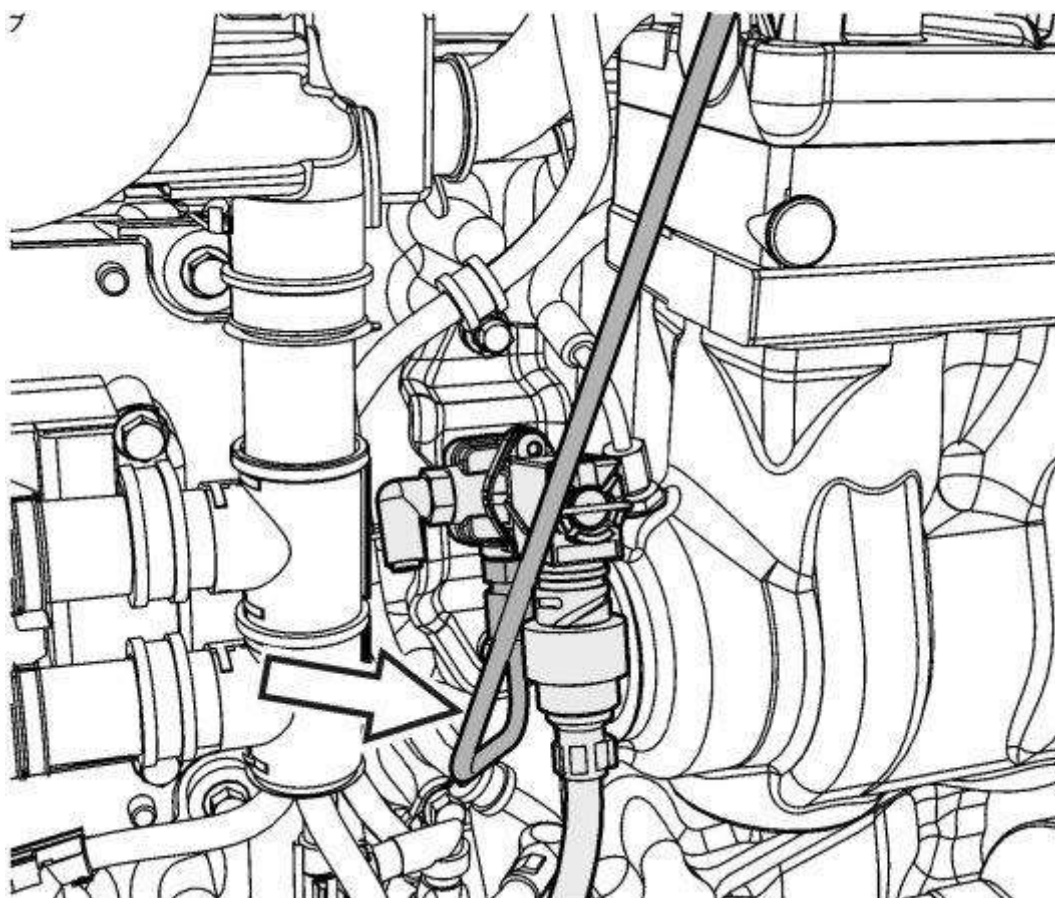
Discharge Recirculation Valve (DRV) air line service kit 21377589 has been developed for the repair or replacement of DRV air line on Mack MP7 engines. If the DPF (Diesel Particulate Filter) failed regeneration due to slow T1 temperature rise during activation of the DRV, there may be an issue with a broken DRV line. The original single piece, steel tubing DRV line may be broken at the control solenoid valve on the left side of the engine. Fault Code MID 128 PPID 330 FMI 7 may be logged when this occurs. Repair of this single piece steel tubing requires removal of a section of line and installation of service kit 21377589. The service kit consists of a section of flexible braided line with a compression fitting used to splice into the existing line.

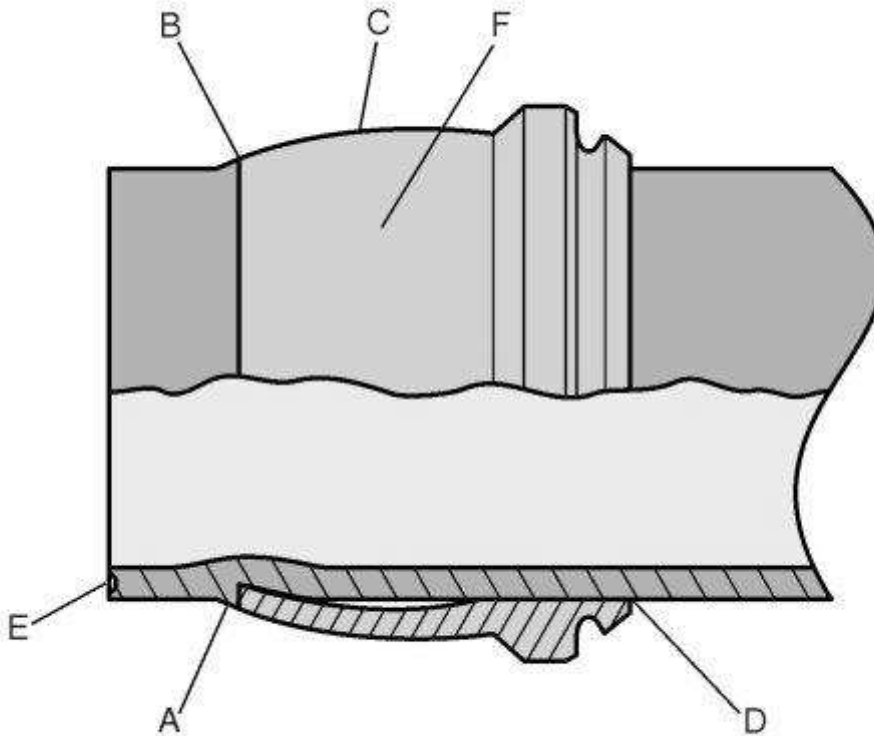
Ferrule Bite/Pre-Set Inspection	
Item	Item
A	A ridge of metal is raised above the pipe surface. The thickness of the raised

surface is 50% of the ferrule's leading edge around the pipe.
B	The leading edge of the ferrule must be flat.
C	There is a slight bow to the pilot section of the ferrule.
D	The tail of the ferrule is snug against the pipe.
E	There is a slight indentation around the end of the pipe. The indentation indicates the pipe was bottomed in the tool or fitting during pre-setting. If evidence of complete contact is not visible, the ferrule is not properly seated.
F	Avoid rotating the ferrule. Do not move the ferrule back and forth along the pipe beyond the bite area.

9. Follow detailed steps for Ferrule Bite/Pre-Set inspection.
