Turbocharger Smart Remote Actuator (SRA) Faults

M-255-016

(March 2009)

All CXU,CHU,GU,TD,MRU,LEU models built with MP7, MP8, MP10

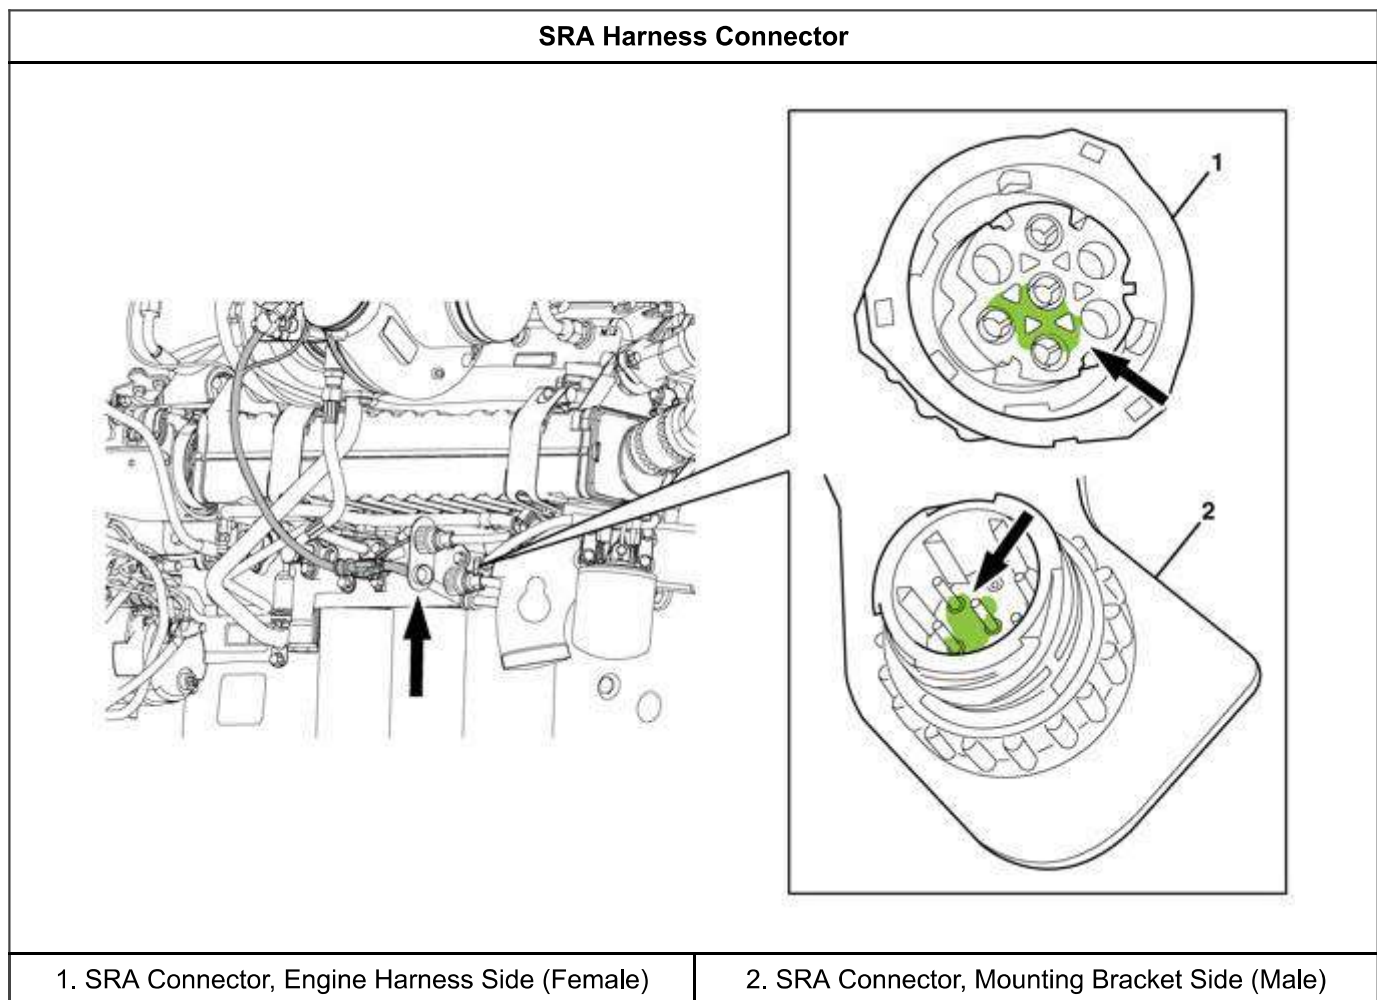
Wires within the smart remote actuator (SRA) connector located on the right-hand side of the engine below the turbocharger, are subject to vibration during engine operation. This vibration can result in terminal fretting which produces very fine dust particles, and can be seen as a fine green dust inside the connector. When these particles migrate between the female and male pin connections, intermittent contact problems will result and be made evident by SID 27 and PSID 232 fault codes.

Installing a connector back shell (part number 3985620) on the back of the male (mounting bracket side) SRA connector and securing the harness wires by installing a tie wrap around the fabric cover as shown in the illustration below, will correct this condition by dampening the vibration to reduce terminal fretting.
