# Technical product information

<b>Topic</b>	New Continental GT, GTC, New Flying Spur - Blind spot monitors not functional DTC C1114F3 logged in address 003C or 00CF
<b>Market area</b>	Russische Föderation (5RU),Australia E04 Bentley rest Asia and Australia (6E04),China 796 VW Import Comp. Ltd (Vico), Beijing (6796),Germany E02 Bentley rest Europe (6E02),Japan E03 Bentley Japan (6E03),Korea, (South) E08 Bentley South Korea (6E08),United Arab Emirates E06 Bentley Middle East and Africa (6E06),United Kingdom E01 Bentley UK (6E01),United States E05 Bentley USA and rest America (6E05)
<b>Brand</b>	Bentley
<b>Transaction No.</b>	2062884/4
<b>Level</b>	EH
<b>Status</b>	Approval
<b>Release date</b>

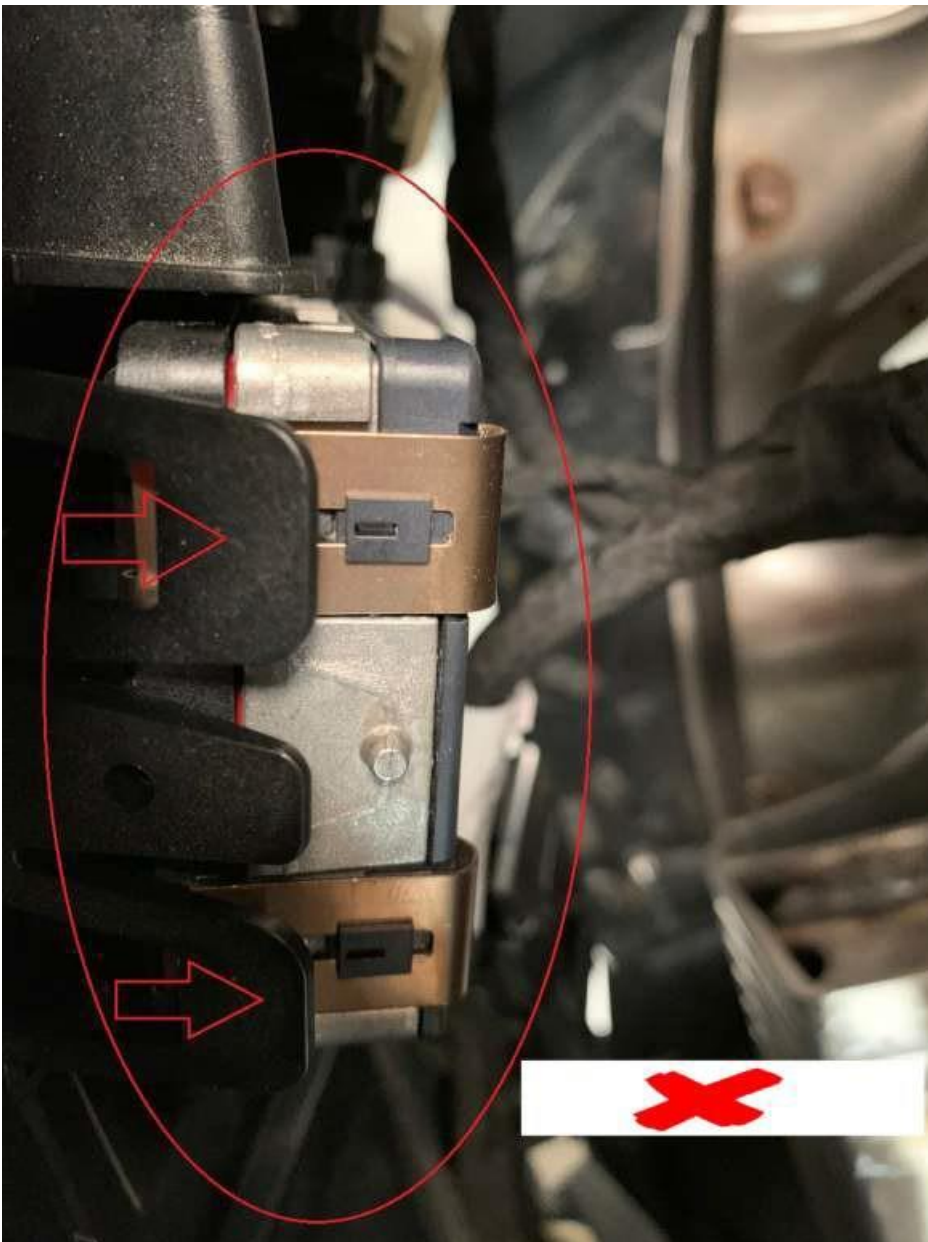
Figure 2

Master or slave rear radars are not fitted correctly (unclipped or poorly installed)

Diagnostic Trouble Code (DTC) C1114F3 - Lane change assistance control module restricted view, logged with address 003C or 00CF

- 003C: Inspect the RHS rear radar fitment and/or bracket damage
- 00CF: Inspect the LHS rear radar fitment and/or bracket damage

3) In the event one or both control units are loose/detached - Refer to Figures 2 (Before adjustment) and 3 (After adjustment) and also reference Rep.Gr - 44 Lane change assist control units (J769 and J770) - To remove and fit
