Technical product information

Topic	DTC C10BCF6 and/or DTC C12E2F2 stored in address 0003 - Parking brake warning in DIP
Market area	Russische Föderation (5RU),Australia E04 Bentley rest Asia and Australia (6E04),China 796 VW Import Comp. Ltd (Vico), Beijing (6796),Germany E02 Bentley rest Europe (6E02),Japan E03 Bentley Japan (6E03),Korea, (South) E08 Bentley South Korea (6E08),United Arab Emirates E06 Bentley Middle East and Africa (6E06),United Kingdom E01 Bentley UK (6E01),United States E05 Bentley USA and rest America (6E05)
Brand	Bentley
Transaction No.	2064519/2
Level	EH
Status	Approval
Release date

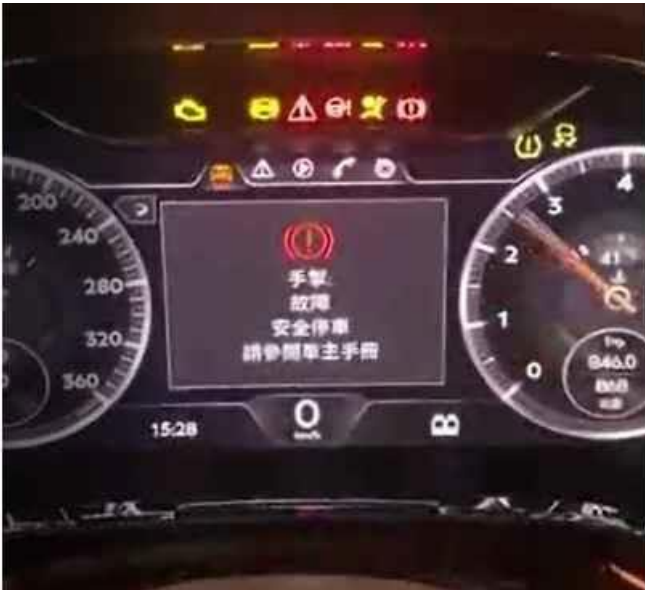
Figure 1

Parking brake warning light evident within the DIP (See example shown in Figure 1)

C10BCF6 - Left parking brake motor Engine speed implausible OR

C12E2F2 - Right parking brake motor Engine speed implausible

10) In the event that no other issues have been found and permission has been granted via the open DISS query - Replace the defective actuator - Rep.Gr 46
