Technical product information

Topic	Electronic Parking Brake (EPB) functionality issues
Market area	Russische Föderation (5RU),Australia E04 Bentley rest Asia and Australia (6E04),China 796 VW Import Comp. Ltd (Vico), Beijing (6796),Germany E02 Bentley rest Europe (6E02),Japan E03 Bentley Japan (6E03),Korea, (South) E08 Bentley South Korea (6E08),United Arab Emirates E06 Bentley Middle East and Africa (6E06),United Kingdom E01 Bentley UK (6E01),United States E05 Bentley USA and rest America (6E05)
Brand	Bentley
Transaction No.	2062184/6
Level	EH
Status	Approval
Release date

New Continental GT/GTC and New Flying Spur

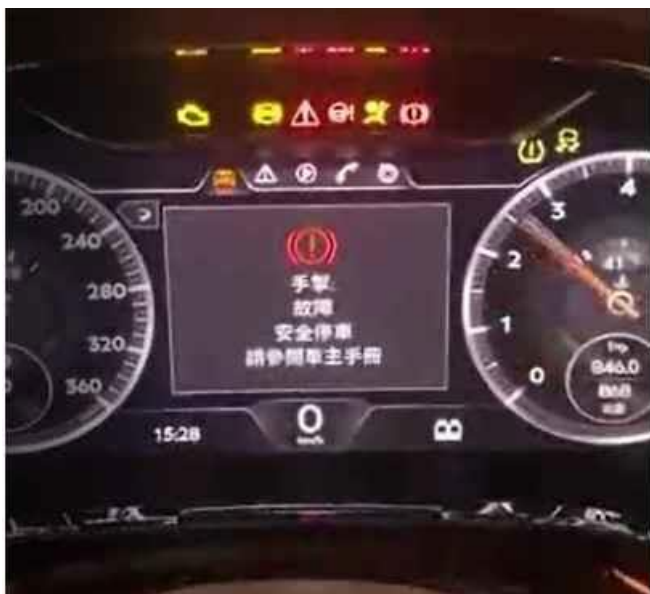
Figure 1

- The following issues could be evident during PDI or found whilst in service
 - Electronic Parking Brake (EPB) found not operating to specification
 - EPB may not hold the car effectively
 - Parking brake components showing signs of wear
 - Parking brake warning light may also be evident within the DIP (See example shown in Figure 1)
