Service Alert

Mazda North American Operations
Irvine, CA 92618-2922

| Subject: CONNECTED VEHICLE SYMPTOM TROUBLESHOOTING | Service Alert No.: SA-017/22 |
| | Last Issued : 08/25/2022 |

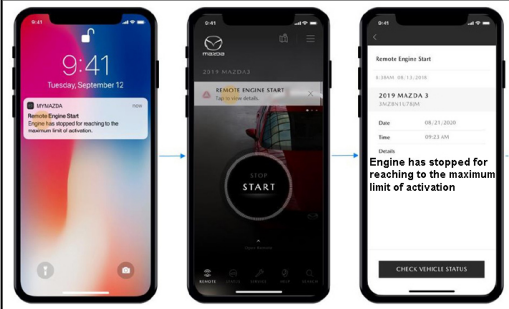
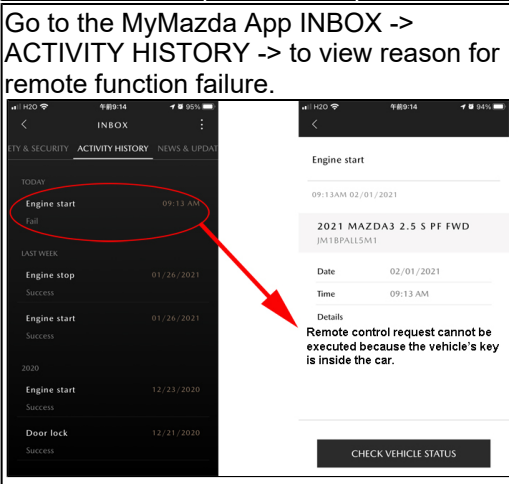
| Connected Vehicle Troubleshooting | | |
|---|---|--|
| 1 Remote function(s) inoperative. <ul style="list-style-type: none"> • Engine Start / Stop • Door Lock / Unlock • Lights ON / OFF | Go to the MyMazda App to view the reason for remote function failure. | <p>Push Notification</p> <div style="display: flex; justify-content: space-around;"> <div style="border: 1px solid black; padding: 5px; text-align: center;"> OS Lock Screen Tap the push notification </div> <div style="border: 1px solid black; padding: 5px; text-align: center;"> Home Tap the alert card </div> <div style="border: 1px solid black; padding: 5px; text-align: center;"> Inbox Detail Tap "check vehicle status" </div> </div> |

| Connected Vehicle Troubleshooting | | |
|---|---|--|
| | | <p>Activity History</p> <p>Go to the MyMazda App INBOX -> ACTIVITY HISTORY -> to view reason for remote function failure.</p> |
| | | <p>Troubleshooting needed</p> <ol style="list-style-type: none"> 1. Use MDARS to ID the vehicle and check for DTC's stored. Are DTC(s) stored? <ul style="list-style-type: none"> • Yes - Go to MGSS and perform normal DTC diagnostics. • No - Go to next step. 2. If applicable, confirm SSPC7 or DRW41 is closed. Go to eMDCS Vehicle Inquiry. 3. Confirm TCU software version is at the following using TCU Software Version Check <ul style="list-style-type: none"> • Mazda3 - 10006 or later • CX-30 - 10006 or later |

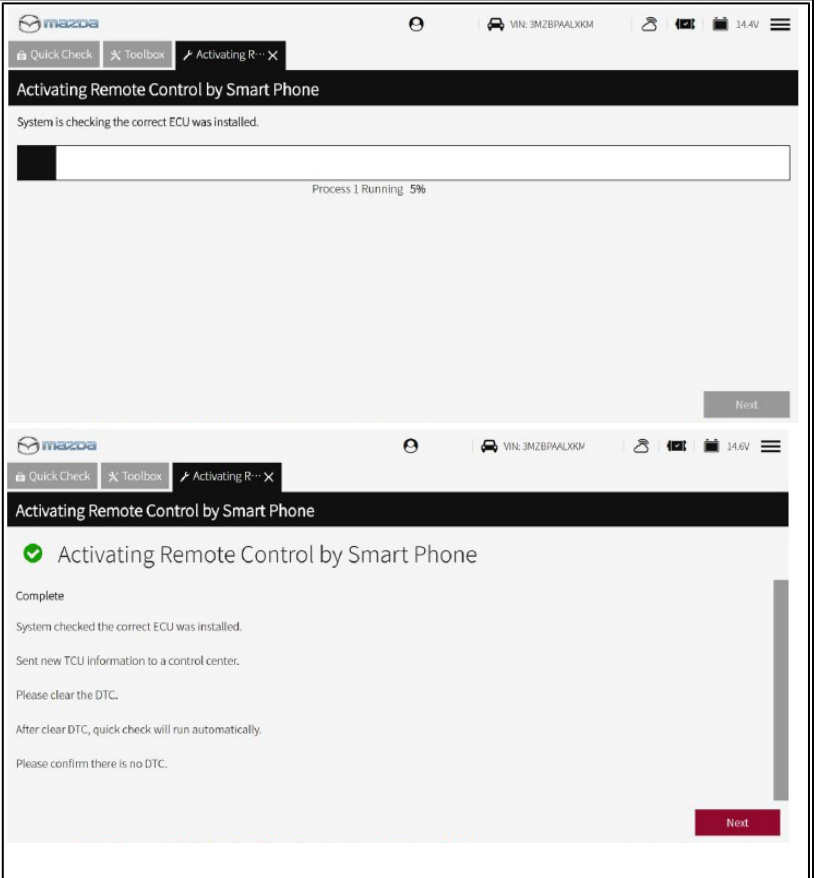
NOTE: If the Activating Remote Control by Smart Phone shows "Incomplete", the possible causes are:

- a. The advanced key is not in the vehicle.
- b. The connected Vehicle Maintenance Mode is enabled.
- c. The Key transmitter power saving function is enabled.

d. The pacemaker radio wave interference prevention function is enabled.
