## Service Bulletin

#### Subject: Front Suspension Squeak/Squawk Noise Over Small/Medium Bumps

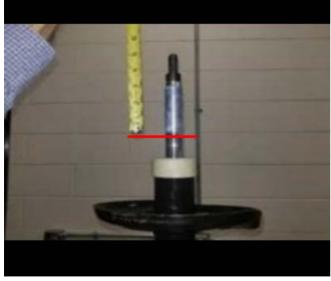
5607815

| Involved Region or Country | North America, Europe, Russia, Middle East, Israel, Japan, GM Korea Company, China | |
|--|--|--|
| Cause | This condition may be caused by the interaction of the jounce bumper to the strut rod. | |

Note: DO NOT APPLY GREASE TO THE STRUT ROD THREADS.

- 2. Apply PTFE Grease–High Viscosity to the strut rod 12.7 cm (5.0 in) down from the top, as shown in the graphic above.
- 3. Re-assemble the strut and install back into the vehicle. Refer to *Shock Absorber, Shock Absorber Component, or Spring Replacement* in SI.
