Service Bulletin

Bulletin No.: 21-NA-027

Subject: Trailing Connector Loose Within Rear Bumper

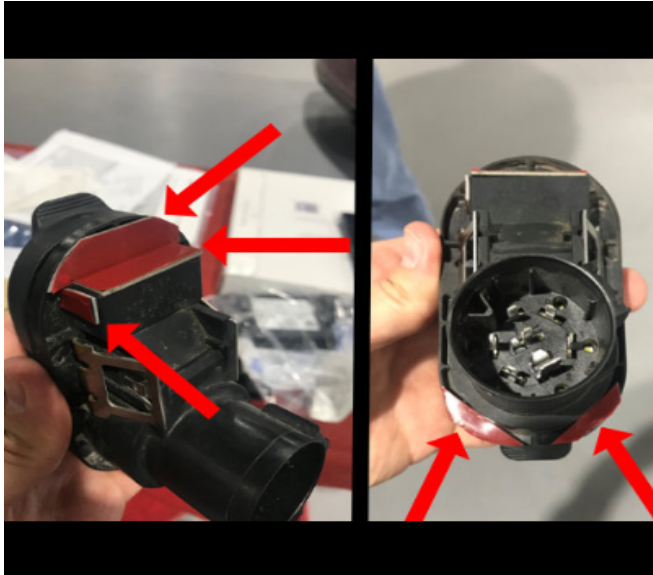
5732388

Involved Region or Country	North America, Middle East, Israel, Palestine, Chile, Paraguay, Uruguay, Thailand.
Additional Options (RPOs)	
Condition	Some customers may comment on the trailing connector loose within the rear bumper.
Cause	Repeated use and a high stack up tolerance may cause the 7-way connector to be loose in the bumper.
Correction	Follow the procedure outlined below to correct this condition.

2. With the connector removed, add double sided tape to one or more of the following locations.
3. Install the connector and trim away and of the remaining tape so that its not visible.
