Service Bulletin

Bulletin No.: 22-NA-144

Subject: Power Windows, Door Locks and Outside Mirrors Inoperative, Unwanted Theft Alarm Activation, Random Messages Displayed on Driver Information Center (DIC)

Brand:	Model:	Model Year:		VIN Breakpoint:		Engine:	Transmission:
		from	to	from	to		
GMC	HUMMER EV	2022	2022	SOP	NU100230	—	—

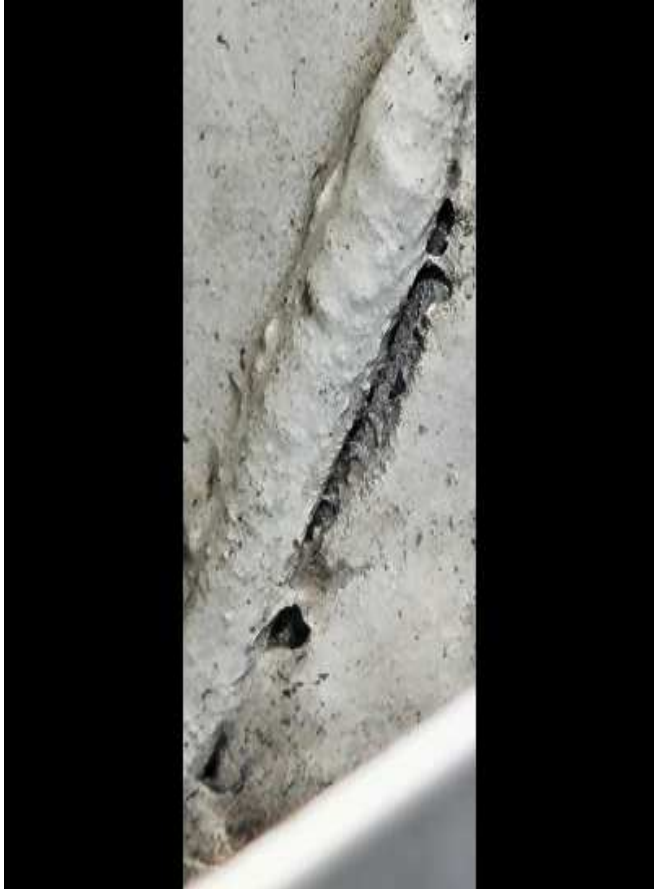
<p>6103692</p> <p>Note: The image above depicts a close-up of a failed seal below the driver side windshield area.</p> <p>This condition may be caused by the driver's front door X500 in-line connector that may have corroded terminals due to a water leak entering inside the upper A-pillar through the panels not sealed properly.</p>
<p>Correction</p>	<p>Open the X500 and inspect for corroded terminals. Perform a water leak test on suspected sheet metal area, reseal, and re-test for leaks.</p> <p>Repair and/or replace X500 terminals as required.</p>

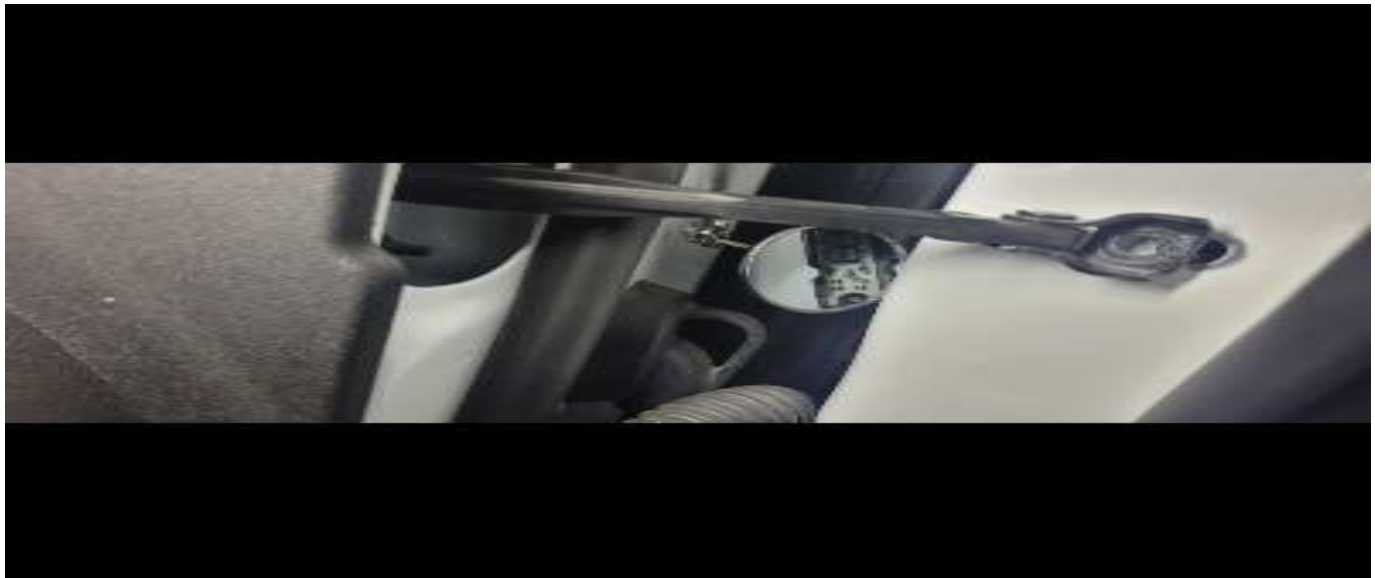
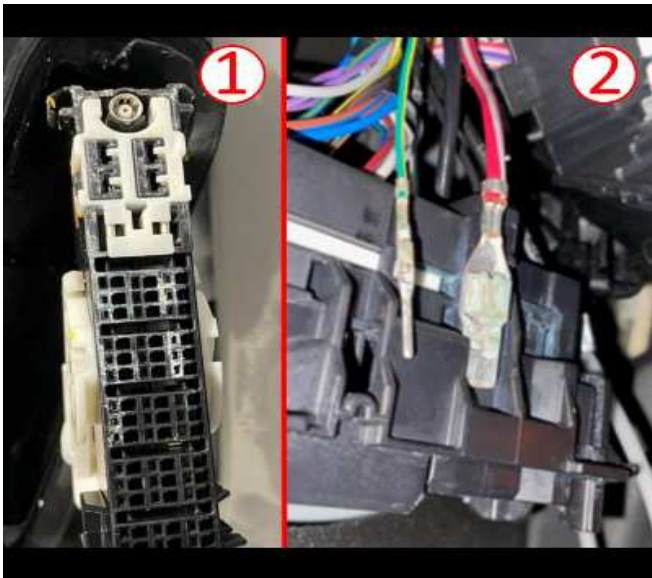
Note: The graphics above are an example of what the corrosion may look like in the X500 connectors.

6. Utilizing a mirror or equivalent, inspect the A-pillar side connector terminals for corrosion.

- If corrosion is found at the door side connector (1) or the instrument side connector (2), continue to step 7.
- If corrosion is not found on the connectors, refer to step 14.
