CR234 – ABS Control Unit Software Update and IMU Sensor Correct Assembly Check

Desert X MY2023 (USA country versions only)
Technical Service Bulletin SRV-TSB-22-009

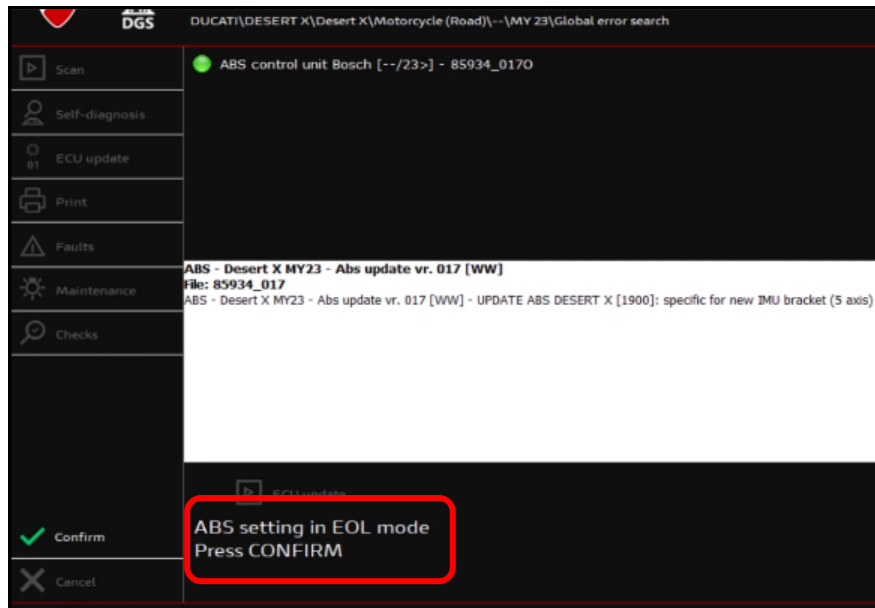
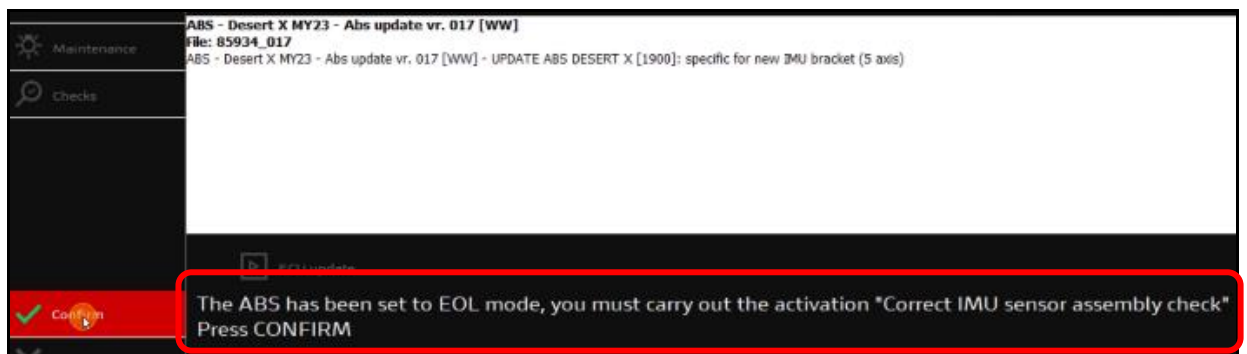
3. After the ABS control unit update, the DDS 3.0 will automatically set the ABS to EOL mode and inform you that the correct IMU sensor assembly check is required ("**Correct IMU sensor assembly check**").

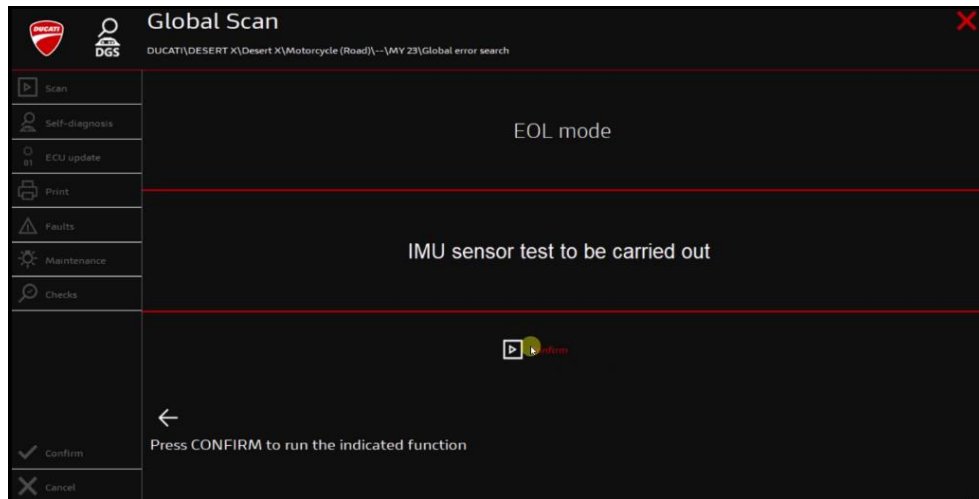
4. Upon the next **Global Scan**, the DDS 3.0 will guide you through the procedure for checking the IMU sensor correct assembly.

5. At the end of the procedure, if the test outcome was successful, the DDS 3.0 will suggest you run a new **Global Scan** and will finally ask you to remove the *"Transport Mode"* function. After the *"Transport Mode"* has been removed, an error deletion procedure must be carried out.
6. If the test ends with errors, you must:
 - a. Access *"ABS Diagnosis"* select the *"Settings"* window and click on *"ABS setting in EOL mode"*. Then set the ABS control unit in EOL mode
 - b. Check that the software version of the ABS control unit is the correct, in *Info ECU ABS*, field *BB number (algorithm) = 85934*
 - c. Check the shape of the IMU sensor Support Bracket to confirm part number is **8301B191BA**
