Service Bulletin

Bulletin No.: 21-NA-186

Subject: Service Engine Soon Illuminated in Driver Information Center (DIC) and/or a Malfunctioning Fuel Gauge, DTC U0076/U18A2/P1001/P1434 or Other Message Counter Incorrect Codes Set

Brand:	Model:	Model Year:		VIN:		Engine:	Transmission:
		from	to	from	to		
Chevrolet	Malibu	2020	2022	—	—	1.5L (LFV)	—

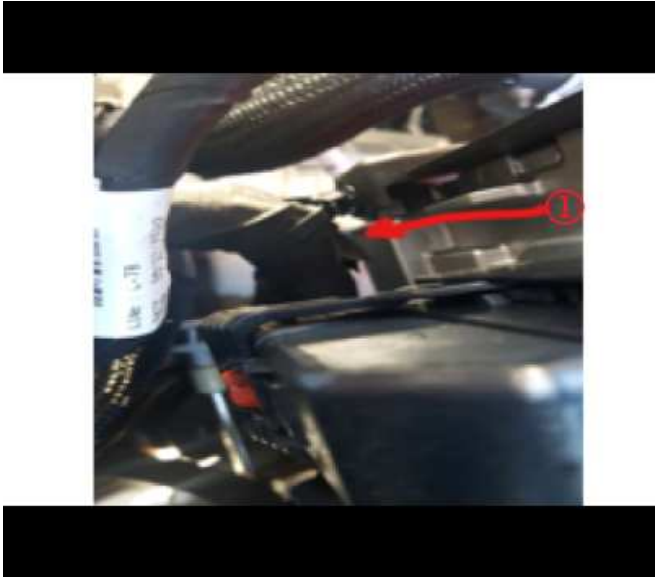
5890376

1. Locate the ECM harness (1) in the engine compartment near the battery. Refer to *Engine Control Module Replacement* in SI.

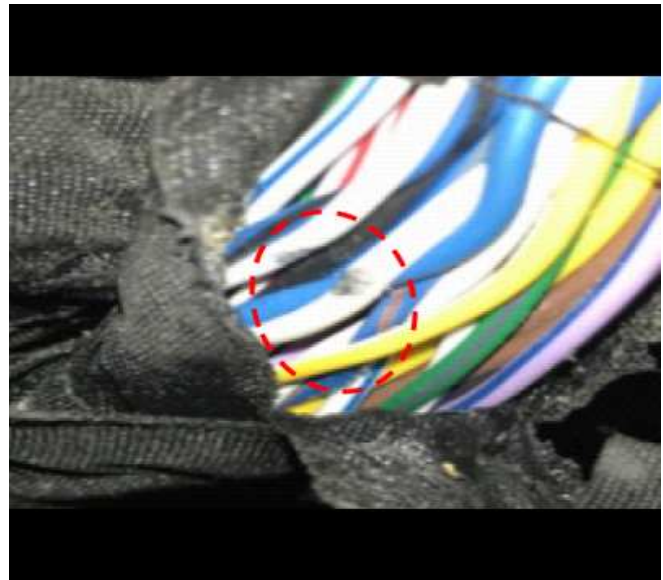
5890381

- 2. Inspect the ECM wire harness for any chafing. Repair any damaged wires. Refer to *Wire to Wire Repair* in SI.
- 3. Wrap the wire harness with anti-abrasion tape to prevent more chafing and re-secure the harness.
