Service Bulletin

Bulletin No.: 22-NA-084

Subject: Information on Unable to Open Folding Top, DTC B19E1 sym64 Possibly Set

Brand:	Model:	Model Year:		VIN:		Engine:	Transmission:
		from	to	from	to		
Chevrolet	Corvette	2020	2023	—	—	All	All

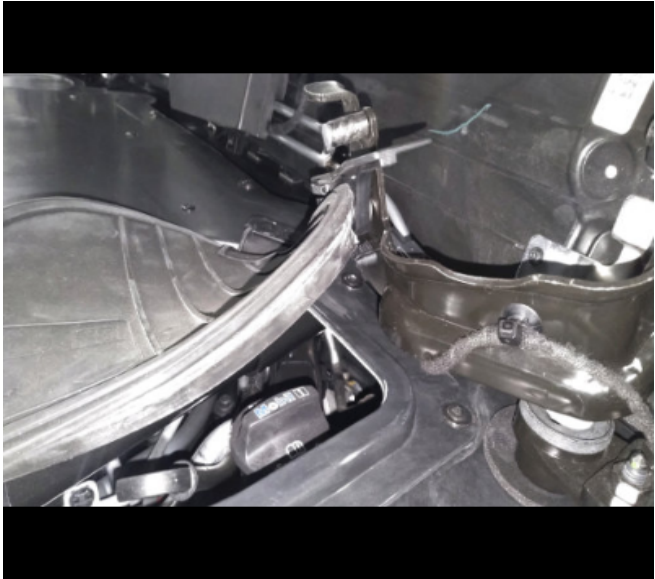
Involved Region or Country	North America, Europe, Middle East, Japan, Israel, Palestine, Thailand, Australia/New Zealand
Condition	Some customers may comment that the folding top will not open. Technicians may find DTC B19E1 sym64 set.
Cause	<div style="text-align: right; margin-bottom: 5px;">6039905</div>

<p>The cause of the condition may be that the body side frame access hole plug may not have been seated properly. This may lead to the plug interfering with B373 Folding Top Side Rail - Roof Panels Stowed Sensor.</p> <p>Note: The body side frame access hole plug must be fully seated whenever the plug is removed.</p>
Correction	<ol style="list-style-type: none"> 1. First gain access to the body side frame access hole plug. Refer to <i>Opening the Folding Top Stowage Compartment Lid — Engine Access</i> section within <i>Folding Top and Folding Top Stowage Compartment Lid Operation</i> in the Service Manual. 2. Inspect the body side frame access hole plug to assure it is fully seated. <p>Note: The customer should be informed to ensure the access plug is secured, and fully seated, before driving the vehicle whenever the oil or coolant is checked. Please share this information with the customer, including a copy of this bulletin.</p>
