Complaint – Creaking Noise from the Driver's or Passenger Footwell: Reworking Floorpan (98/21)

Model Series: **Taycan (Y1A / Y1B / Y1C)**

Model Year: **As of 2020 up to 2022**

Concerns: **Floorpan**

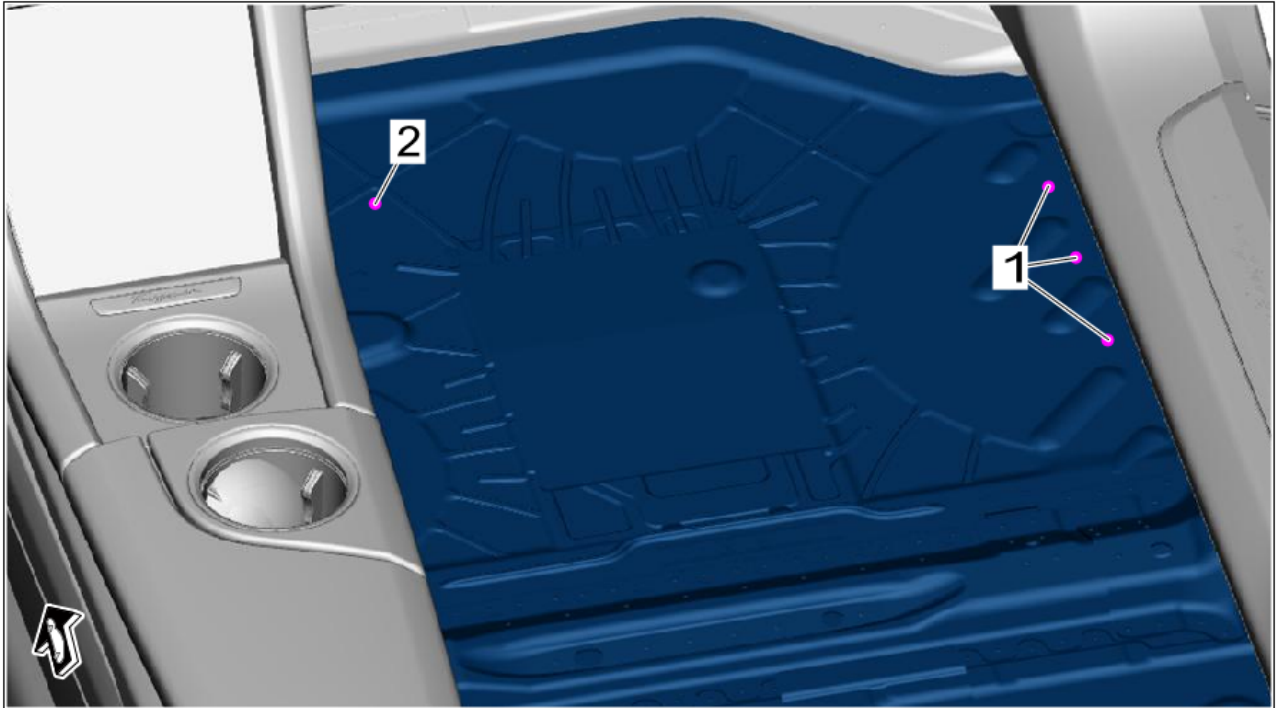
Overview of floorpan (example in right footwell)

Information: Creaking noise can be heard from the driver's or passenger's footwell when the vehicle floor is loaded and relieved (e.g. when getting in and out of the vehicle). This is caused by the floor pan, which bends downwards and then jumps back to its original position.

- 1 – Re-stamping position 1 (3 places in total)
- 2 – Reshaping position 2 (one place , only if required)

Action required: In the event of a customer complaint, reshape the floor pan on the relevant side in order to increase rigidity.
Also attach 4 plastic foam strips to the high-voltage battery.

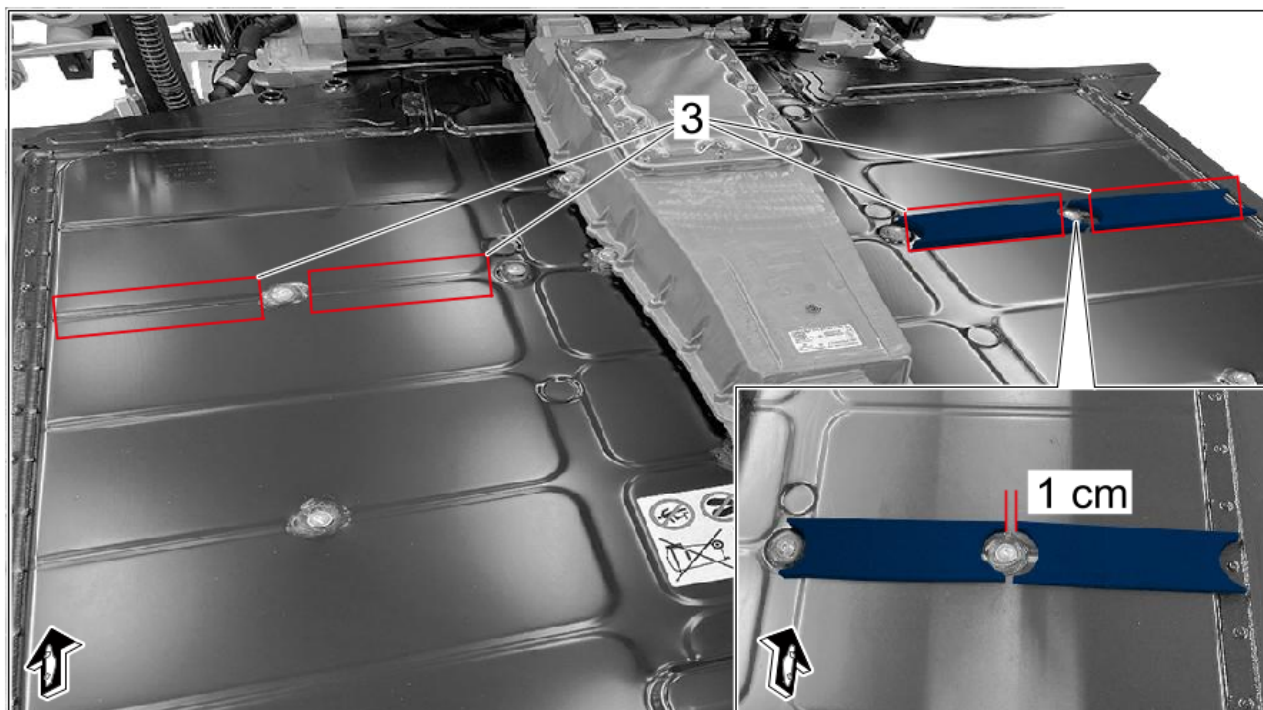
Overview of bonding areas on foam strips

3 – Bonding position of foam strips (4 places in total)
