Service Bulletin

Bulletin No.: 22-NA-166

Subject: Waterleak into Interior of Vehicle

Brand:	Model:	Model Year:		VIN:		Engine:	Transmission:
		from	to	from	to		
Chevrolet	Equinox	2018	2023				
GMC	Terrain

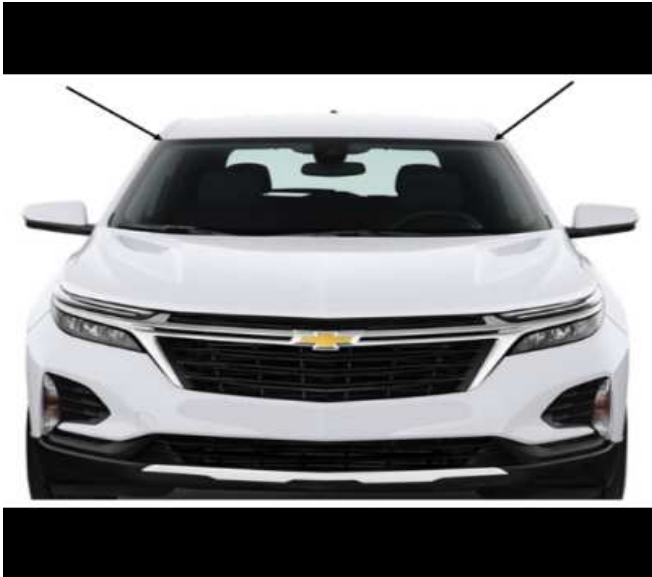
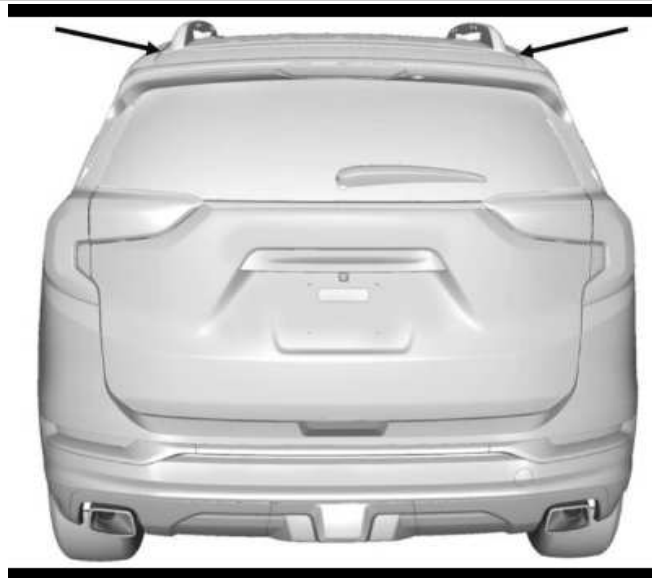
- "Pin hole" voids in the roof panel to outer ring laser braze and seam sealer. The pin holes are most commonly found near the top of the windshield or the top of the liftgate near the D-pillars.

2. Seal any of the suspected leak areas following the recommendations below:
 - Cowl and other less visible body seams can be sealed with Kent® Brushable Seam Sealer*, Kent® High-Tech Seam Sealer Clear* P10200, or Wurth Euroseal Gel Clear* 18920104, or equivalent.
 - Seal the pin holes/crack in any laser braze area following the steps below:
 - 2.1. Mix a small amount of Kent® High-Tech Seam Sealer Clear* P10200, or Wurth Euroseal Gel Clear* 18920104, or equivalent WITH the proper touch-up paint color.
 - 2.2. Avoiding excess sealer build up within the ditch, work a small amount of the sealer into the hole with a gloved finger.
 - 2.3. Wipe away any excess sealer with a light amount of solvent on a rag or paper towel. The solvent will help the sealer flow into the hole/crack.
3. Clean and dry any wet trim. Refer to *Floor Carpet Drying*, in SI.

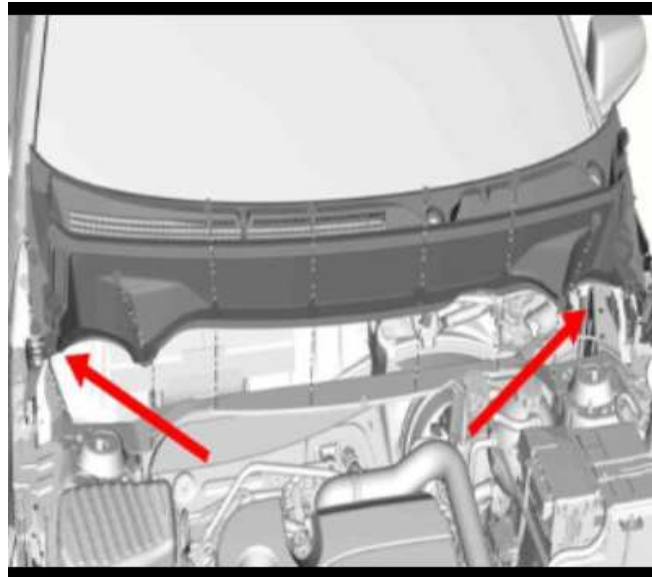
6140949

- Seam leak or "Pin hole" voids at the front cowl area.
- Disconnected sunroof drain hoses at the front cowl or at rear locations.
- Missing or misapplied body seam sealer along any of the body seams.

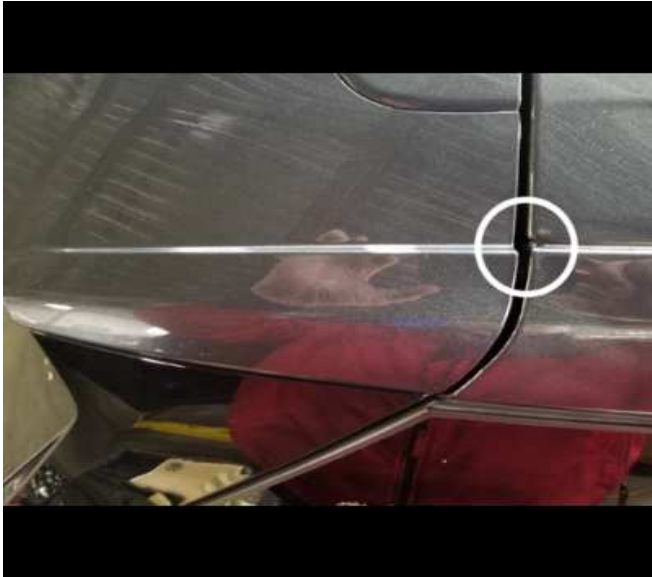
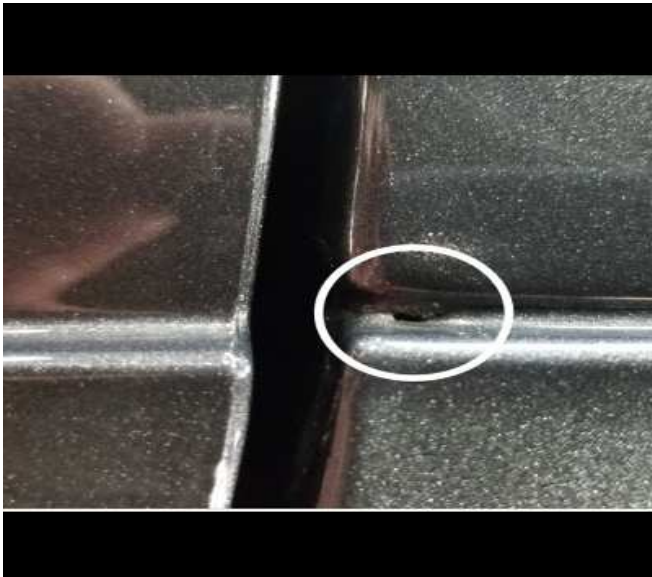
Note: The pin holes/cracks may be more difficult to see on darker color finishes.

- Visually inspect the front and rear, right and left roof laser braze corners, for pin holes or a crack.
- Also inspect for missing or poorly applied seam sealer at the right and/or left cowl, under the air inlet screen. Refer to *Air Inlet Grille Panel Replacement*, in SI, as necessary.
- If equipped with a sunroof, make sure the 4 sunroof drains are properly installed, and not plugged. Refer to *Sunroof Drain Inspection and Cleaning*, in SI.

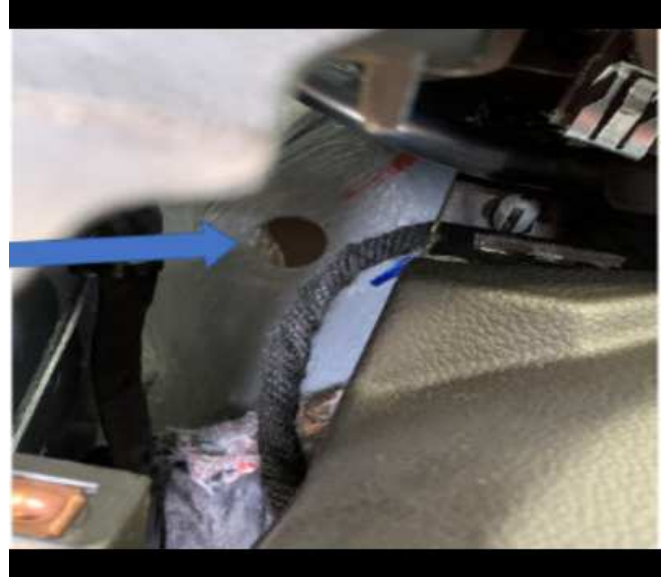
6140963

- Check for Sunroof Grommet / Close-out plug missing or not fully seated.
- Check for Paint shop sealer interfering with sunroof grommet / close out plug interfering with fit to A-pillar.
- Locate any seams that do not have sealer properly applied
