# Service Bulletin

Bulletin No.: 22-NA-173

**Subject:** Information on Transmission Fluid Leak

Brand:	Model:	Model Year:		VIN:		Engine:	Transmission:
		from	to	from	to		
Chevrolet	Corvette	2020	2023	—	—	6.2L (RPO LT2)	8-Speed Automatic (RPO M1L)

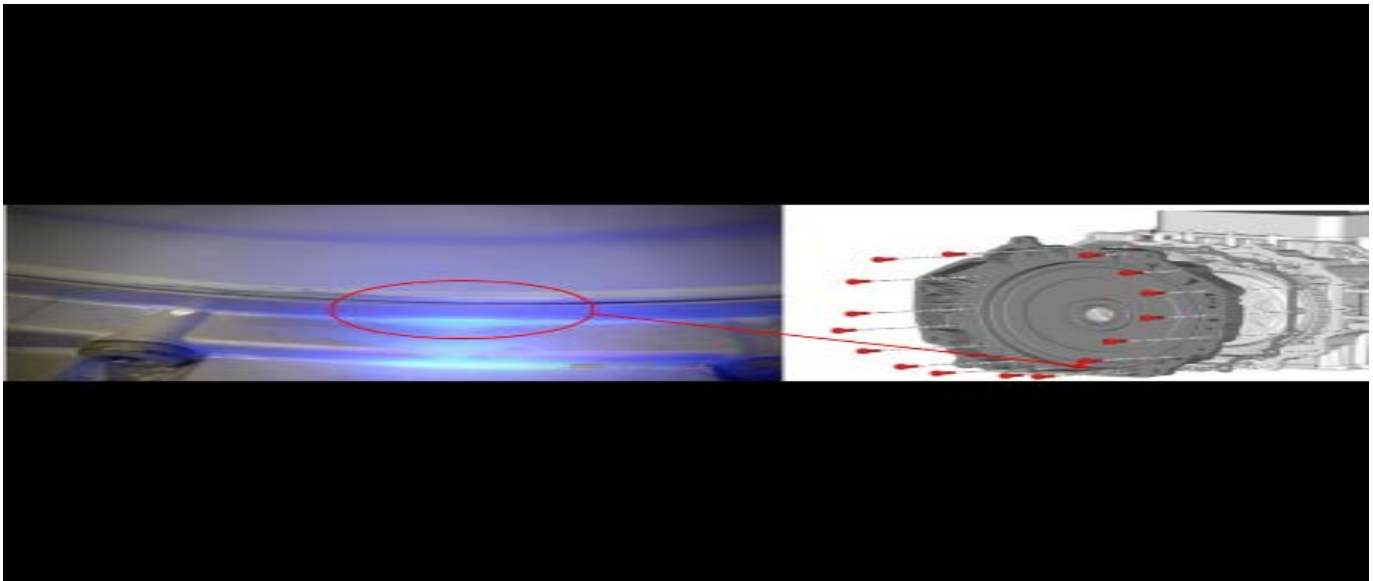
6142752

A leak between sealing plate and Bell Housing.

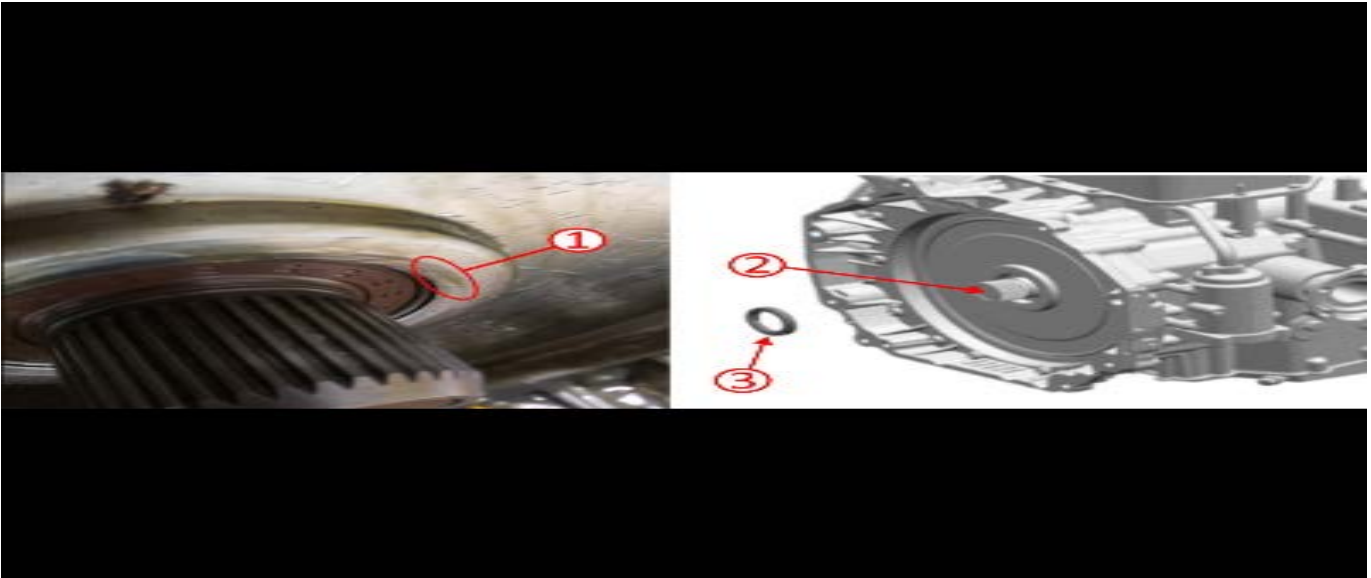
6142814

A small crack in the clutch cover area (1) of the input shaft seal can be mis-diagnosed as an input shaft seal leak (3). Additional cases have been verified at the input shaft end plug/seal (2), was damaged during transmission to engine mating.

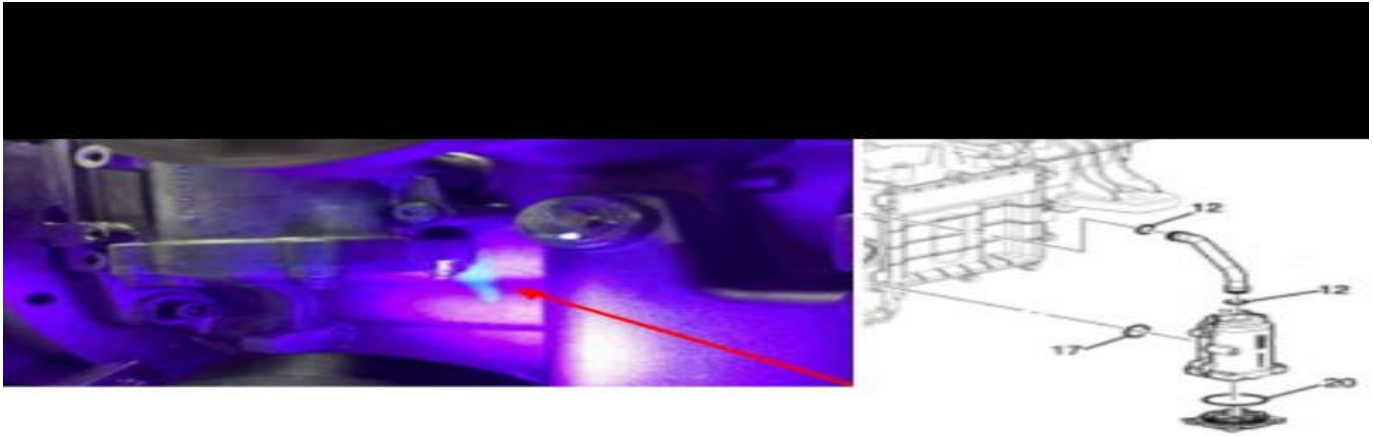
6142744

The auxiliary canister filter can create leaks in several areas. The most common area is cover seal (20), O-ring installation issues after filter replacement. Other areas of concern can be found at the are O-rings (12) and (17).
