Service Bulletin

Bulletin No.: 22-NA-175

Subject: Radio Software Update V160 (Mexico Only)

Brand:	Model:	Model Year:		VIN:		Engine:	Transmission:
		from	to	from	to		
Cadillac	XT4	2023	2023	—	—	—	—

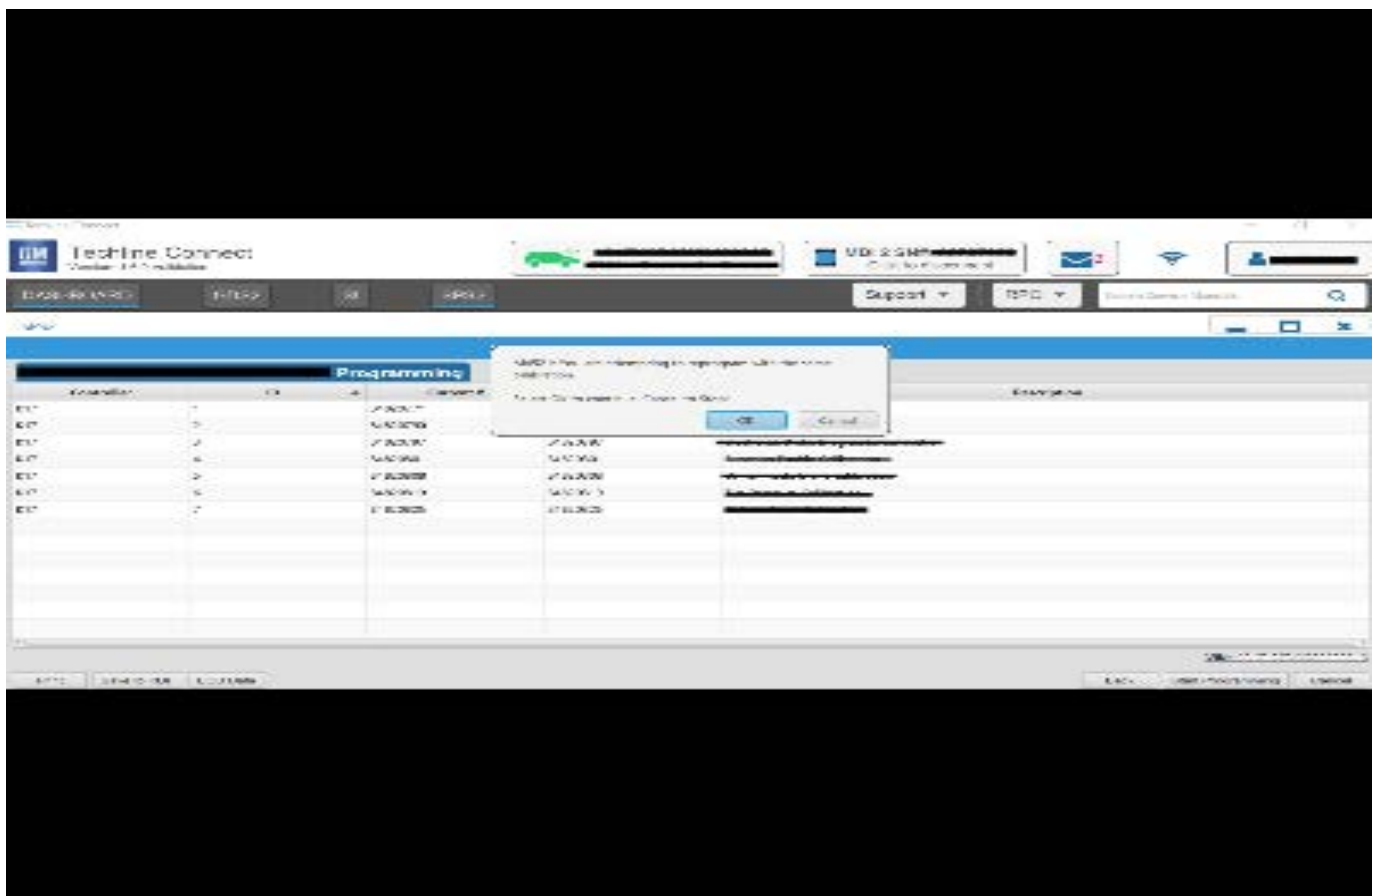
5644477

Important: Techline Connect screen shown above.
