Service Bulletin

Bulletin No.: 22-NA-067

Subject: Poor Engine Performance in Extremely Cold Weather Conditions, PCV Bypass Hose and Charge Air Cooler Icing for LUV Engines, Malfunction Indicator Lamp (MIL) Illuminated - DTC P0299, P0234, P0236, P2261, P2227, P00C7 Set

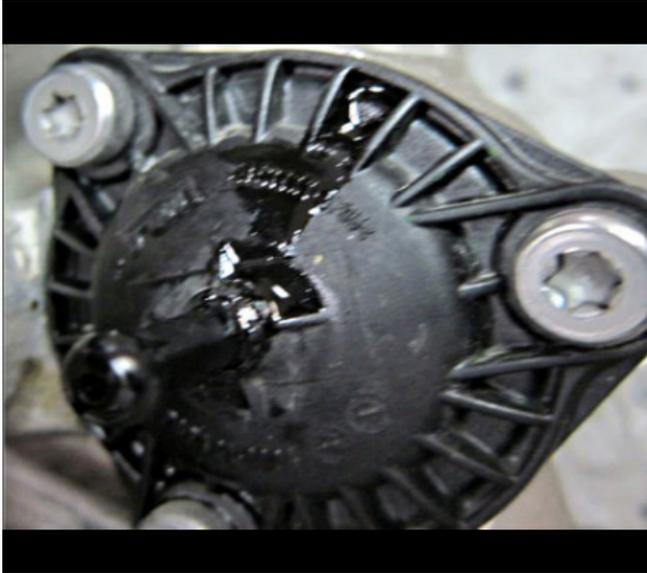
5590615

1. Inspect the charge air bypass valve for ice/oil/water/sludge build-up in the vacuum side port.

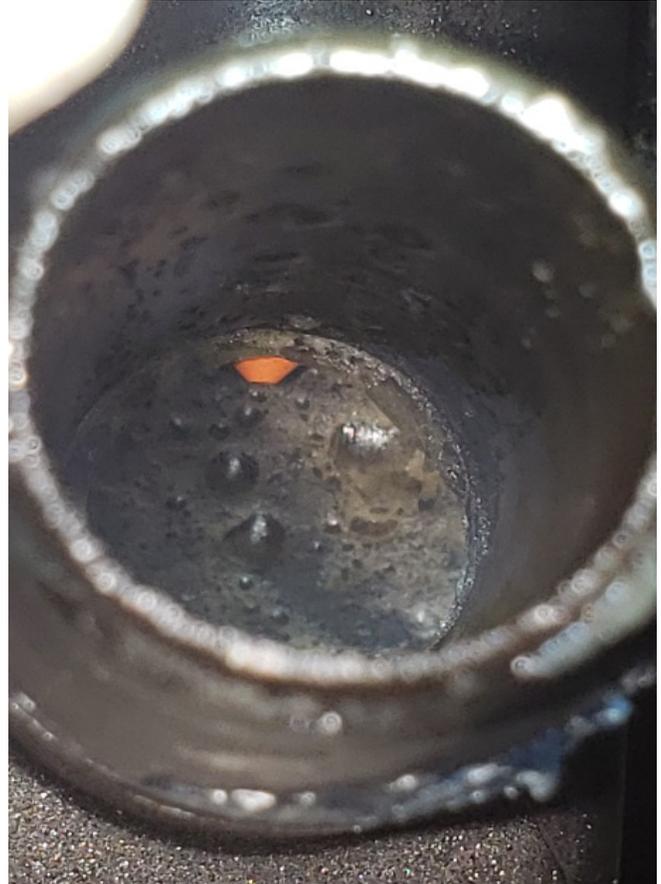
5286434

3. Inspect the vacuum ports of the intake manifold for ice/water/oil accumulation.

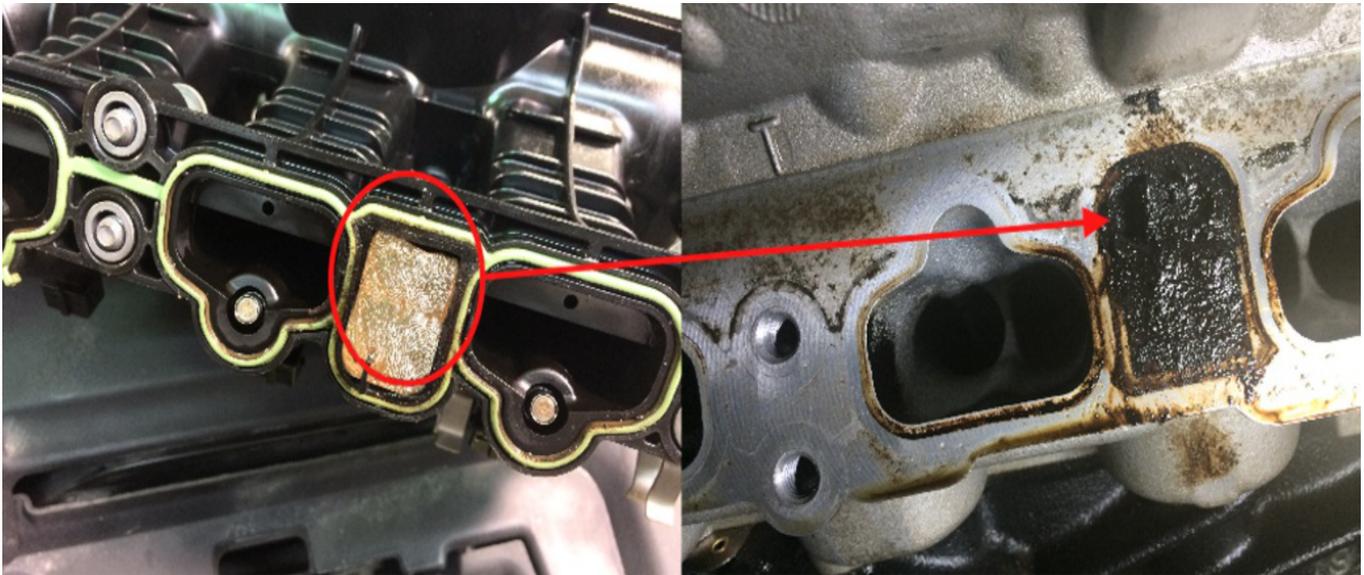
5286457

- 4. Inspect the PCV intake runner for ice build-up blocking the cylinder head as shown above.

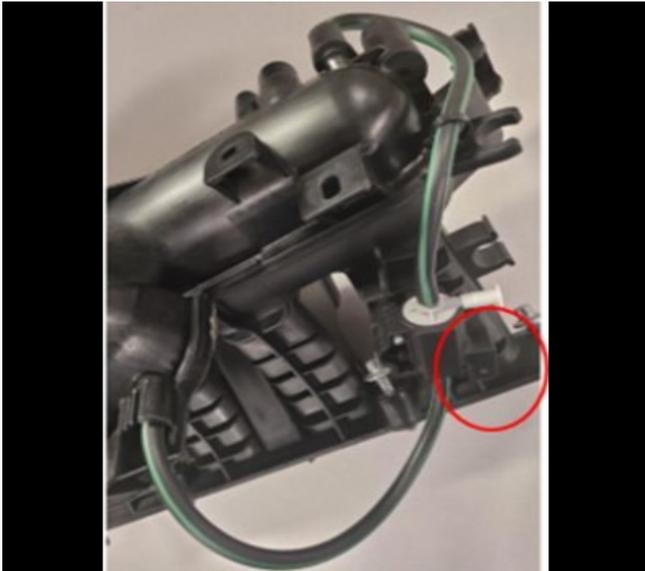
6145028

New Design Intake with incorrect solenoid installation.

Note: The electrical receptacle location. Remove and re-install the lines and solenoid as they are retained to the intake if installed incorrectly. Tabs reversed, the solenoid is keyed and will not be seated in retainers.

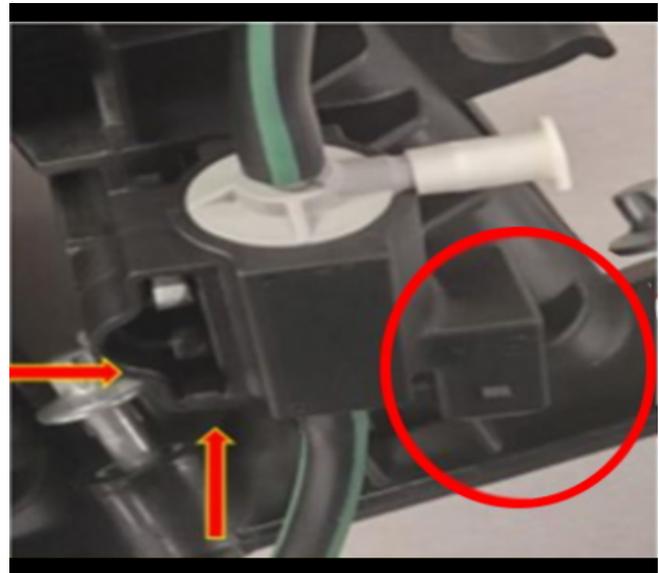
6145030

New Design Intake with solenoid retainers not seated and the electrical connector facing the cylinder head. Keyed section of intake not level with solenoid body.
