Service 153/22 ENU

WNC5 - Check Universal Joint on the Intermediate Steering Shaft and Exchange Intermediate Steering Shaft if Necessary (**Stop Delivery** / Workshop Campaign)

Model Series:	Macan (95B)
Model Year:	As of 2021 up to 2023
Concerns:	Intermediate steering shaft
Information:	There is a possibility that the universal joint on the intermediate steering shaft was damaged during the production process on the affected vehicles.
	If this is the case, there may be clearly perceptible play and possible noise in the steering.
Action required:	Check bolts on universal joint of intermediate steering shaft and exchange intermediate steering shaft depending on the outcome of the check.
Affected Vehicles:	Only the vehicles assigned to the campaign (see also PCSS Vehicle Information).
Check universal joint on the intermediate steering shaft and exchange intermediate steering shaft if necessary

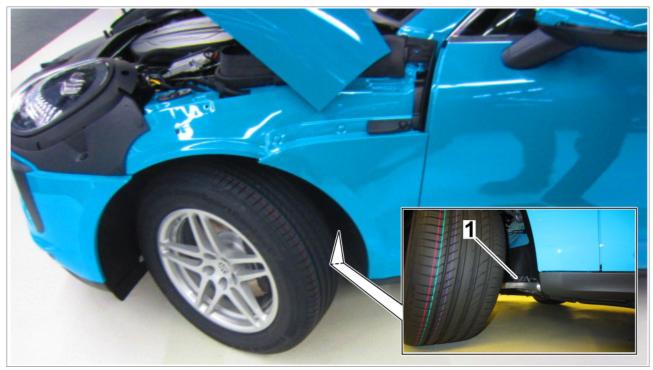
Installation position of universal joint

Both **bolts** \Rightarrow Checking universal joint -1- are within the visible impression:

- You can feel and see one or both bolts sticking out of the universal joint: The universal joint is damaged and the intermediate steering shaft must be replaced. To do so, proceed with ⇒ Workshop Manual '482819 Removing and installing intermediate steering shafts'. The incurred labor costs and the additional cost of parts required must then be invoiced using a reimbursement claim for the original campaign claim for this campaign. In this case, photographic documentation is absolutely essential and must be attached to the campaign claim.
- 3 Remove vehicle from the lifting platform ⇒ Workshop Manual '4X00IN Lifting the vehicle'.
