TEAM TIP

Communication #: T-22-08-01

Model Year(s): 2015+

SUBJECT: REAR AXLE AND BEARING INSTALLATION

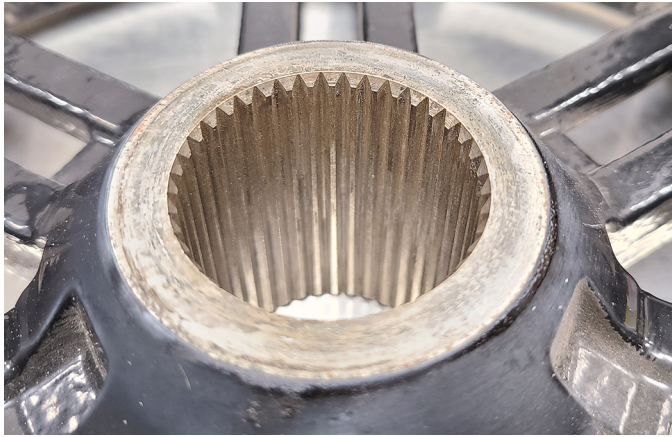
CLEAN

It is critical that that all cured and uncured Loctite be removed from any components being reinstalled. When properly cleaned, the sprocket should slide freely onto the axle by hand with minimal force. See examples below.

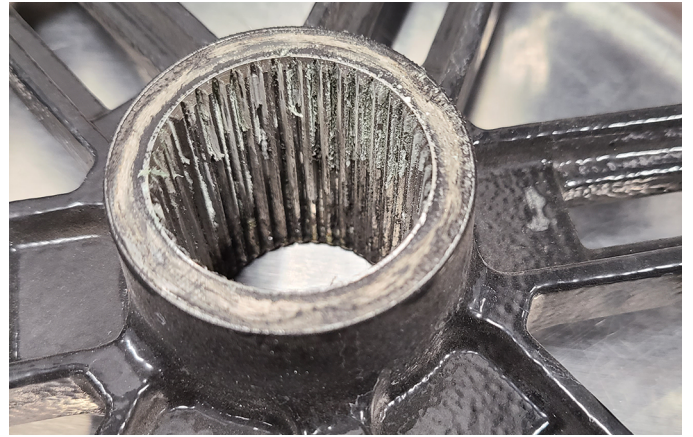
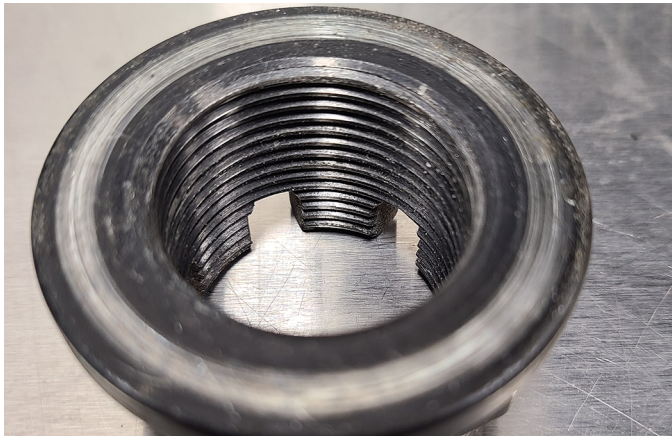
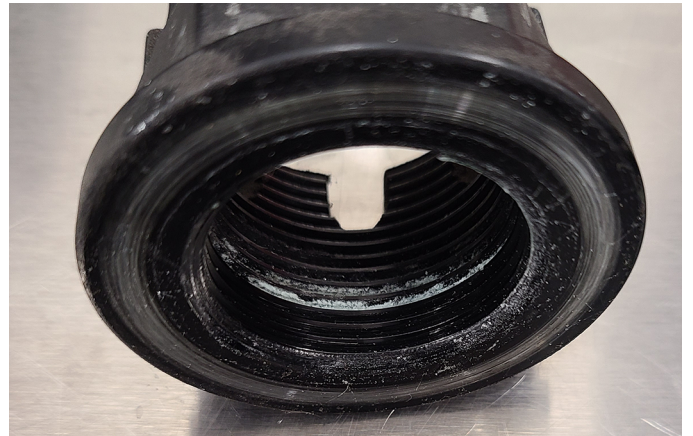
DIRTY

Improper installation of the axle may result in insufficient clamp load. When proper clamp load is not achieved, the vehicle may experience erratic or incorrect rear wheel speed sensor readings. Symptoms include a reduction in deceleration during engine braking and a feeling of cruise control being engaged or ABS activation during light braking.

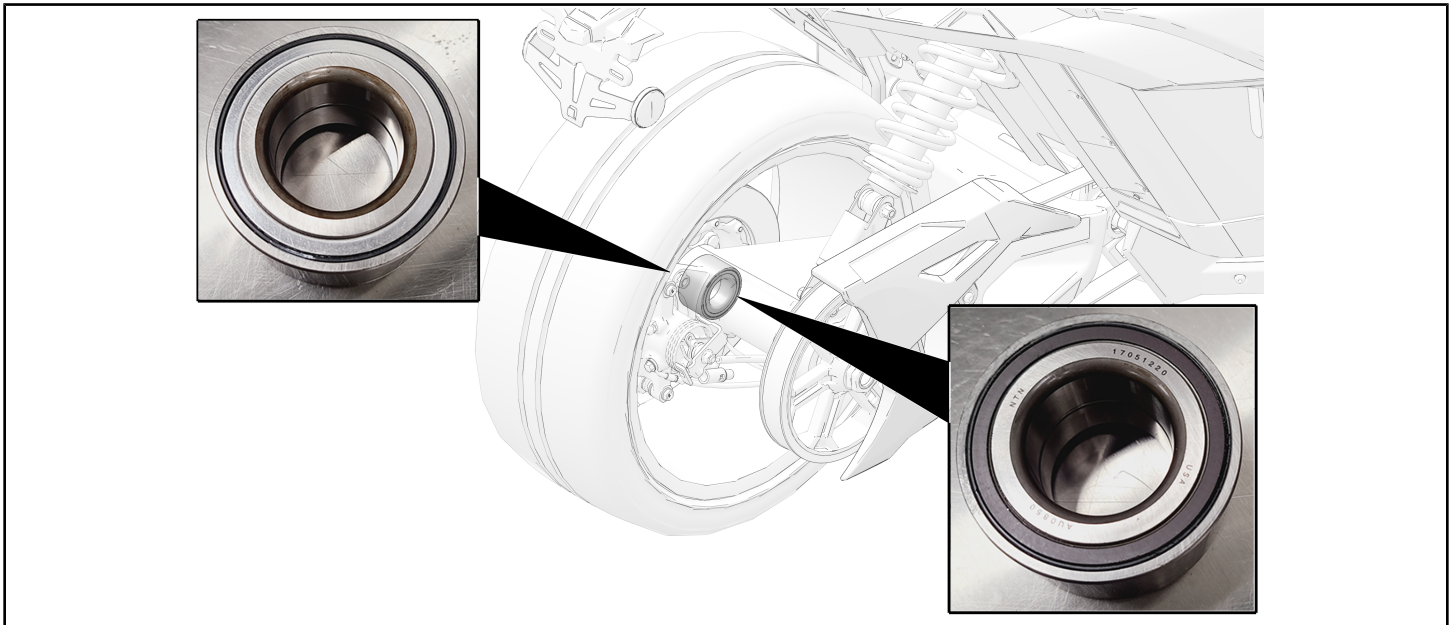
The rear wheel bearing in the driver side of the swingarm has an encoder that is used to produce the rear wheel speed signal. When the bearing is installed incorrectly the rear wheel speed reading may become erratic or not read at all meaning the axle clamp load is improper or the bearing is worn/failed.

During installation, the bearing must be installed with the brown seal side inward toward the swingarm for proper operation, as outlined in the service manual.

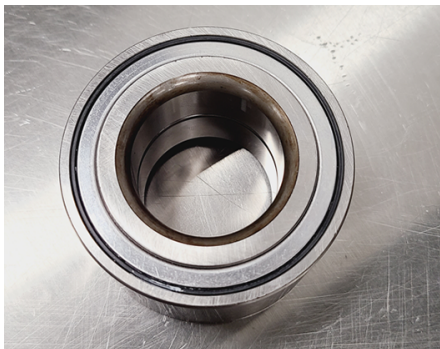
Silver Side: Faces outward toward the wheel and has no visible part numbers.

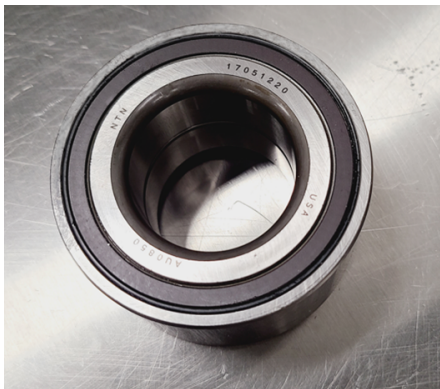
Brown Seal Side: Faces inward toward the swingarm and has etched part number/label.
