**Symptom - Engine - Engine is Sluggish When Revving Up/Maximum Speed is not Reached:
Checking Part Number of Throttle-Housing Cover (SY 104/19)**

Vehicle Type: **911 GT3 Touring (991)**

Concerns: **Throttle-housing cover**

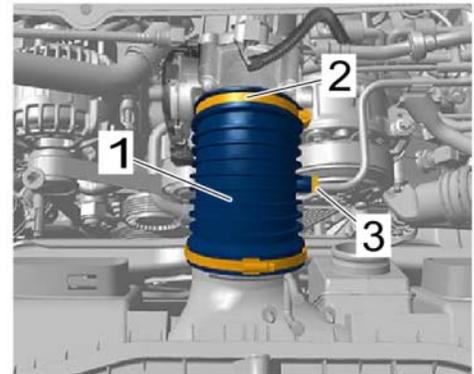
Throttle-housing cover

Cause: In the case of 911 GT3 **Touring** vehicles, the cover between the air cleaner housing and throttle housing can become deformed due to insufficient material hardness while driving.

Work Procedure: 1 Check part number ⇒ *Throttle-housing cover -1-*.

- 1.1 Replace throttle-housing cover with Part No. **99111027091**, see ⇒ *Workshop Manual '242519 Removing and installing air cleaner housing'*.
