WLD4 - Replacing Hose for Positive Crankcase Ventilation (Workshop Campaign)

Vehicle Type: **Cayenne (9YA)**

Subject: **Positive crankcase ventilation hose**

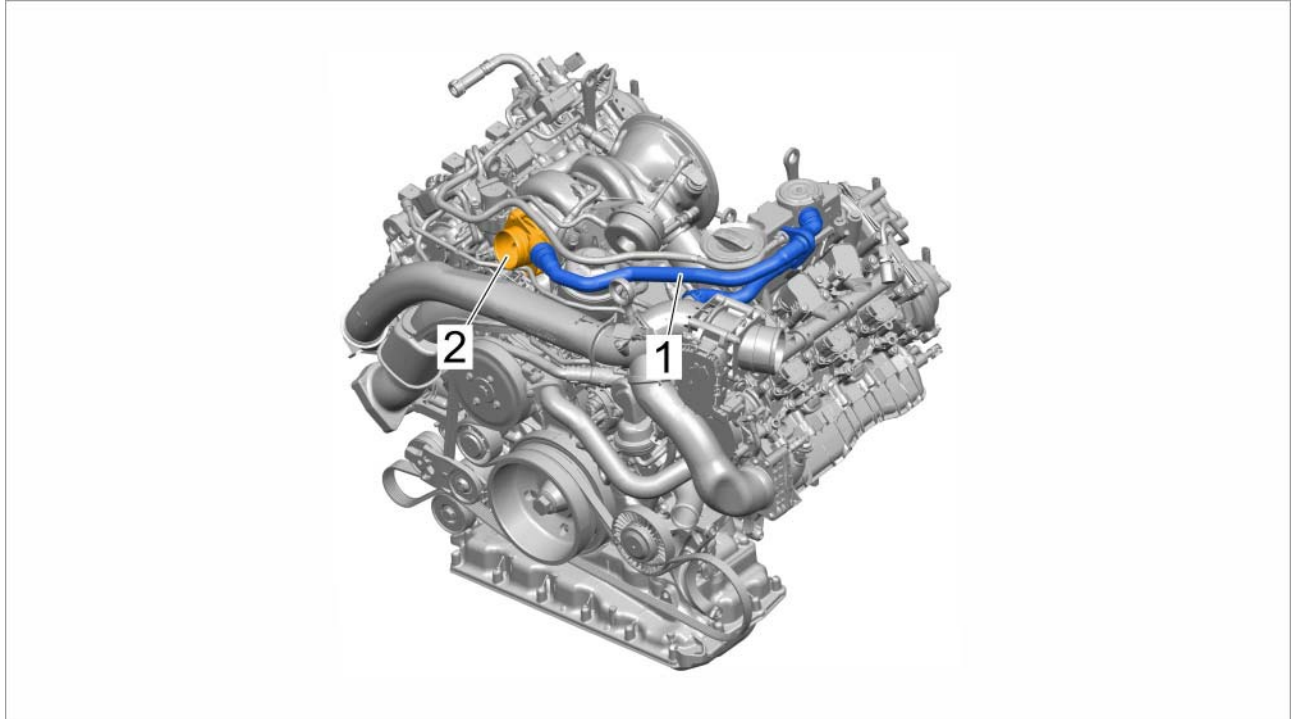
Information: **A part-load valve was installed in the hose for crankcase ventilation on the affected vehicles which has a sealing washer that does not meet the required specifications and could possibly crack when the crankcase pressure rises.**

Installation location for positive crankcase ventilation hose.

- 1 – Positive crankcase ventilation hose
- 2 – Intake manifold

Remedial Action: Replace positive crankcase ventilation hose.

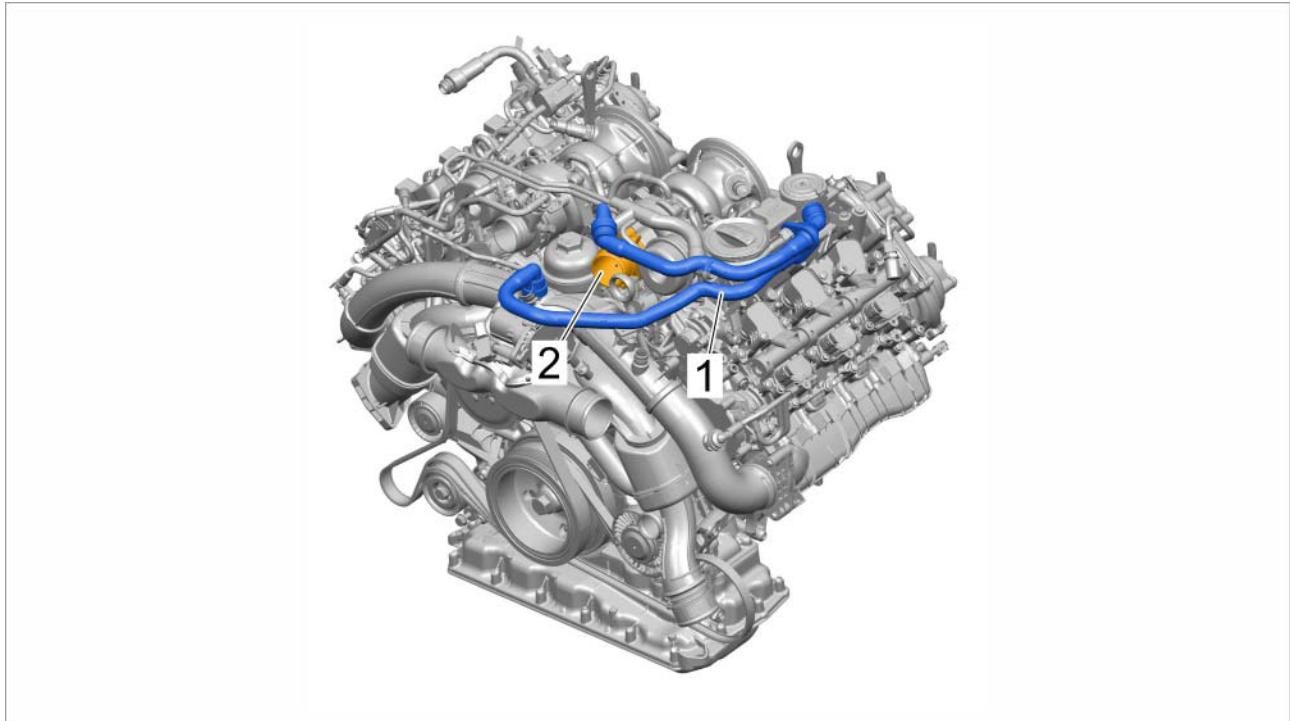
Information: **A part-load valve was installed in the hose for crankcase ventilation on the affected vehicles which has a sealing washer that does not meet the required specifications and could possibly crack when the crankcase pressure rises.**

Installation location for positive crankcase ventilation hose.

- 1 – Positive crankcase ventilation hose
- 2 – Intake manifold

Remedial Action: Replace positive crankcase ventilation hose.
