WLD4 - Replacing Hose for Positive Crankcase Ventilation (Workshop Campaign)

Model Line: **Panamera (971)**

Subject: **Positive crankcase ventilation hose**

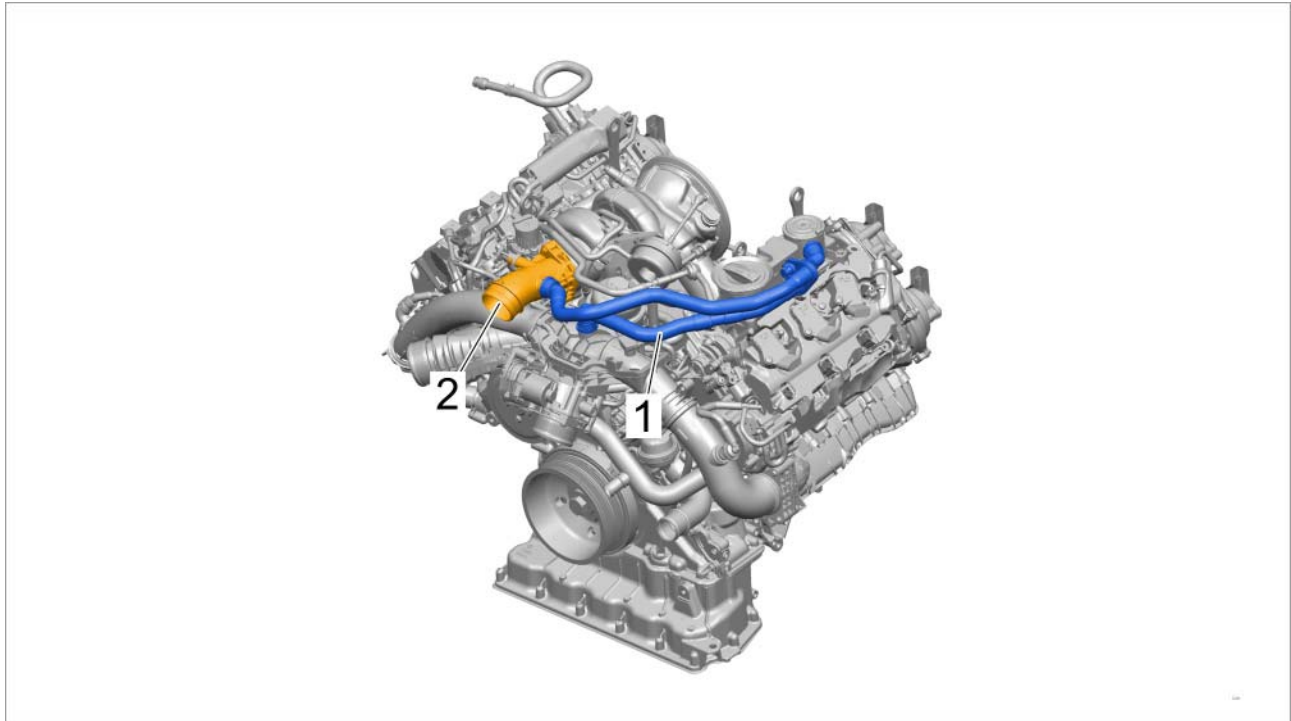
Information: **A part-load valve was installed in the hose for crankcase ventilation on the affected vehicles which has a sealing washer that does not meet the required specifications and could possibly crack when the crankcase pressure rises.**

Installation location for positive crankcase ventilation hose.

- 1 – Positive crankcase ventilation hose
- 2 – Intake manifold

Remedial Action: Replace positive crankcase ventilation hose.

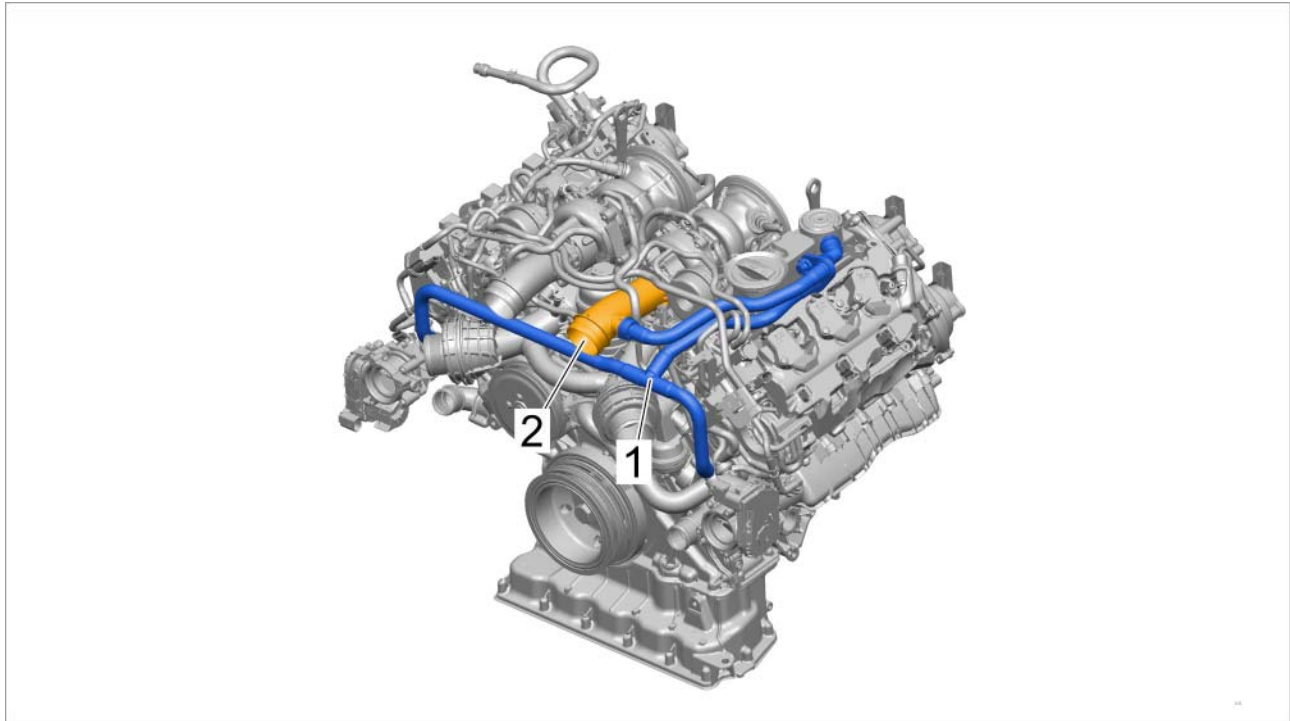
Information: **A part-load valve was installed in the hose for crankcase ventilation on the affected vehicles which has a sealing washer that does not meet the required specifications and could possibly crack when the crankcase pressure rises.**

Installation location for positive crankcase ventilation hose.

- 1 – Positive crankcase ventilation hose
- 2 – Intake manifold

Remedial Action: Replace positive crankcase ventilation hose.
