SERVICE PROGRAM BULLETIN

APPLICABILITY: 2022 MY WRX

NUMBER: WRA-22R

SUBJECT: WRX EyeSight® Reprogramming

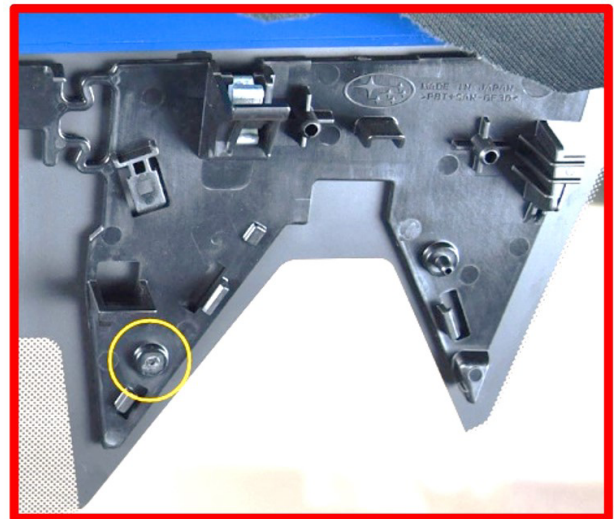
If EyeSight® stereo camera assembly removal is required, particular care must be taken while removing the cover in order to avoid damaging the camera bracket. If excessive force is applied to the camera cover during removal the camera cover may contact the lens hood alignment pins on the camera bracket, causing them to break. If this happens, the windshield will require replacement.
