SHOP FOREMAN | AUGUST 2022  
CONFERENCE CALL

## SAFETY RECALL N678 – DRIVER SAFETY BELT EMERGENCY LOCKING RETRACTOR

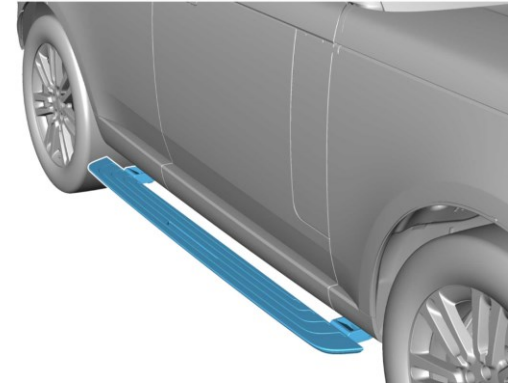
- Customer states that the deployable side steps are not operational

- This has occurred after CCF As-Built has been loaded into the vehicle. Loading the CCF as-built has removed the Deployable Sidestep option from the CCF

- Please follow step 8 completely in the accessory fitting instructions for Deployable Side Steps (Electrical Only) only after all other CCF work has been completed.
- SSM75802 has been released for this concern

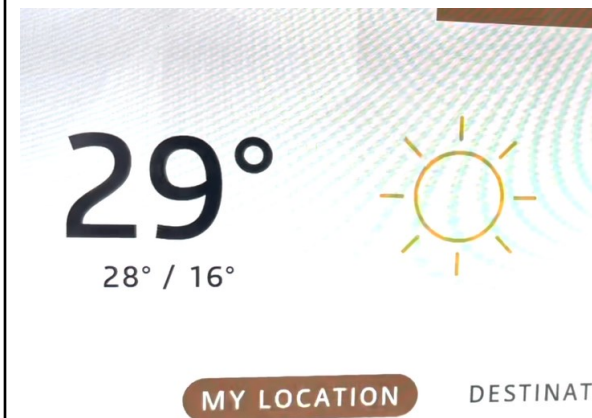
- Weather information is no longer available after software update.

- An error is possible with web application download after flashing PIVI Pro to IP34 via SOTA (OS 3.3.0)/ TOPIx Cloud and will result in web applications (Weather), being removed on update and not being reinstalled.
- There is no error message presented to the user to indicate that the vehicle has entered the error state.
- This issue is caused by a software bug and may affect a small percentage of cars. This bug will be fixed in the next PIVI Pro software release. Therefore, it is not necessary to replace any components to repair this issue

- The error state can be repaired by following instructions in SSM75814/SSM75813

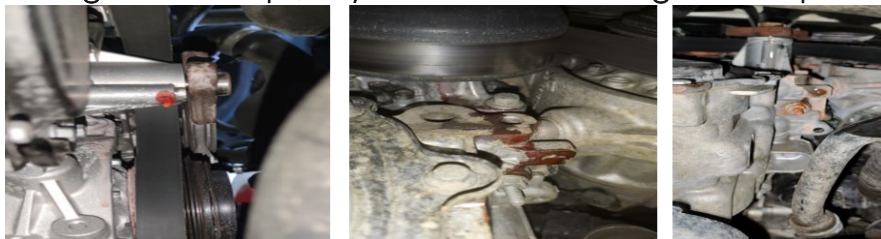
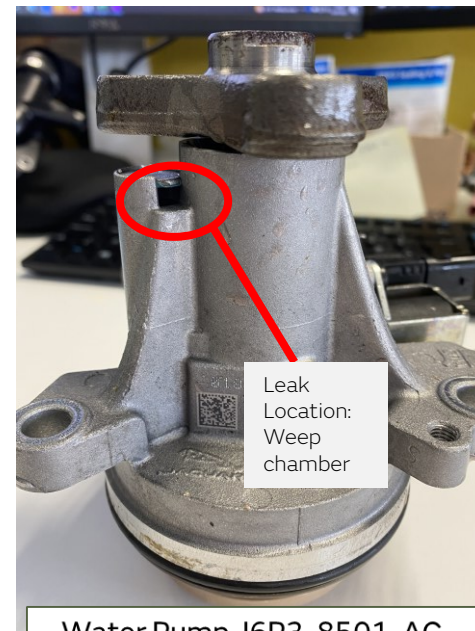
**Water Pump J6P3-8501-AC**  
LR Service Number: LR121418  
Jaguar Service number: T4A41037

- Coolant warning light and/or coolant leaking from vehicle.

- Water Pump to be replaced due to leakage at water pump weep chamber.

Example Leaking Water Pumps, Any observation of leakage to be reported

- Raise an EPQR to support the ongoing investigation.
- Take 1 quart Coolant sample before repair.
- Remove Water Pump and package with coolant sample for collection via PRR.
- Refer to TOPIx 303-03C: Engine Cooling - INGENIUM I6 3.0L Petrol for diagnostic and repair instructions.

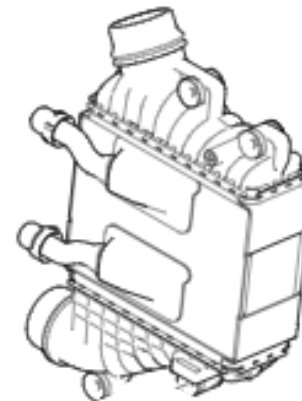
**SSM 75808/75809**

INGENIUM I4 2.0L PETROL - Message centre displays 'Coolant Level Low' warning message.

- Customer reports coolant level low message on dash or a coolant leak.

- If the customer concern has been rectified, attach all the information identified to an EPQR, quoting this SSM, along with the:
- Confirmation of customer complaint: Coolant light on, low coolant, or has a leak.
- Diagnostic steps: Photos of the Charge Air Cooler internals showing evidence of coolant leak.
- Please also save for return to JLR:
  - 100ml of coolant from the vehicle.
  - The Charge Air Cooler.
  - Parts Return Request (PRR) will be raised on receipt of EPQR.

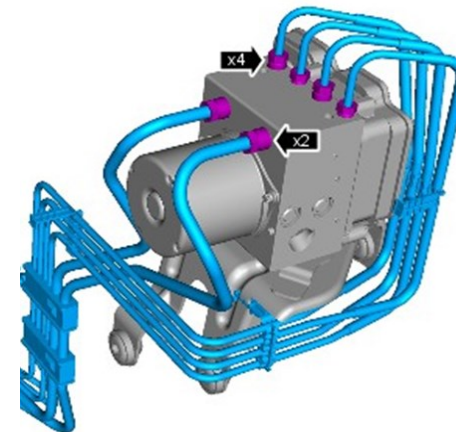
Refer to SSM 75681 / 75682

- Concern is caused by torque wind up in the rear axle, potentially resulting in ‘skipping’ of the rear inside wheel. This cyclic driveline wind-up/release is the root cause of reported ‘judder / vibration’ at low speed.

- Update the Anti-lock Brake System (ABS) and TCCM module software.
- This procedure requires TOPIx Cloud and alternatively minimum of Pathfinder build 366 loaded or later depending on vehicle.
- The issue is predominantly linked to older levels of ABS and TCCM software. TOPIx (Section 307-07 > Diagnosis and Testing > Transfer case) has been updated to reference the software update:

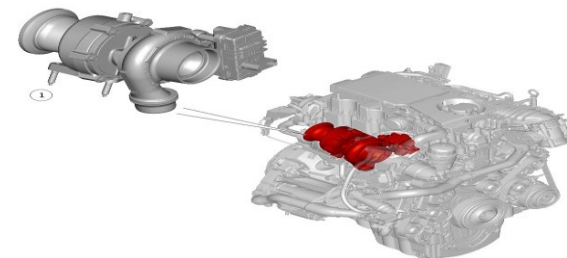
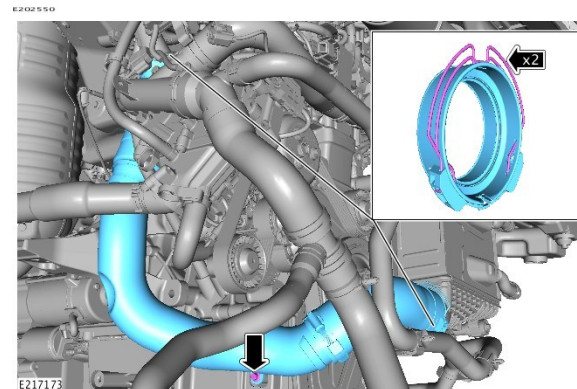
REFER to TOPIx section 303-04E, Pinpoint test D1 and D2  
SSM 75633/75634

Turbocharger removal/replacement. Residual Debris/Oil Causing Mechanical damage  
- AJ20-D4

- After mechanical repairs to the Diesel Engine Turbocharger have been completed, excessive smoke and/or lack of power is noticed.
- This can be after turbocharger removal or replacement that has resulted in metal parts and/or engine oil pooling in the intake system.

- When completing repairs to the Turbocharger, please ensure that any debris, and/or oil ingress is cleared out all of the intake channels (air-path pipes, intake manifold, intercooler, turbocharger, and breather hose assemblies) prior to completion of the repairs.
- **All residual oil must be removed.**
- Failure to do so may cause subsequent mechanical failures to the engine and/or turbocharger assemblies.

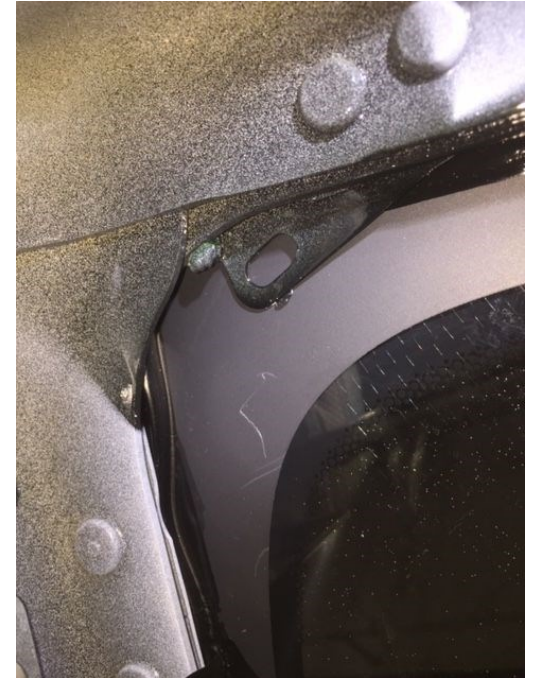
- This may be caused by a body flange contacting the windshield glass.

- Engineering is currently investigating this concern.
- SSM 75800 has been published to address this concern.
- The body flange can be easily be repositioned away from the windshield glass without the need to remove the windshield, using a suitable tool.
- Care should be used to avoid damaging the windshield glass.

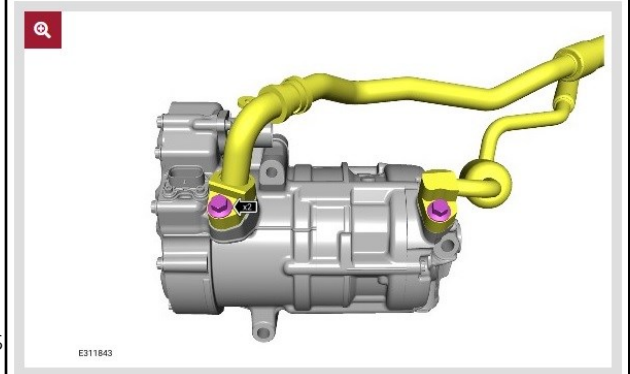
- A customer may report that the air conditioning system does not blow cool/cold air.

- This may be caused by a refrigerant pipe that has cracked.

- Engineering has developed redesigned refrigerant pipes to address this concern.
- TSB JLRTB02109NAS2 has been published to address this concern.
- Both the suction (low pressure) and the discharge (high pressure) refrigerant lines must be replaced together (even if only one line has developed a crack) when changing to the new redesigned refrigerant lines.
