# SAFETY BULLETIN

**Communication #:** I-19-02-A/B/C

## VERSION: R04 (August 29, 2022)

## SUBJECT: INDIAN MOTORCYCLE - FORWARD LIGHTING

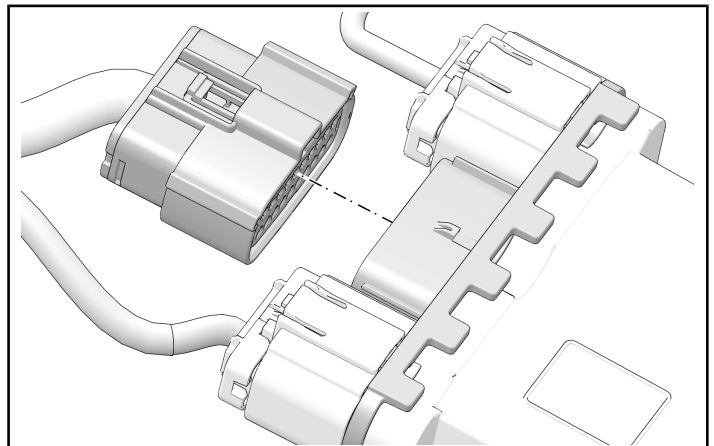
2. Disconnect the center connector on the VCM. Locate Pin 11 of the VCM1 (center) connector and check for any discoloration.

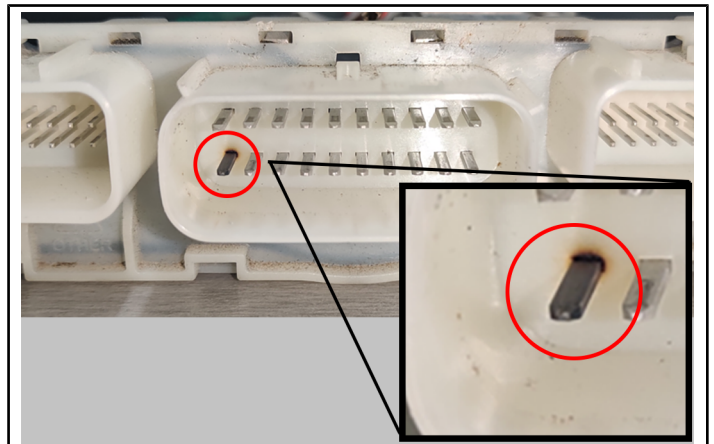
Inspect the male pin on the VCM board for damage.

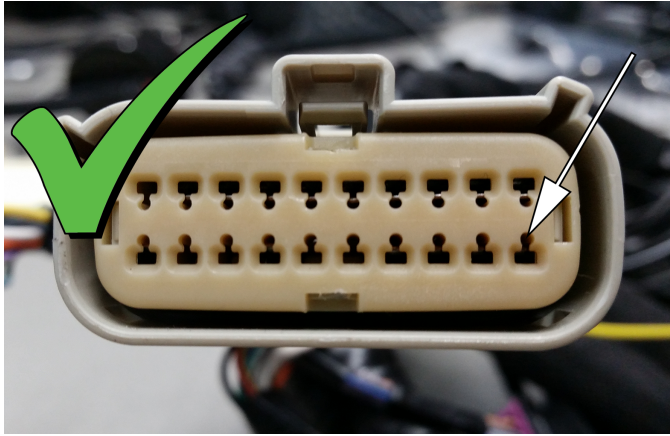
VCM connector, pin 11

#### **DAMAGE IS NOT PRESENT**
