Technical Service Bulletin

SUBJECT:		No: TSB-22-51-002	
REAR (AIR) SPOILER CRACK		DATE: August 2022	
		MODEL: See Below	
CIRCULATE TO:	<input type="checkbox"/> GENERAL MANAGER	<input checked="" type="checkbox"/> PARTS MANAGER	<input checked="" type="checkbox"/> TECHNICIAN
<input checked="" type="checkbox"/> SERVICE ADVISOR	<input checked="" type="checkbox"/> SERVICE MANAGER	<input checked="" type="checkbox"/> WARRANTY PROCESSOR	<input type="checkbox"/> SALES MANAGER

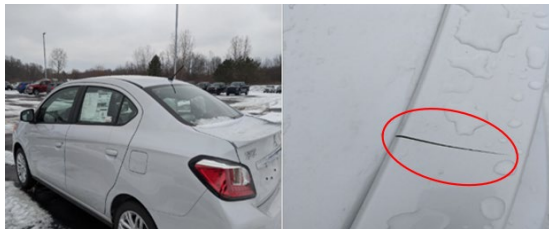
A customer may find a crack on the Rear Spoiler, also known as Air Spoiler. Multiple factors such as heavy pad compression on the spoiler bolt retainer during shipping and vast temperature fluctuations causing shrinkage and expansion may be the cause.

This TSB instructs the dealers to replace the Air Spoiler, RR on a customer complaint basis.
