# Exhaust Flex Pipe Cracks

M-252-001

(January 2009)

All CXU,CHU,GU,TD models with MP7, MP8 built before May 2008

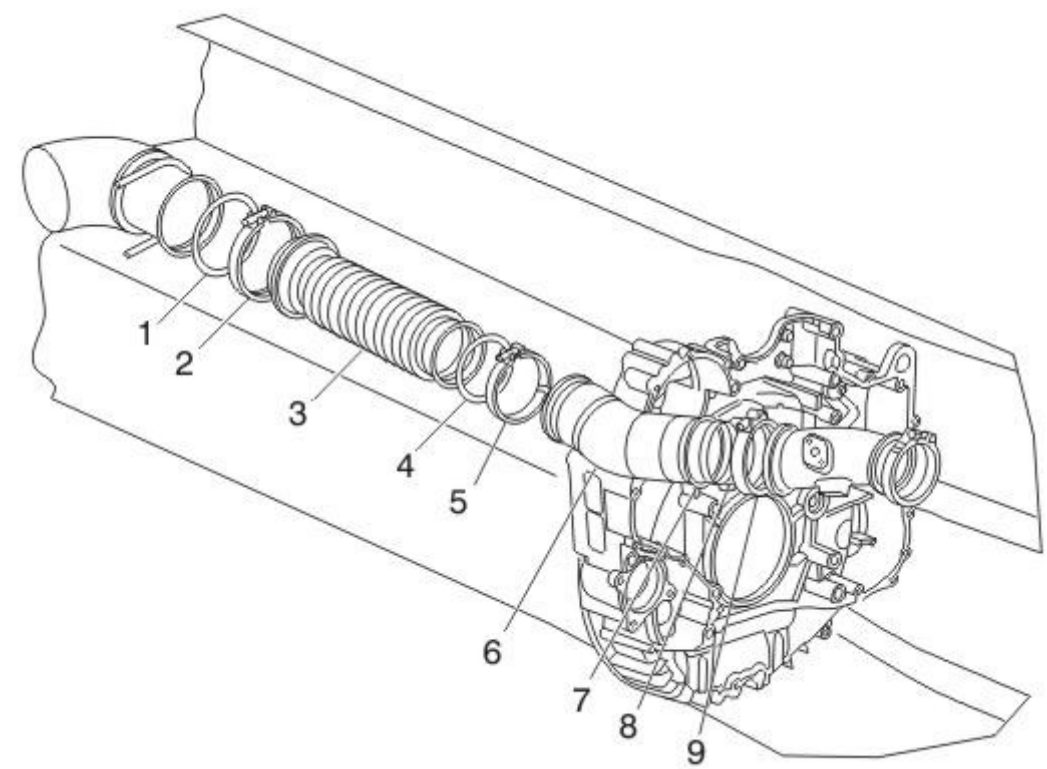
Revised Exhaust Flex and Turbocharger Outlet Pipes

Effective May 9, 2008, a redesigned exhaust flex pipe and turbocharger outlet pipe (located between the turbocharger cast diffuser and the exhaust flex pipe) were implemented into production on CXU, CHU and GU model chassis. Both the turbocharger outlet pipe and the exhaust flex pipe were redesigned to improve exhaust pipe alignment, and the diameter of the inside liner of the flex pipe was reduced by 6.35 mm (1/4") to prevent contact with the pipe bellows. These changes were made to prevent the exhaust flex pipe from cracking. Should a cracked exhaust flex pipe be encountered on a chassis manufactured prior to May 9, 2008, the existing flex pipe and turbocharger outlet pipe should be replaced with these revised components.

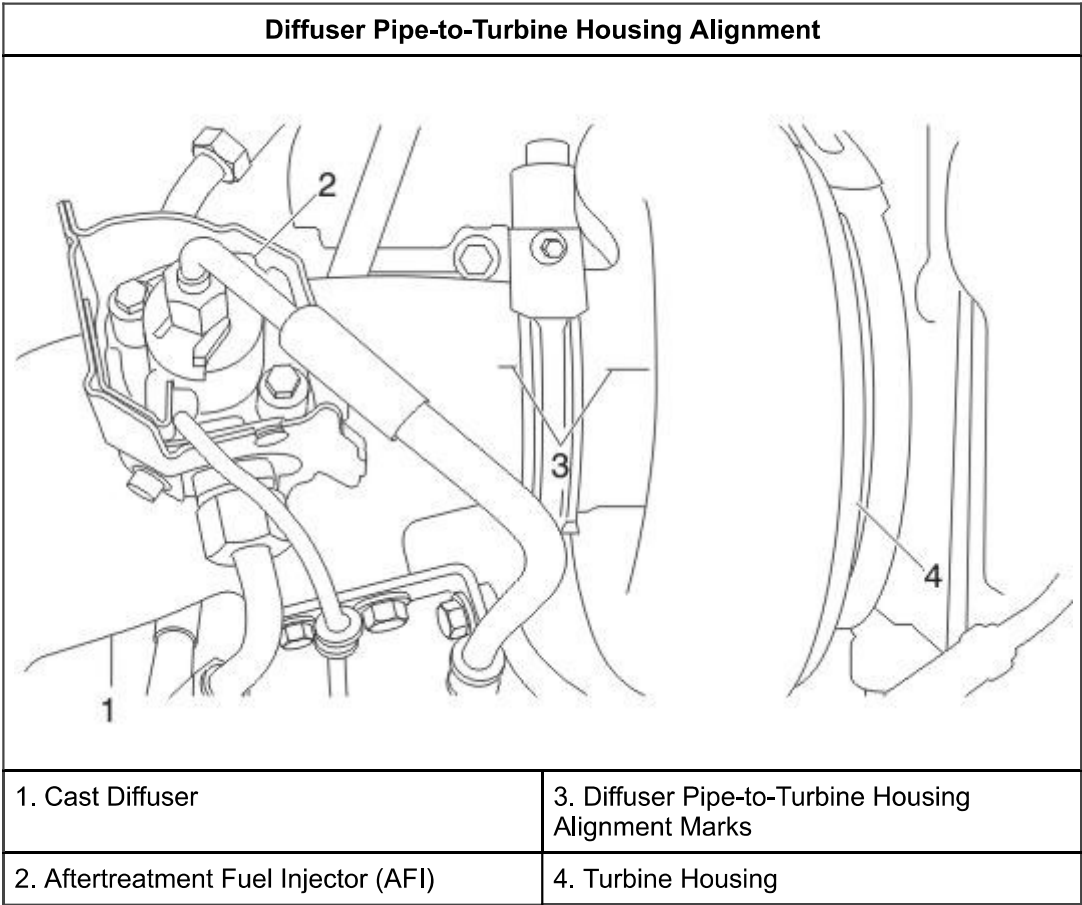
*Note: Alignment of the turbocharger diffuser pipe to the turbine housing, as well as alignment of the turbocharger outlet pipe to the diffuser pipe is critical to prevent the exhaust flex pipe from cracking.*

- 1. Verify that the alignment marks on the cast diffuser and the turbocharger turbine housing are directly opposite each other as shown below.
