## Audio Sound Stops and "No Audio Connection" Message Appears

### AFFECTED VEHICLES

| Year | Model | Trim | VIN Range |
|---|---|---|---|
| 2019–20 | RDX | ALL | ALL |

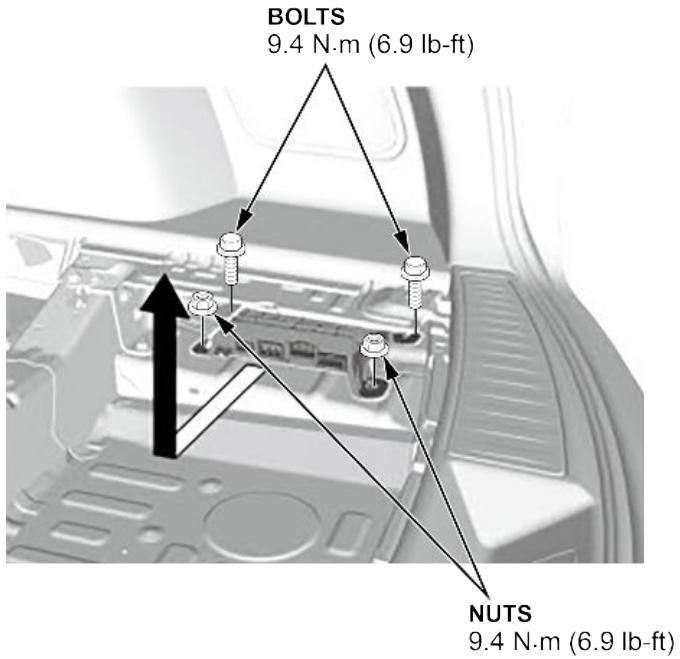
6. Unfasten the associated connectors going into the stereo amplifier.
7. Remove the bolts tightened at **9.4 N·m (6.9 lb-ft)**, and then remove the stereo amplifier as shown.

8. Replace the stereo amplifier.
9. Install the parts in the reverse order of removal.
