HUSQVARNA TECHNICAL BULLETIN HTB2207

JULY 25, 2022

CONTINENTAL TKC 80 TIRE RECALL

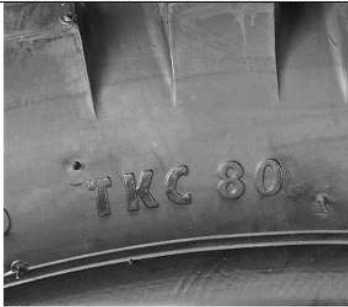
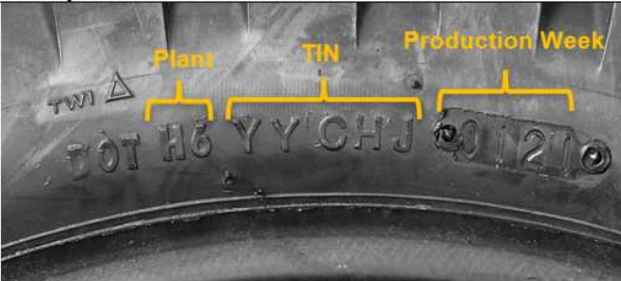
Attachment no. 2 – how to identify Tire line, DOT Plant + TIN Code and Production Week

Tire Line	Tire Line Sidewall Picture	Examples of DOT Plant and TIN Code
TKC80

<p>Multiple TIN codes affected – see Attachment 1</p>
