Service Campaign

2014-2017MY
Forte & Forte Koup (YD)

SC238 (Rev 1, 09/07/2022)

BRAKE TUBE/ LINE INSPECTION/REPLACEMENT &
ANTI-CORROSION MATERIAL APPLICATION (SC238)

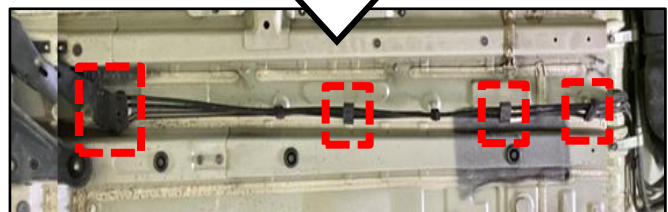
2. Inspect the entire length of the brake lines (L&R - Front to Back of the vehicle) for corrosion and/or fluid leakage, especially in the brake line retaining clip areas shown.

- 3a. Is there evidence of brake fluid leakage and/or corrosion?

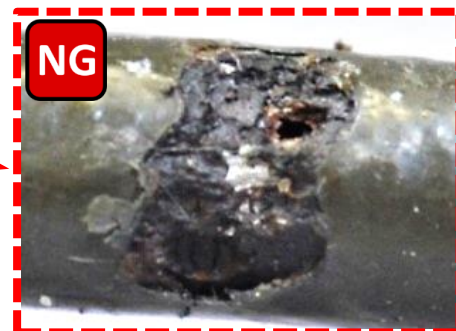
- 3c.
 - **Yes (NG):** Proceed to the 'Replacement Procedure' to replace the brake line(s). (Sample of severe corrosion and brake fluid leak).

1. Remove the center muffler assembly (B) by referring to "Engine Mechanical System → Intake and Exhaust System → Muffler → Repair procedures (Center Muffler)" in the applicable Shop Manual on KGIS.
2. Remove the auxiliary canister (C) by referring to "Emission Control System → Evaporative Emission Control System → Canister → Repair procedures" in the applicable Shop Manual on KGIS.
3. Remove the fuel tank by referring to "Engine Control/Fuel System → Fuel Delivery System → Fuel Tank → Repair procedures" in the applicable Shop Manual on KGIS.
