MIL ON With DTC P019064

Service Category Engine/Hybrid System

Section Engine Control

Some 2019 model year Avalon Hybrid, 2018 – 2019 Camry Hybrid, and 2019 – 2021 RAV4 Hybrid vehicles may exhibit a MIL ON condition with Diagnostic Trouble Code (DTC) P019064 (Fuel Rail Pressure Sensor “A” Signal Plausibility Failure). The Engine Control Module (ECM) (SAE term: Powertrain Control Module/PCM) logic has been modified to reduce the possibility of this condition. Follow the Repair Procedure in this bulletin to address this condition.

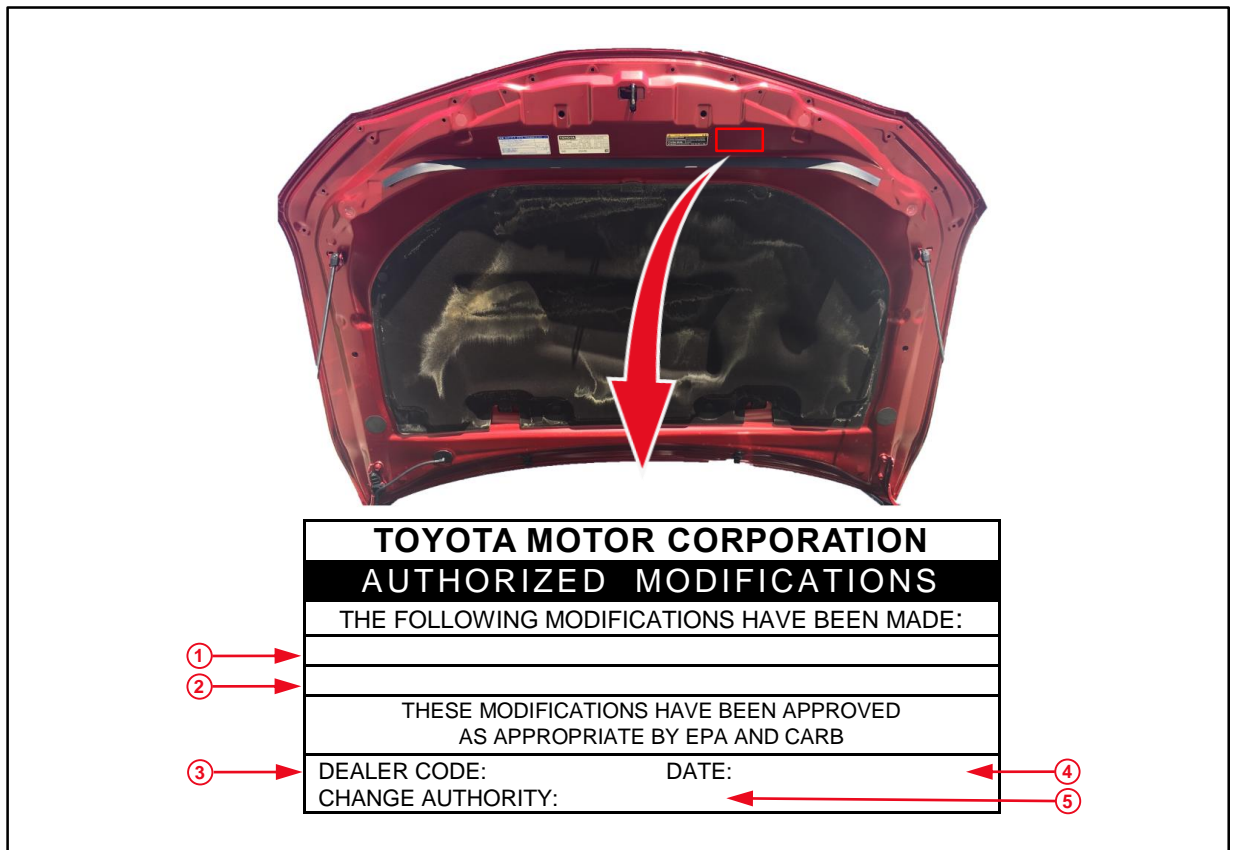
Figure 1. Location of Authorized Modifications Label on 2019 Avalon HV

1	Replacement ECM (PCM) Part Number (e.g., 89661-07651)
2	New Calibration ID (e.g., 896630724100)
3	Dealer Code

4	Date Completed
5	This SB Number

- Prepare and install the Authorized Modifications Label.
 - Using a permanent marker, enter the following information on the label:
 - ECM (PCM) part number [Refer to the **Parts Information** section for the **NEW PART NUMBER**]
 - Calibration ID(s) [Refer to the **Calibration Information** section for the **NEW CALIBRATION ID**]
 - Dealer Code
 - Repair Date
 - Change Authority [This bulletin number]
 - Install the Authorized Modifications Label onto the vehicle at the locations shown in Figures 1 – 3. The Authorized Modifications Label is available through the MDC, P/N 00451-00001-LBL.

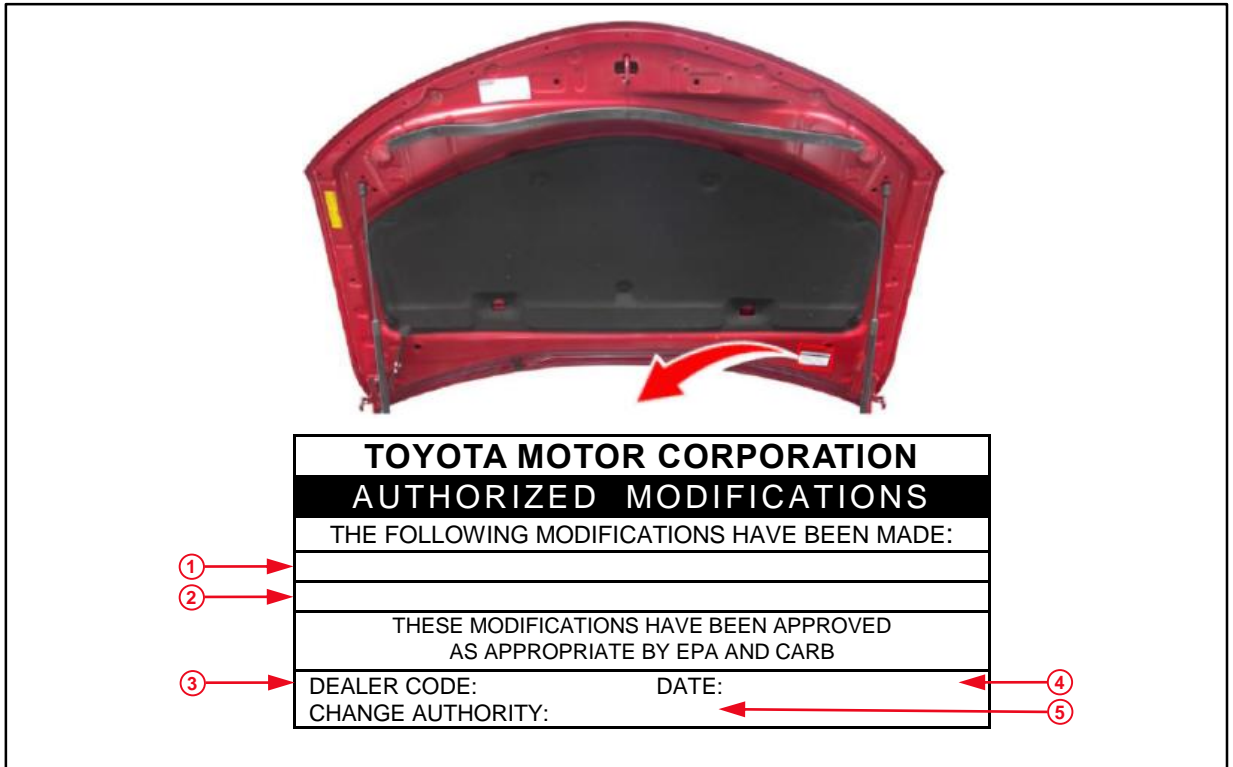
Figure 2. Location of Authorized Modifications Label on 2018 – 2019 Camry HV

1	Replacement ECM (PCM) Part Number (e.g., 89661-0X561)
2	New Calibration ID (e.g., 8966306R6100)
3	Dealer Code

4	Date Completed
5	This SB Number

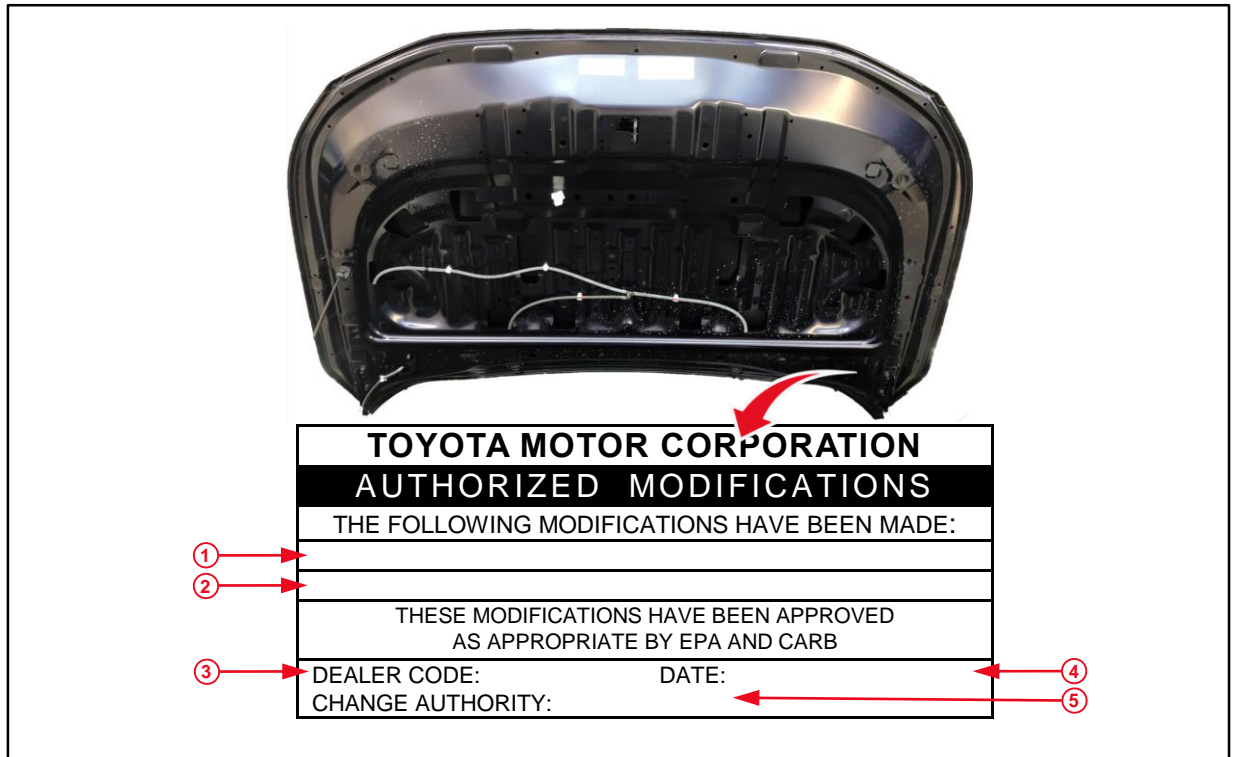
Figure 3. Location of Authorized Modifications Label on 2019 – 2021 RAV4 HV

1	Replacement ECM (PCM) Part Number (e.g., 89661-4AA31)
2	New Calibration ID (e.g., 896634A13100)
3	Dealer Code

4	Date Completed
5	This SB Number
