# Abnormal Whistle Noise From Vehicle Front

YEAR(S)	MODEL(S)	ADDITIONAL INFORMATION
2020 - 2022	Highlander, Highlander HV

Some 2020 – 2022 model year Highlander (except XSE models) and Highlander Hybrid vehicles may exhibit an abnormal whistle noise from the front when driving over 35 mph. This may be caused by the radiator grille bracket. A new radiator grille bracket has been developed to address this condition. Follow the Repair Procedure in this bulletin to address this condition.

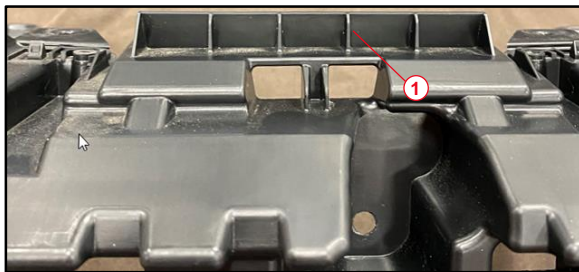
**Figure 1. Radiator Grille Bracket Before 11/5/2021**

- Ensure the NEW radiator grille bracket received is the correct part.  
The OLD and the NEW parts differ in the shape of the ribs directly above the emblem cut out. The OLD grille bracket has closed ribs in the center, while the NEW part has open ribs in the center. Refer to Figure 1 and Figure 2 below for reference.

<b>1</b>	<b>Ribs With Closed Shape</b>
----------	-------------------------------

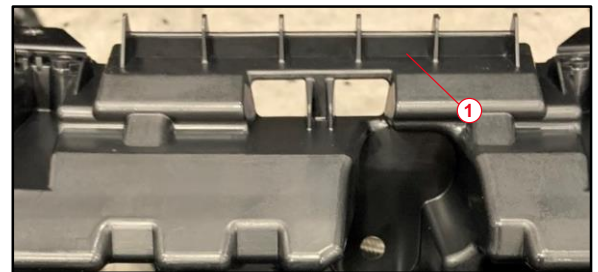
**Figure 2. New Radiator Grille Bracket**

<b>1</b>	<b>Ribs With Open Shape</b>
----------	-----------------------------

- Remove and replace the radiator grille bracket.

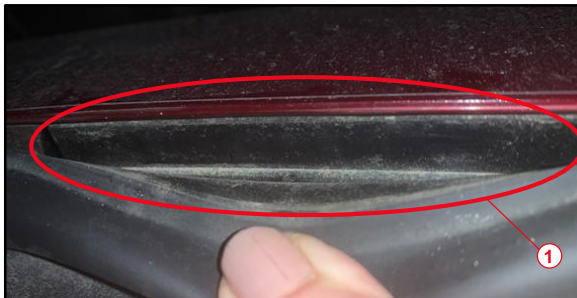
**Figure 3. Radiator Grille Bracket Before 11/5/2021**

<b>1</b>	<b>Does Not Contain Ribs in the Center Section Directly Above the Emblem</b>
----------	------------------------------------------------------------------------------

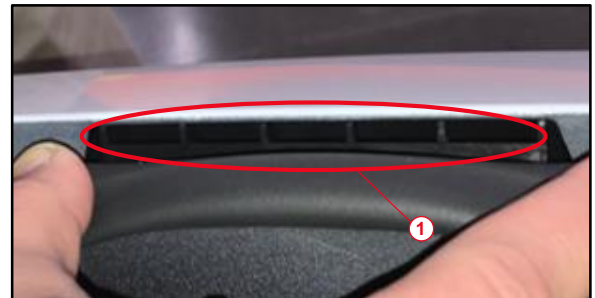
**Figure 4. New Radiator Grille Bracket**

<b>1</b>	<b>Contains Ribs in the Center Section Directly Above the Emblem</b>
----------	----------------------------------------------------------------------

- Confirm the installed NEW radiator grille bracket includes the open ribs in the center directly above the emblem as shown in Figure 4.
