Poor Air Conditioning Cooling Performance - Compressor Pressure Relief Valve Leak

YEAR(S)	MODEL(S)	ADDITIONAL INFORMATION
2021 - 2022	Tacoma

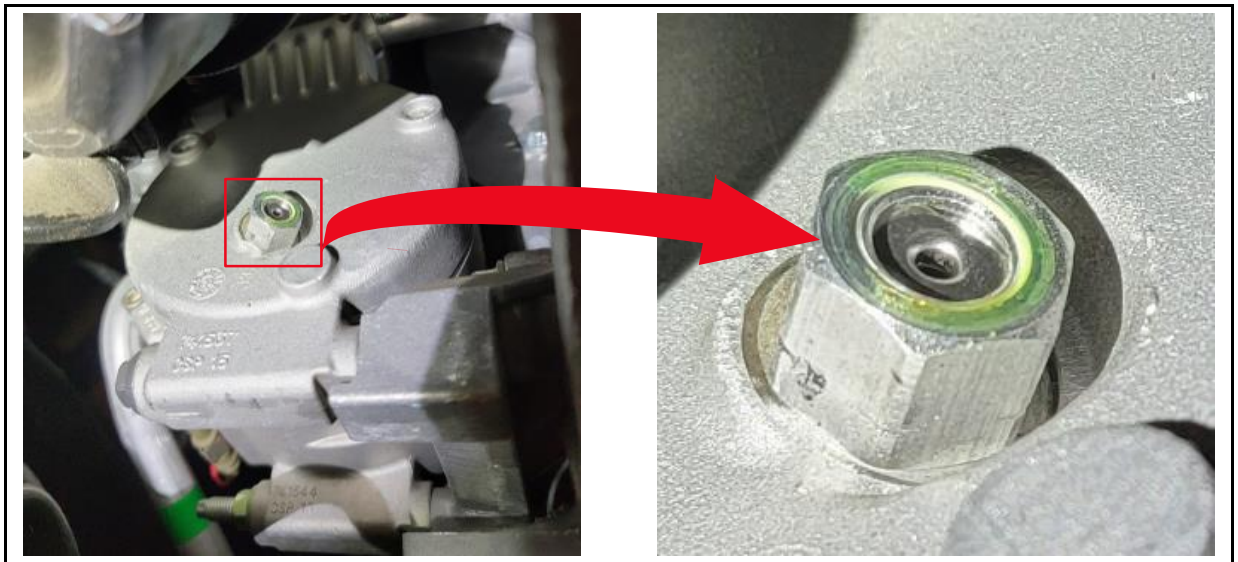
Some 2021 – 2022 model year Tacoma vehicles may exhibit a condition in which the air conditioning system has poor cooling performance sometimes accompanied by refrigerant vapor visible from under the vehicle. This condition is caused by the pressure relief valve opening and purging refrigerant at a pressure below specification. Follow the Repair Procedure in this bulletin to address this condition.

2. Is there evidence of leak detection dye at the pressure relief valve on the compressor?
 - **YES** — Continue to step 3.
 - **NO** — This bulletin does NOT apply. Continue diagnosis using the applicable Repair Manual.

Figure 1. Leak Detection Dye Found on the Pressure Relief Valve

7. Install the NEW pressure relief valve and O-ring.
 - A. Apply sufficient compressor oil (PSD1 or equivalent) to a NEW O-ring and fitting surface of the pressure relief valve.

- B. Install the NEW O-ring onto the pressure relief valve.
 - C. Install the pressure relief valve.
Torque: 8.0 N*m {82 kgf*cm, 71 in*lbf}
8. Reinstall the compressor onto the vehicle.
 Refer to TIS, applicable model and model year Repair Manual:
