Odor Remediation After Water Intrusion

Service Category Vehicle Interior

Section Interior Panels/Trim

May 26, 2022 Rev1:

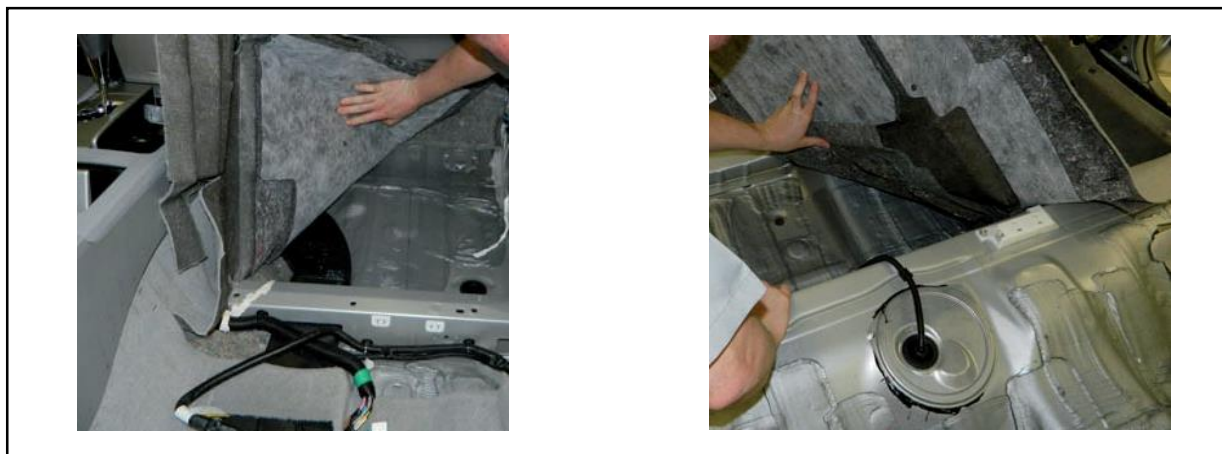
Figure 2. Floorboard Inspection

3. Complete a thorough inspection of the entire interior floorboard areas to ensure ALL affected areas are identified.

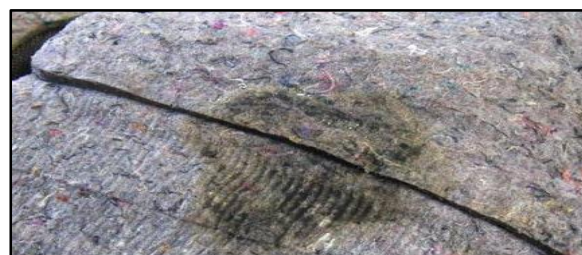
Figure 4. Example of Staining/Organic Matter

4. Inspect ALL soft parts for organic matter growth and/or staining that would indicate water contact.

- Soft parts include items that DO HAVE an absorbent quality that will require them to be removed and replaced with NEW parts if they have come into contact with moisture.
- Keep ALL soft parts that will be replaced away from the parts that will be reused.
Soft parts include:
 - Floor mats.
 - Carpet/Carpet padding/Jute padding.
 - Insulated pads/Styrofoam pads.
 - Dash panel insulator assembly (located behind instrument panel/dash pad).
- These parts should NOT be reused and require replacement with NEW parts once the remediation has been completed.

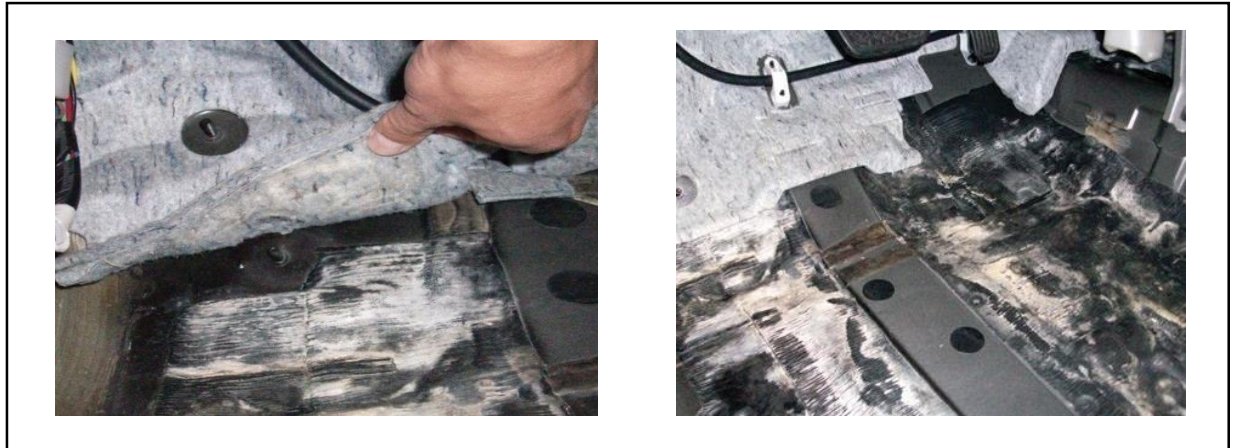
Figure 5. Examples of Organic Matter Growth Due to Water Intrusion Found During Vehicle Inspection

Some 2005 – 2022 model year Toyota vehicles that have undergone water intrusion may exhibit a condition in which a musty smell is present. Follow the procedures in this bulletin to remediate the odor and address this condition. The purpose of this service bulletin is to provide general guidelines and procedures for odor remediation. This service bulletin provides a guide on how to prepare the interior of the vehicle prior to an odor remediation being performed, as well as contact information for an approved vendor who will arrange the remediation, and instructions on how to prepare the interior of the vehicle for reassembly once the remediation has been completed. Refer to all model and model year specific Repair Manuals and the EPA (Environmental Protection Agency) website for the most up-to-date safety and precautionary guidelines. This service bulletin is to provide a general overview and direction for the odor remediation process.

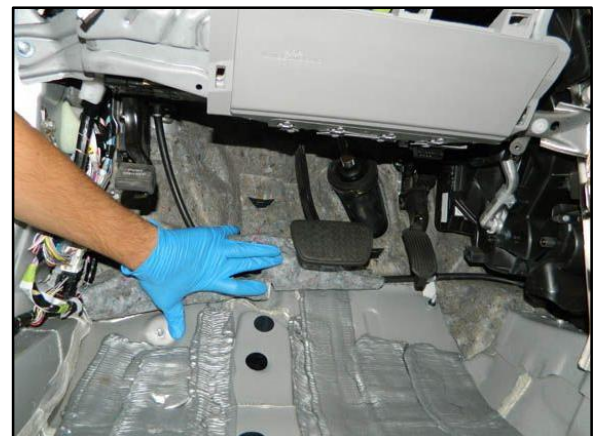
Figure 6. Driver Side Dash Panel Insulator Assembly Inspection

6. Inspect the dash panel insulator assembly along the base of the instrument panel and floorboard area for ANY signs of water or organic matter growth. Perform this inspection on BOTH the driver AND passenger sides of the vehicle. If ANY sign of organic matter growth and/or staining that would indicate water contact has occurred is found, the dash panel insulator assembly will need to be replaced.

If the dash panel insulator assembly requires replacement, it should be removed and replaced with a **NEW** part **BEFORE** remediation of the vehicle. On most vehicles, replacement of the dash panel insulator assembly requires removal of the instrument panel/dash pad assembly and the HVAC ducting. Do **NOT** attempt to cut out affected areas or treat the dash panel insulator assembly.

3. If the dash panel insulator assembly was found to be affected by water contact during the initial inspection, remove and replace the dash panel insulator assembly. Refer to TIS, applicable model and model year Repair Manual for instructions.

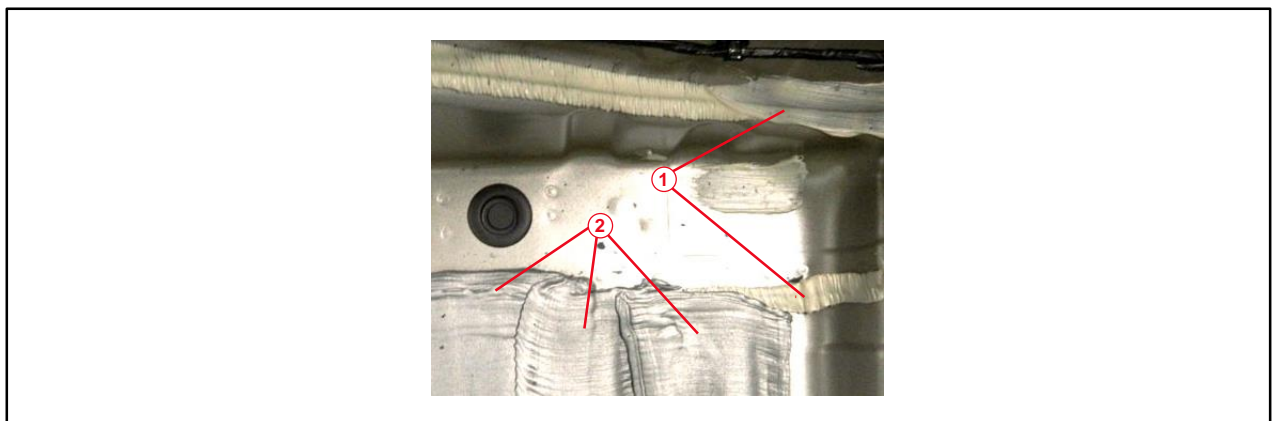
Figure 9.

1	Urethane Seam Sealer
2	LASD

- Avoid removal of the urethane seam sealer where sheet metal panels join. If the urethane seam sealer has been removed during the LASD removal process, it will be necessary to reapply as needed AFTER the remediation process is complete.
