Elapsed Time After Start Does Not Update

YEAR(S)	MODEL(S)	ADDITIONAL INFORMATION
2020	Tacoma

Some 2020 model year Tacoma vehicles may exhibit a condition in which the Elapsed Time After Start does not update in the Trip Information menu on the head unit. The combination meter ECU logic has been modified to reduce the possibility of this condition. Follow the Repair Procedure in this bulletin to address this condition.

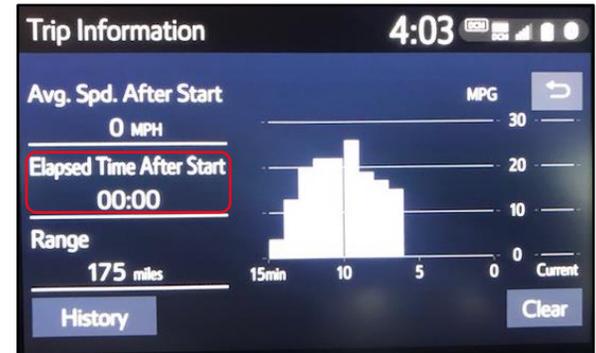
Figure 1.

1. Confirm the condition exists.
 - A. Does the Elapsed Time After Start NOT update in the Trip Information menu on the head unit as shown in Figure 1?
 - **YES** — Continue to substep B.
 - **NO** — This bulletin does NOT apply. Continue diagnosis using the applicable Repair Manual.
 - B. Confirm the combination meter calibration.
 - (1) Use Techstream to confirm if the combination meter has been updated.
 - (2) Is the calibration ID of the combination meter listed in Techstream 8380004N0001?
 - **YES** — Continue to step 2.
 - **NO** — This bulletin does NOT apply. Continue diagnosis using the applicable Repair Manual.

2. Reflash the combination meter.

Follow the procedures outlined in [T-SB-0134-16](#) (USA) or [T-SB-0165-19](#) (Mexico), *Techstream ECU Flash Reprogramming Procedure*, and flash the combination meter with the NEW calibration file update.

3. Using Techstream, perform a Health Check to confirm if the combination meter calibration has been updated and clear ANY stored DTCs.
4. Confirm the condition no longer exists.
